APPENDIX 3. 2009 Inspection Photographs by the New York State Department of Transportation

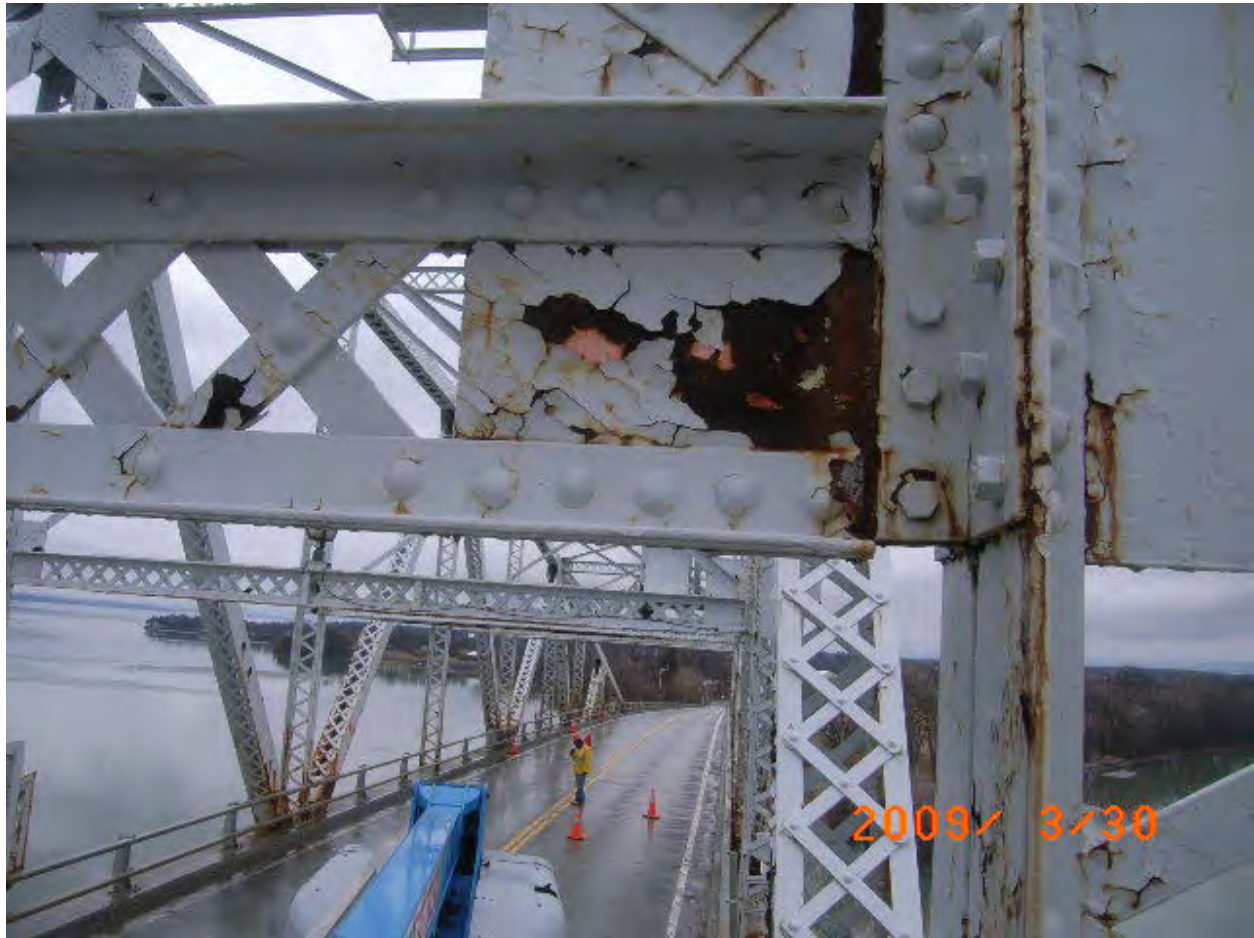
Figure 110. Span 7 strut at Panel Point 16.

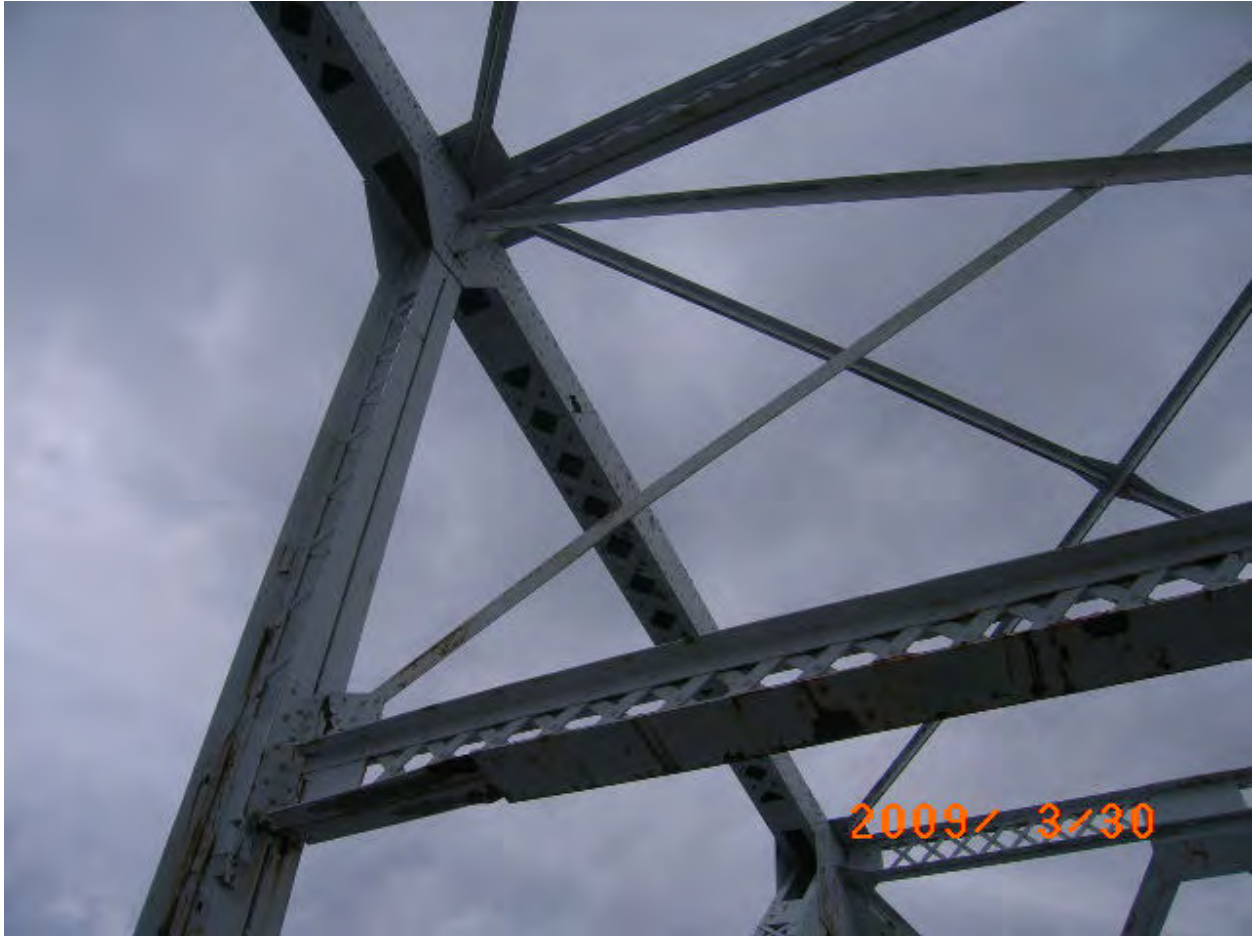
Figure 111. Span 7 strut, upper chord, and sway bracing at Panel Point 16.

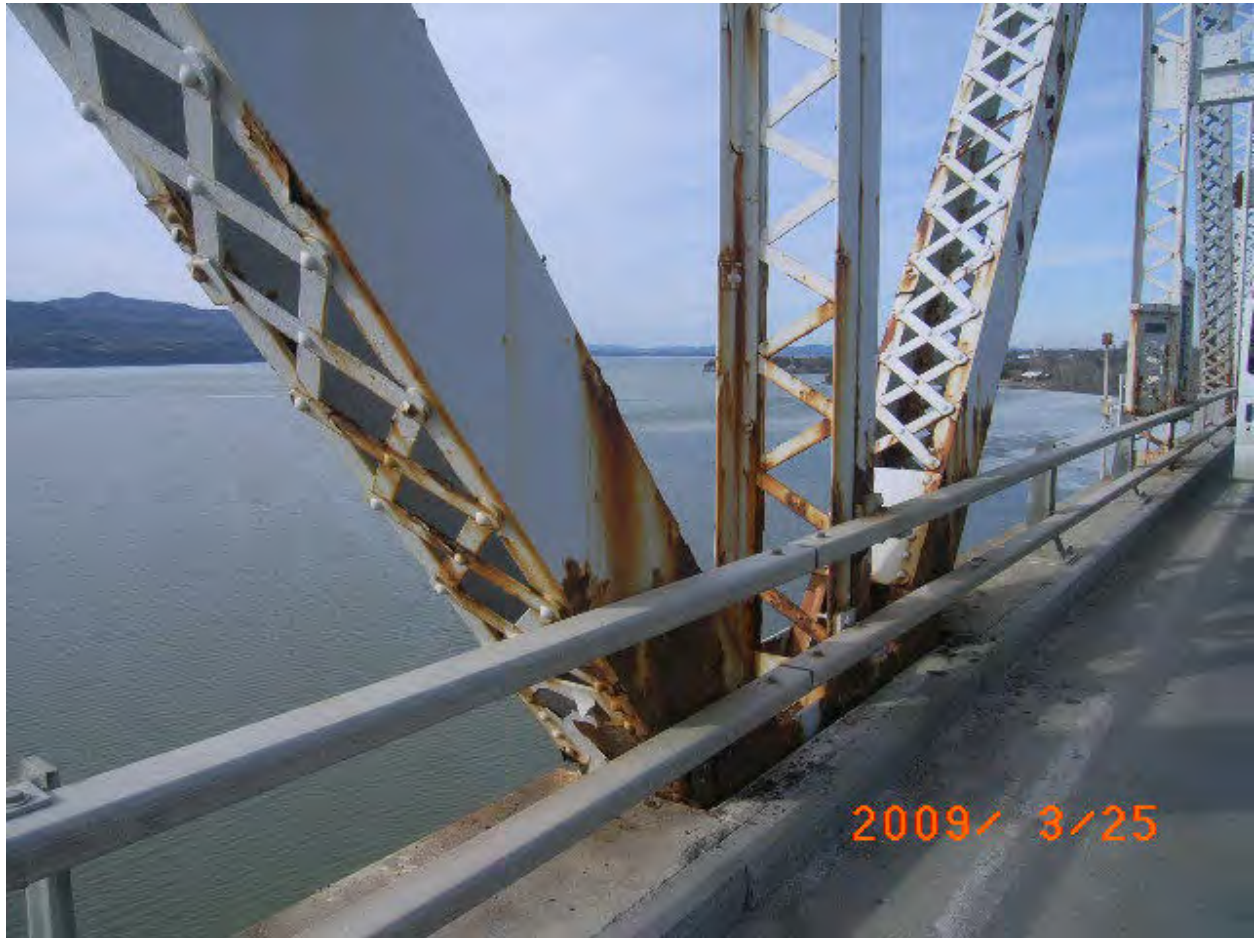
Figure 112. Span 7 deck at connection L16.

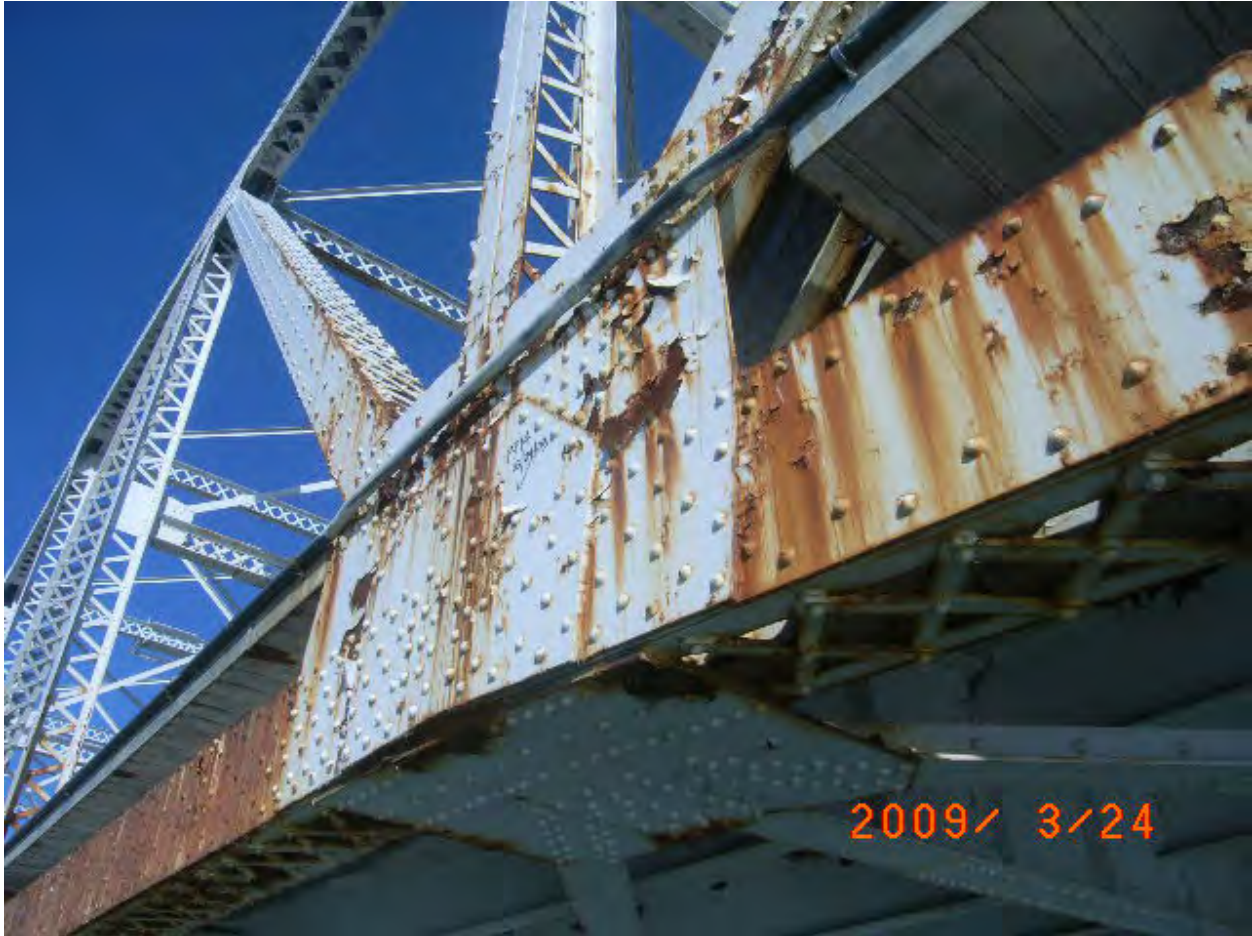
Figure 113. Span 7 lower chord connection at L14.

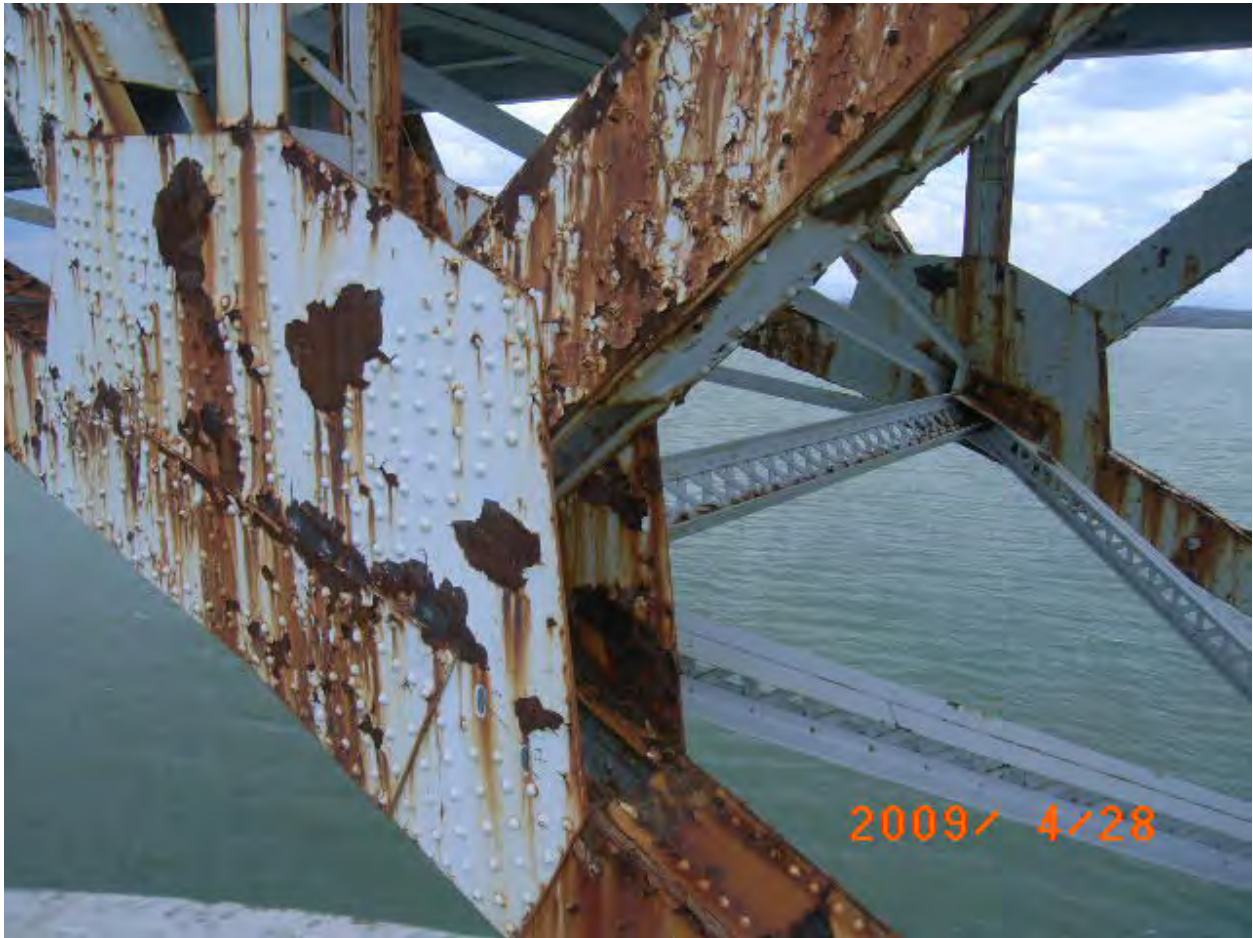
Figure 114. Span 7, lower chord connection at L12.

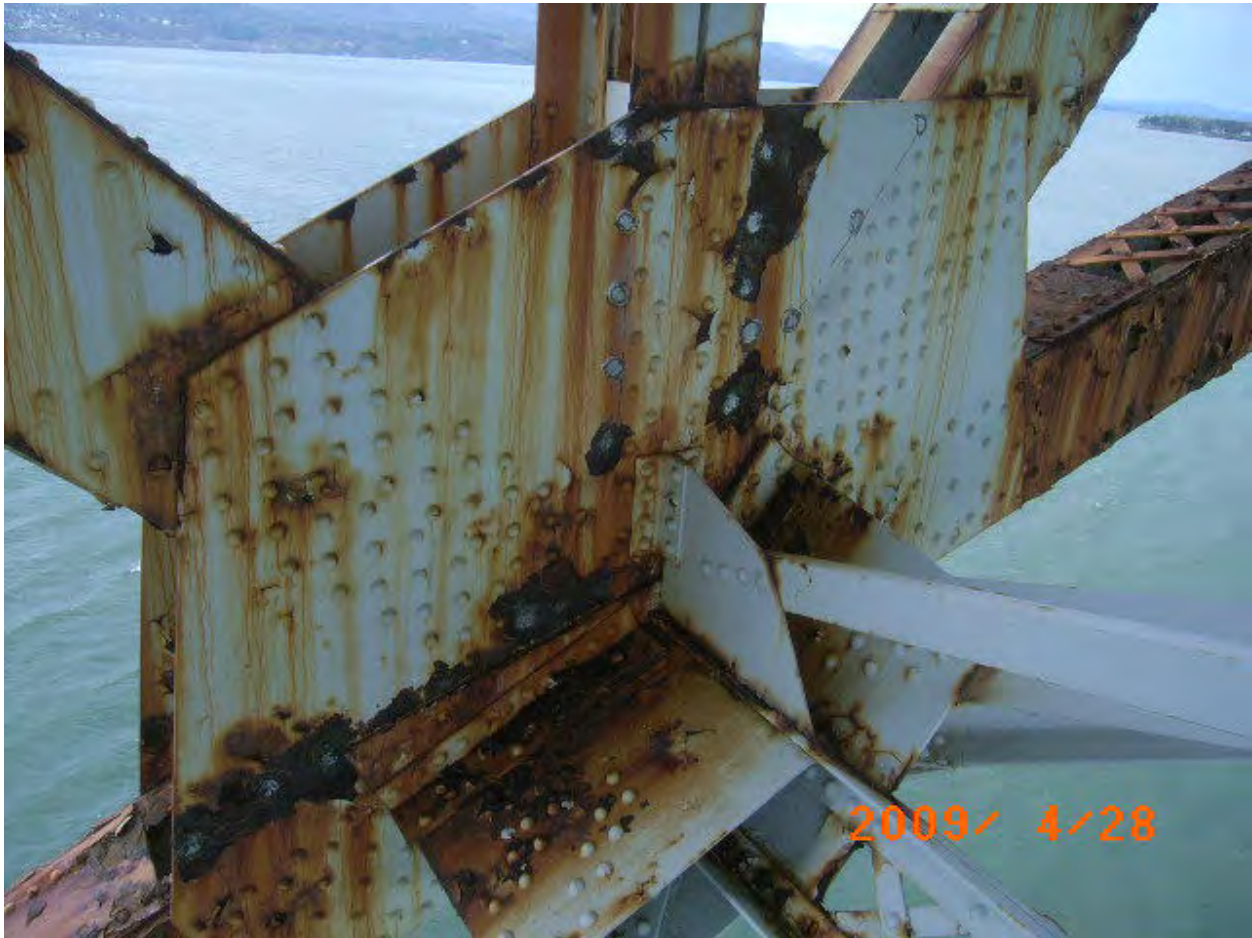
Figure 115. Span 7 lower chord connection at L12, interior side.

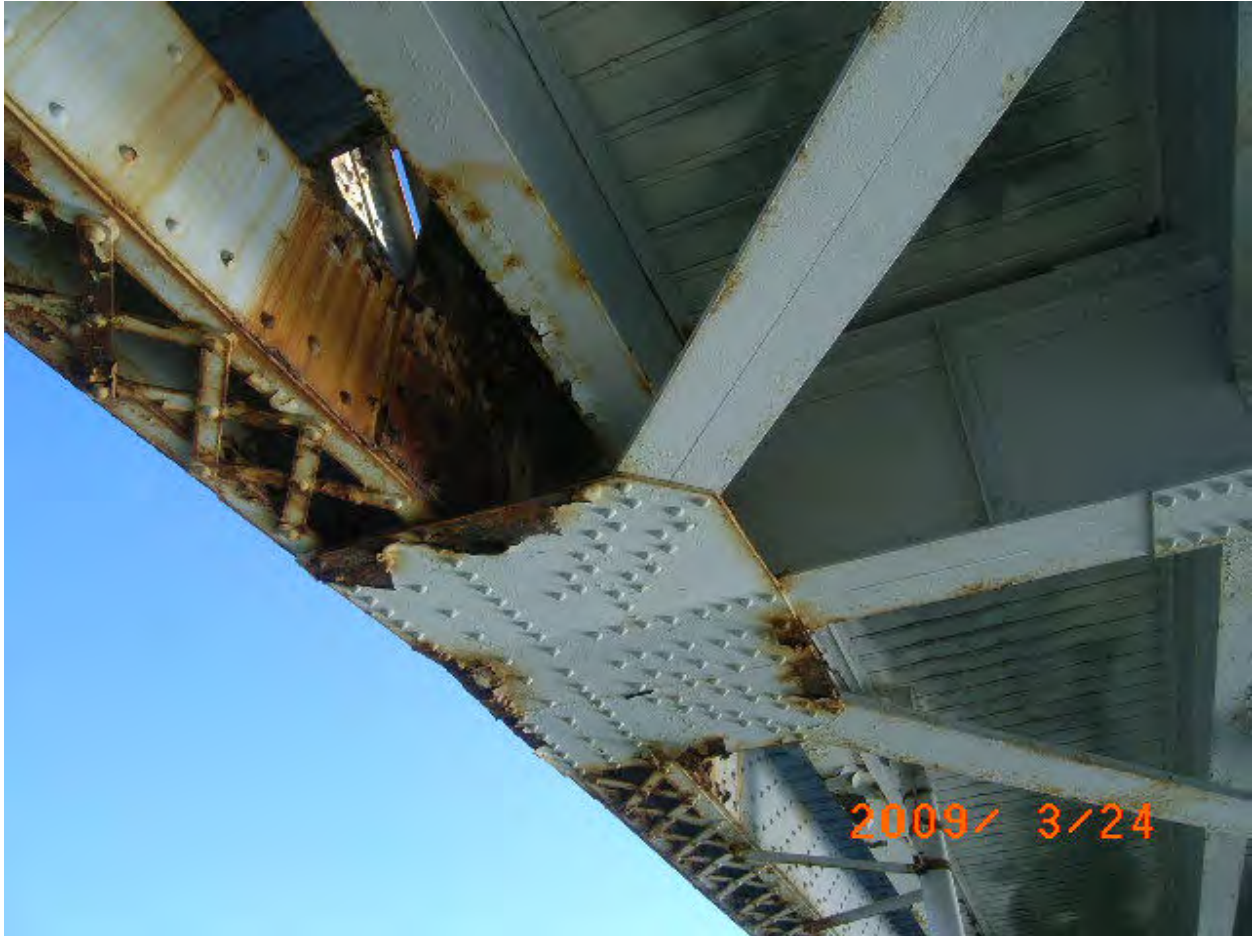
Figure 116. Span 7 lower chord lateral connection at L14.

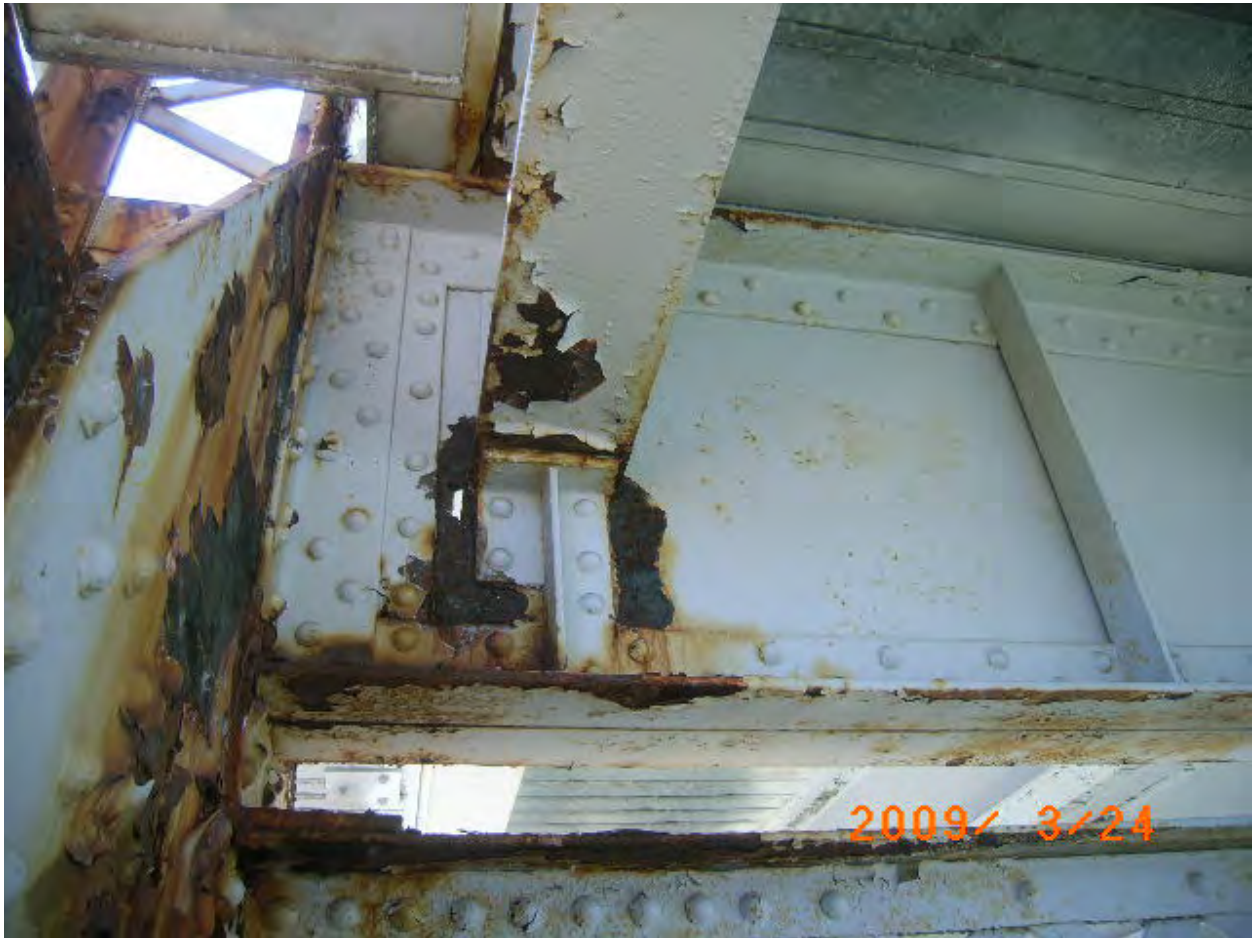
Figure 117. Span 7 Floor Beam 13.

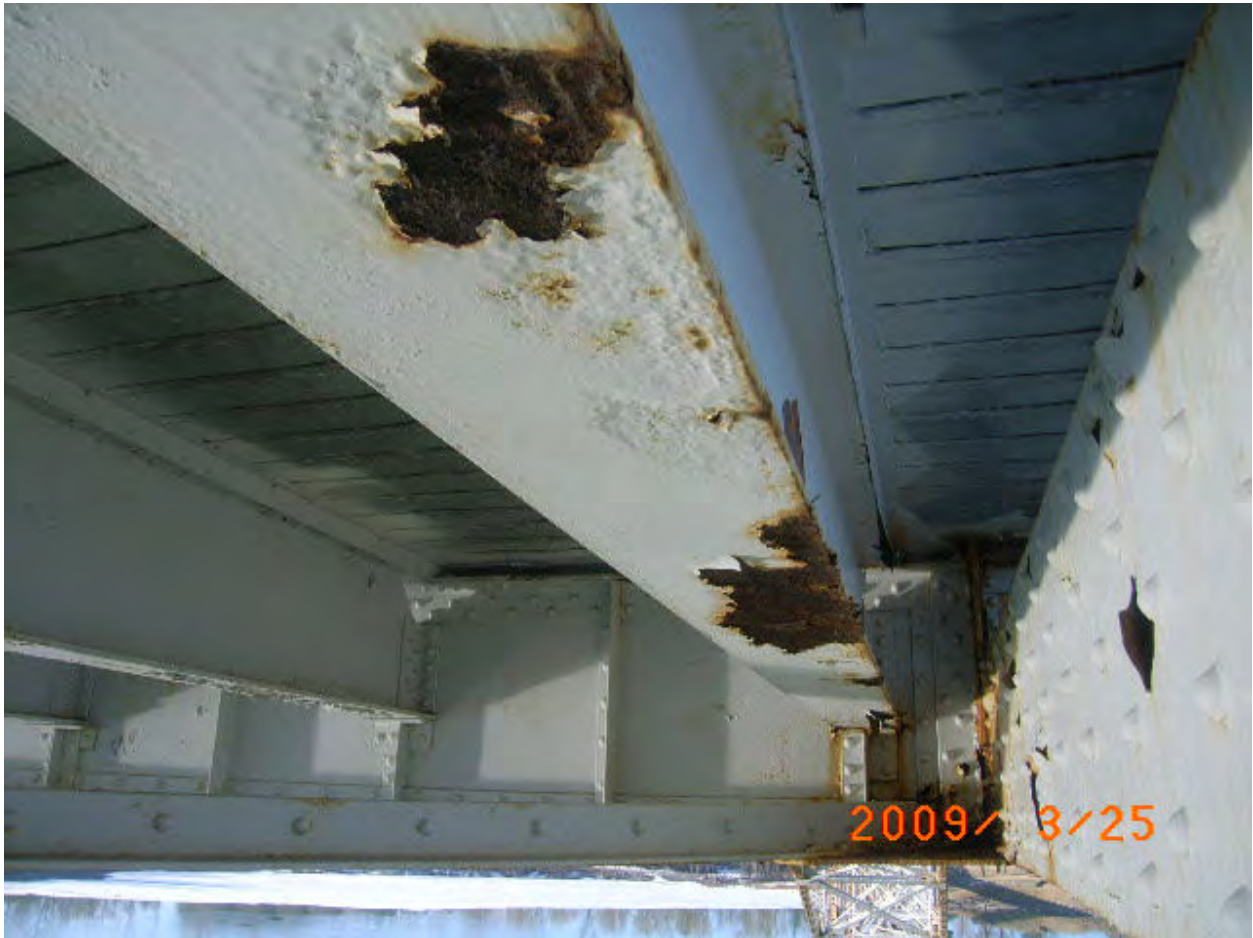
Figure 118. Span 7 Panel 20 stringer.

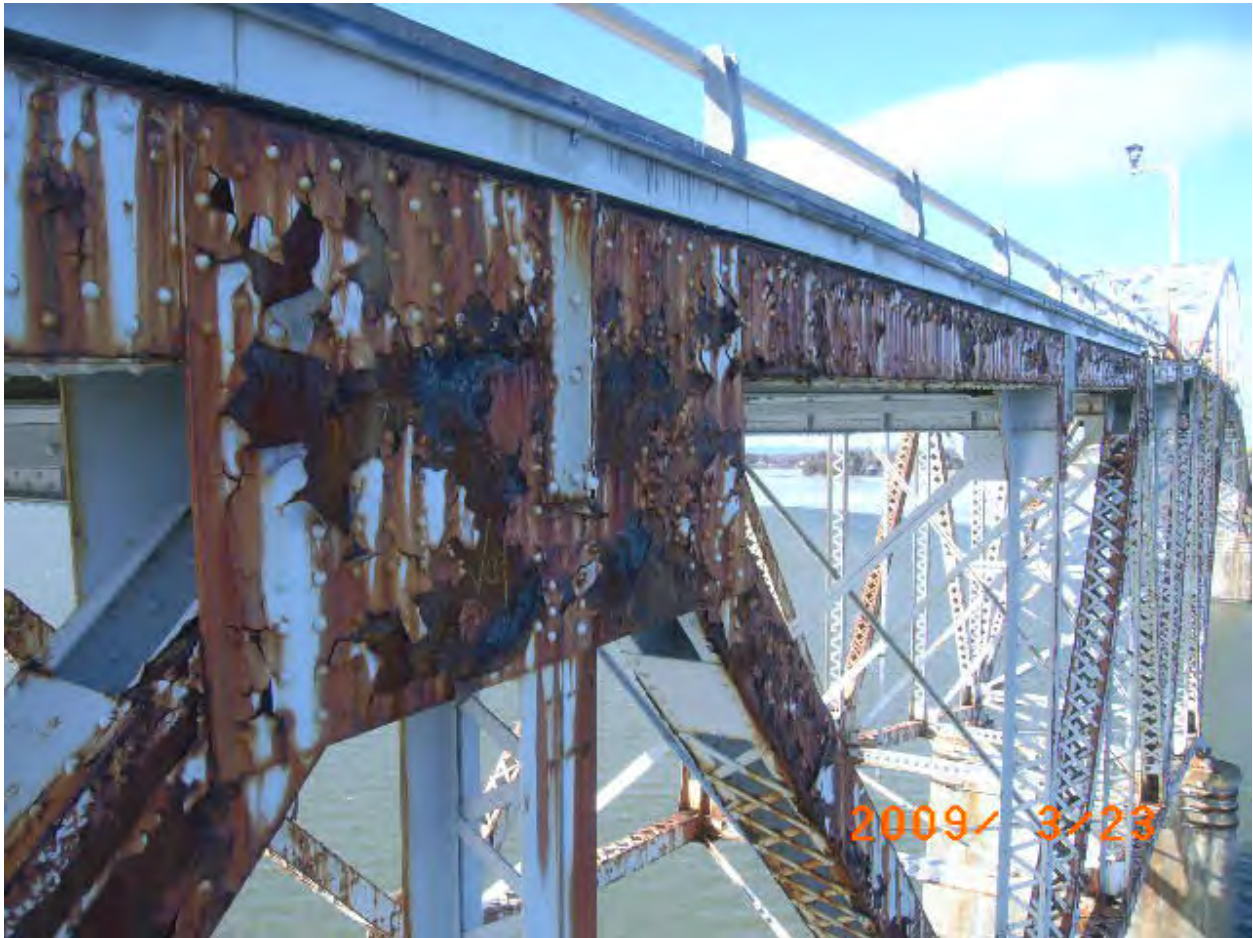
Figure 119. Span 6 upper chord connection at U05.

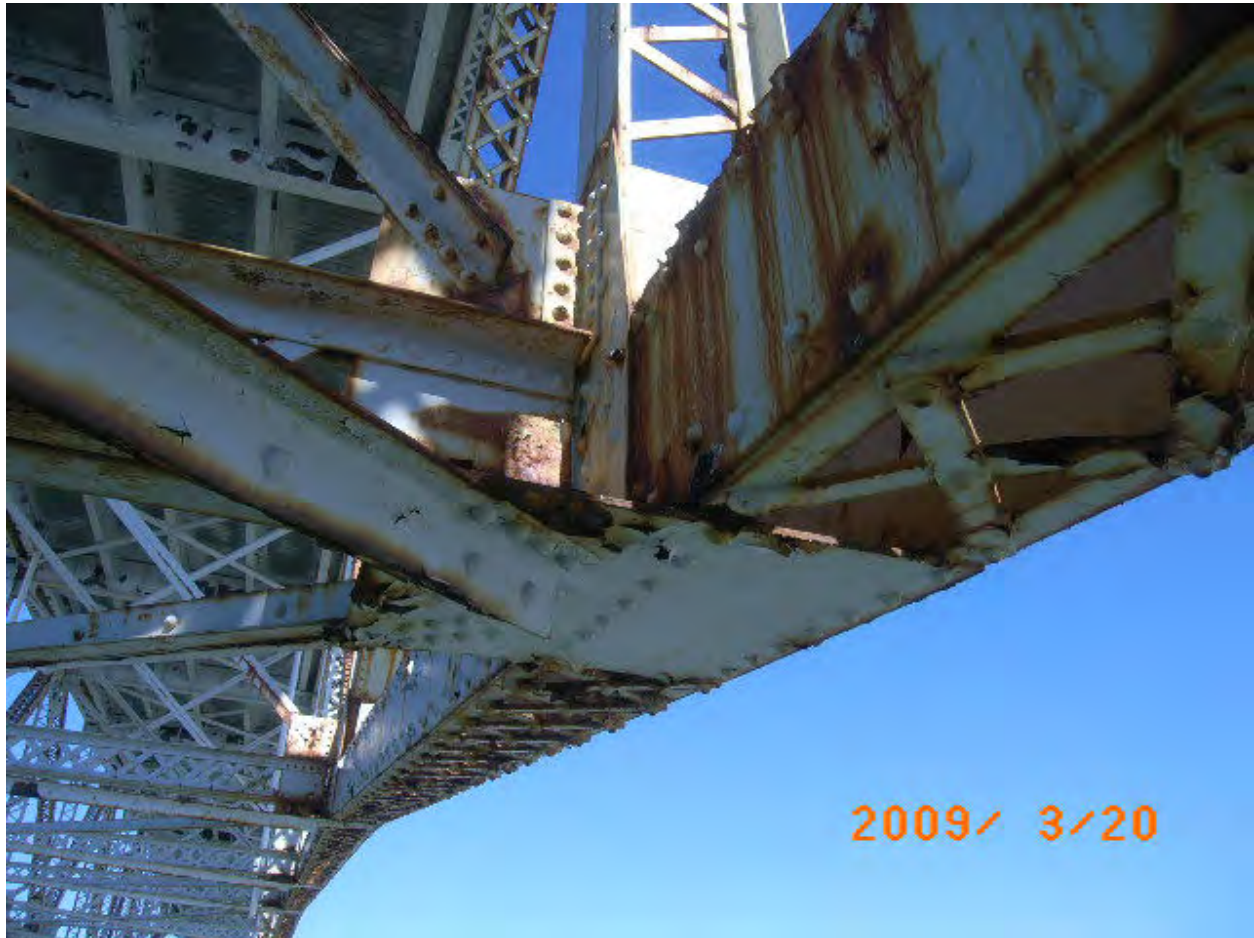
Figure 120. Span 6 lower chord connection at L01 (Spans 4, 5, 6, 8 and 9 are similar).

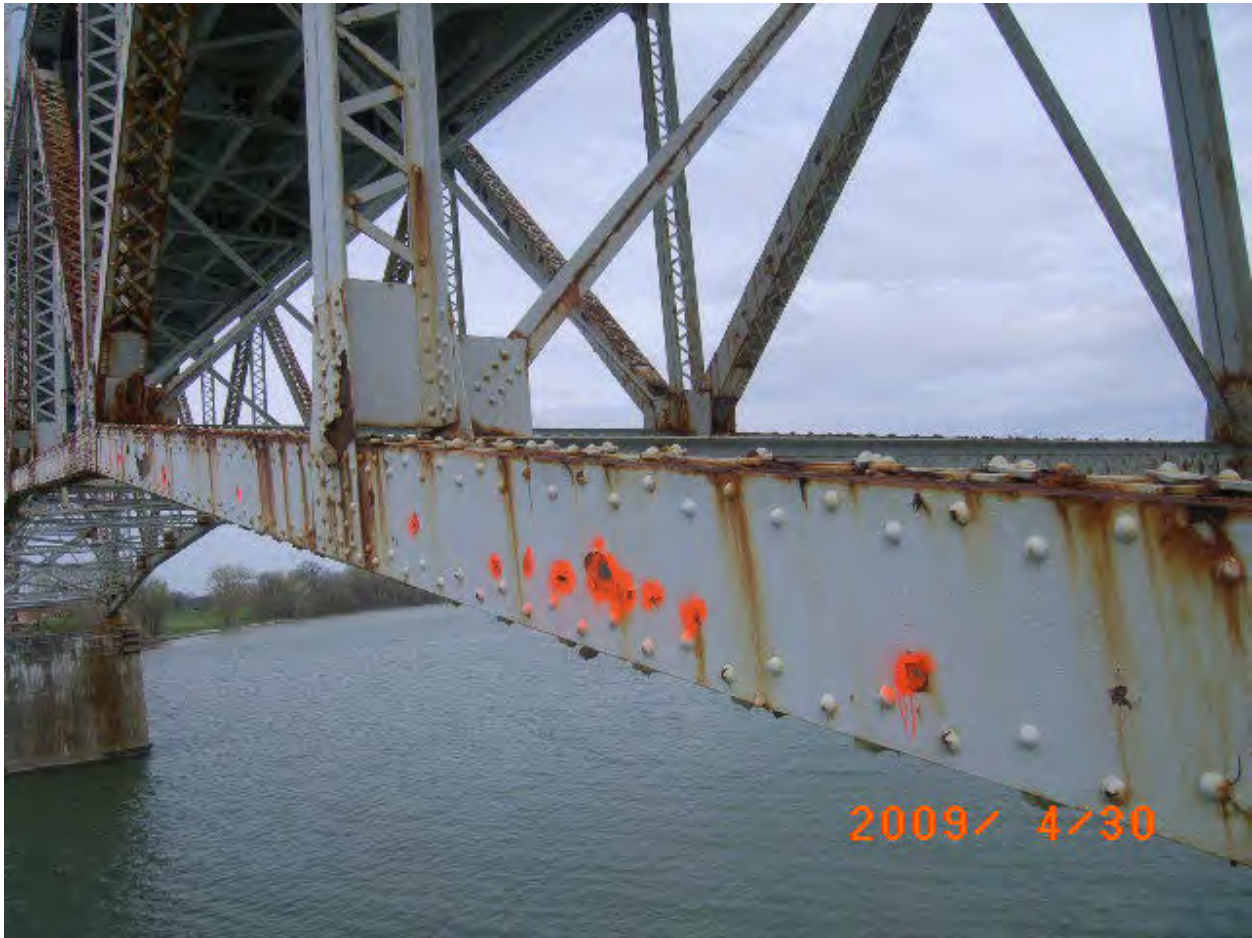
Figure 121. Span 6 lower chord at L00-L02.

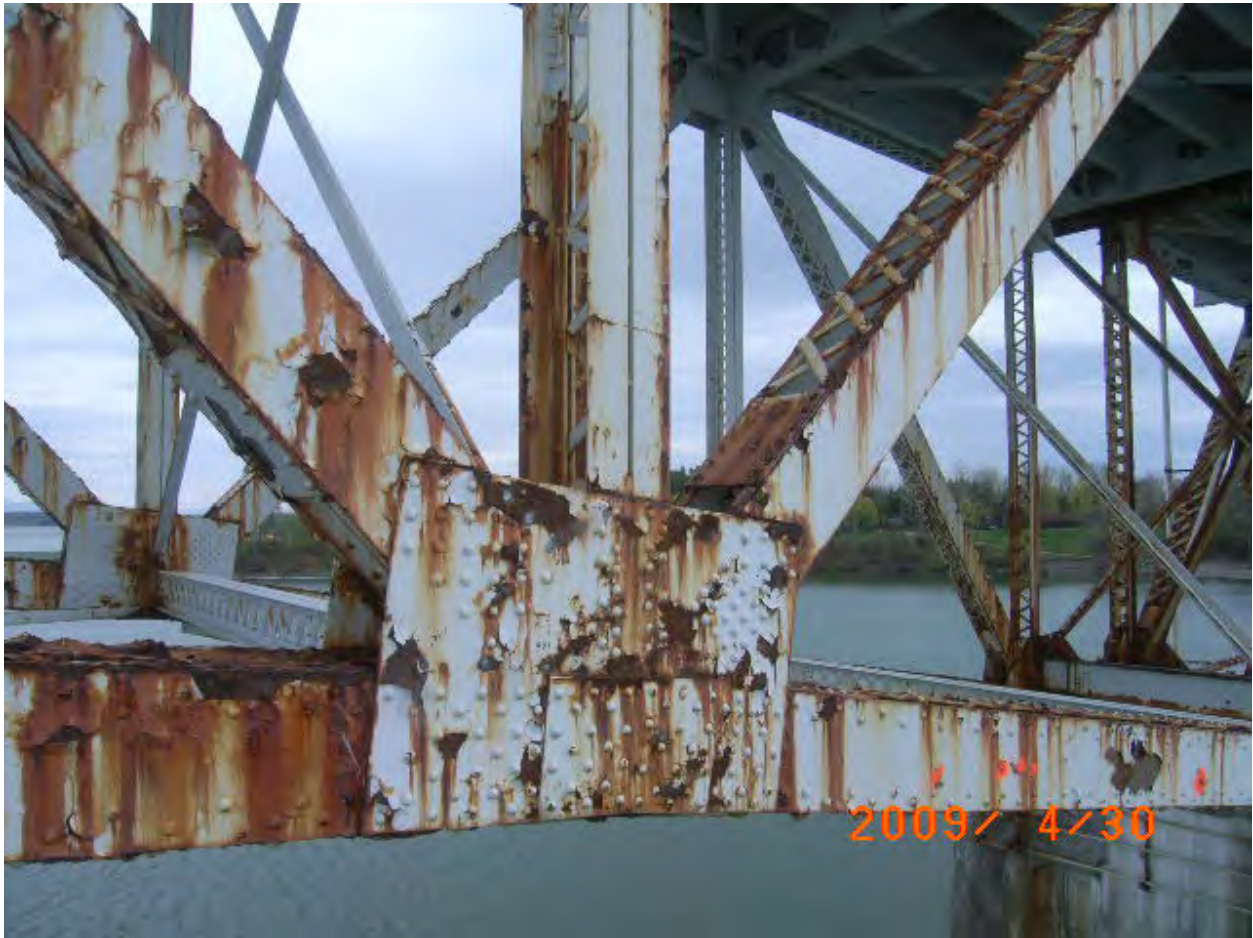
Figure 122. Span 6 lower chord connection at L02.

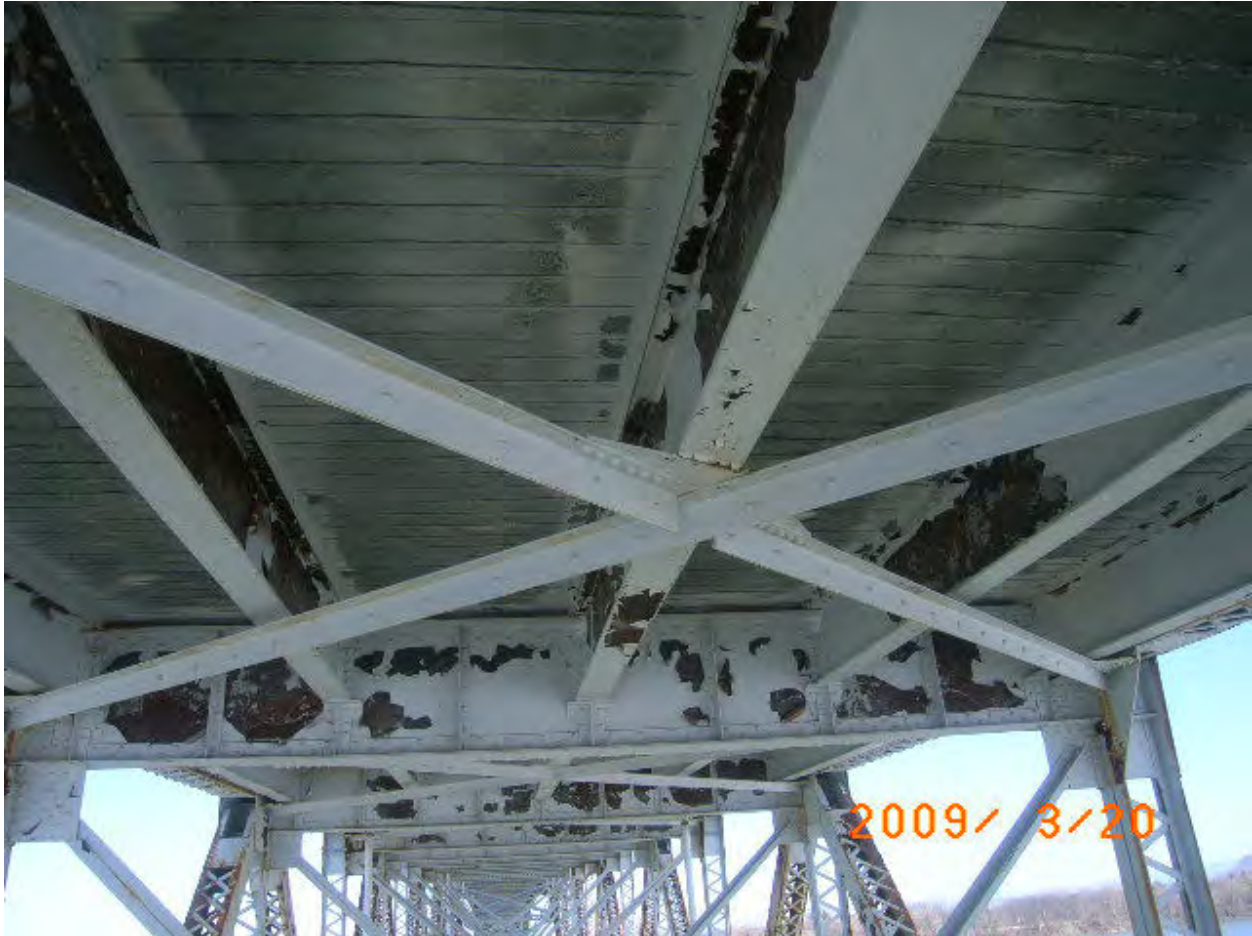
Figure 123. Span 6, Panel 2, laterals, stringers, and floor beam (Spans 4, 5, 6, 8, 9 are similar).

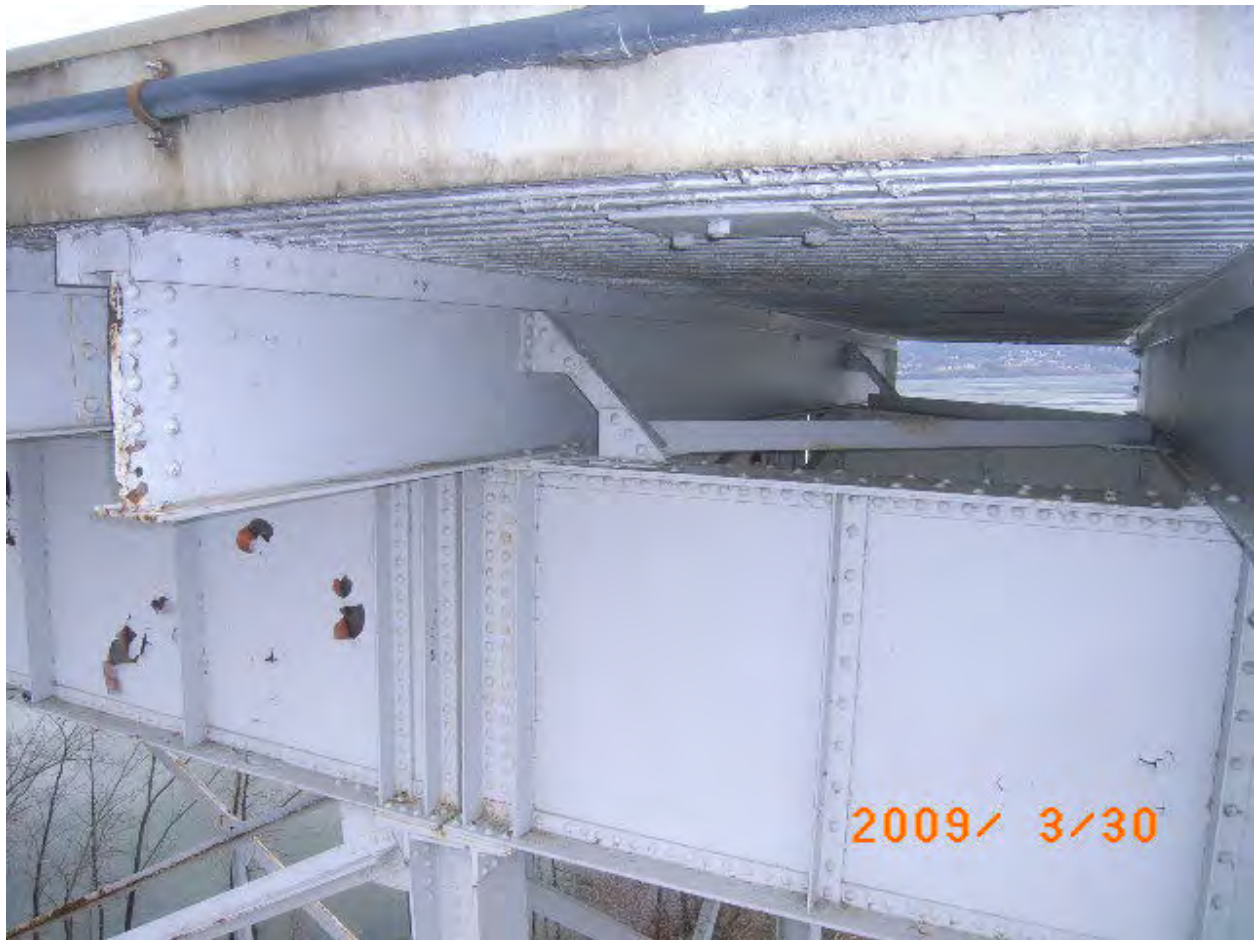
Figure 124. Span 11 Floor Beam at G2 (All girder spans are similar).

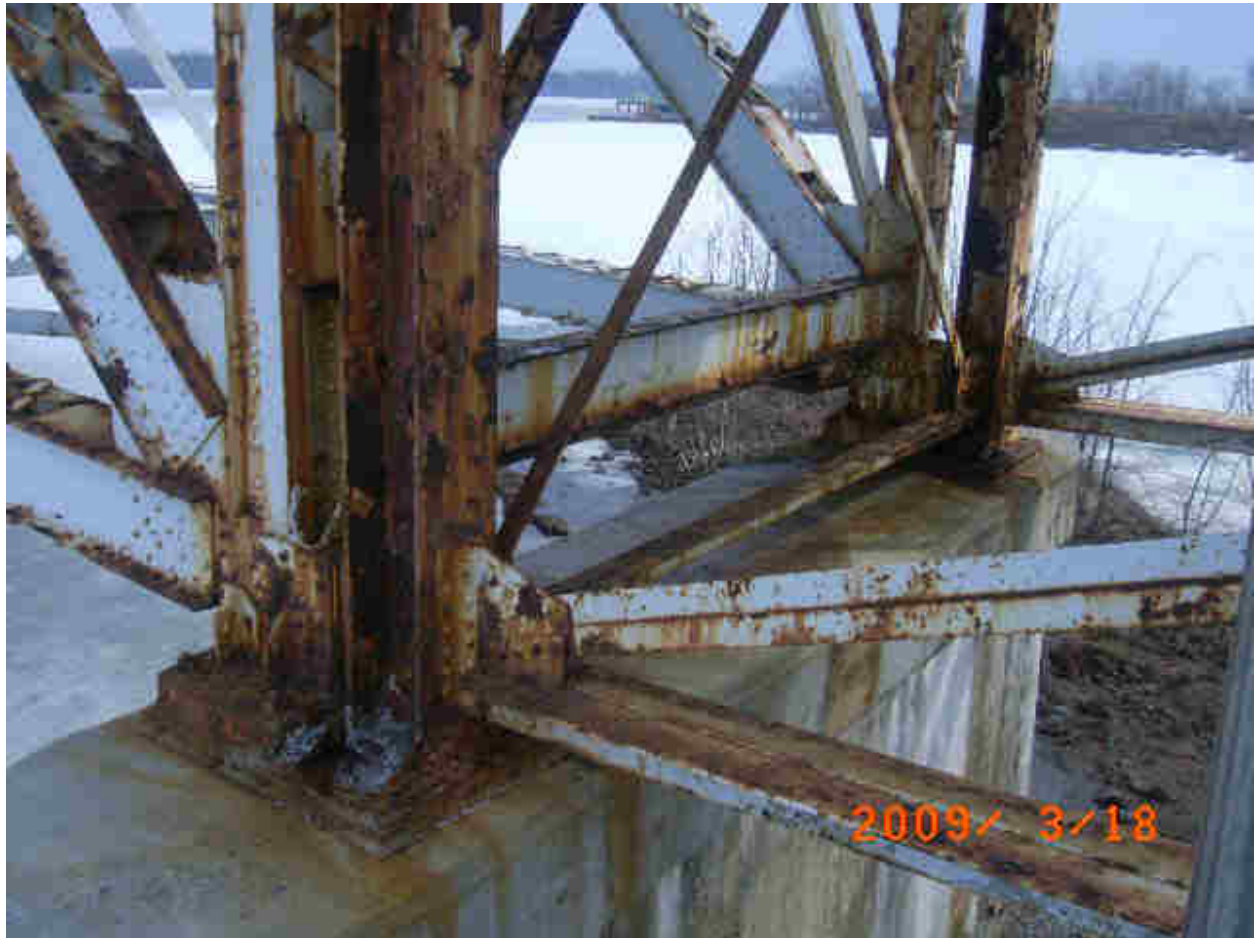
Figure 125. Pier 3 fixed bearings (Spans 3-4).

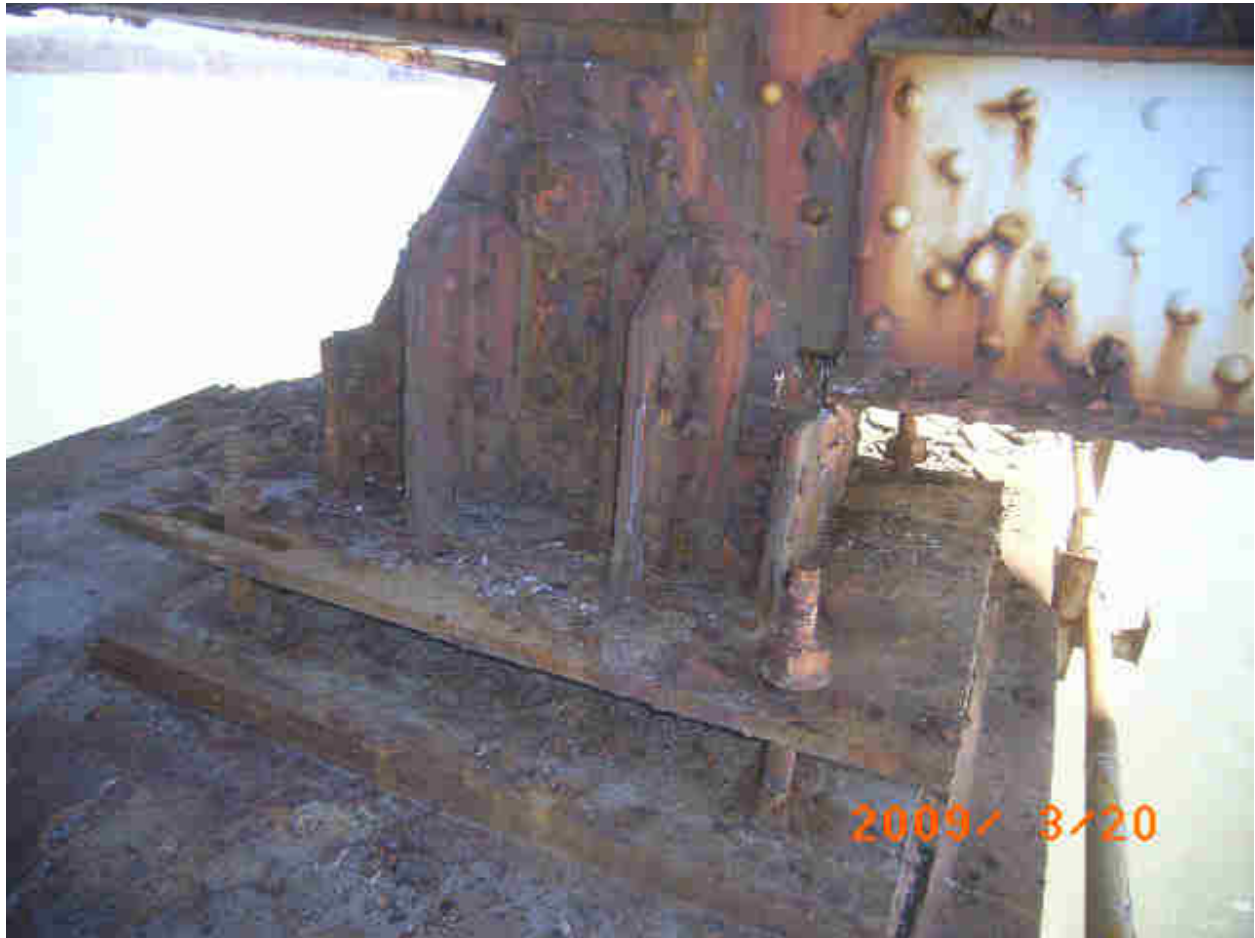
Figure 126. Span 5 at Pier 5, right truss roller bearing.

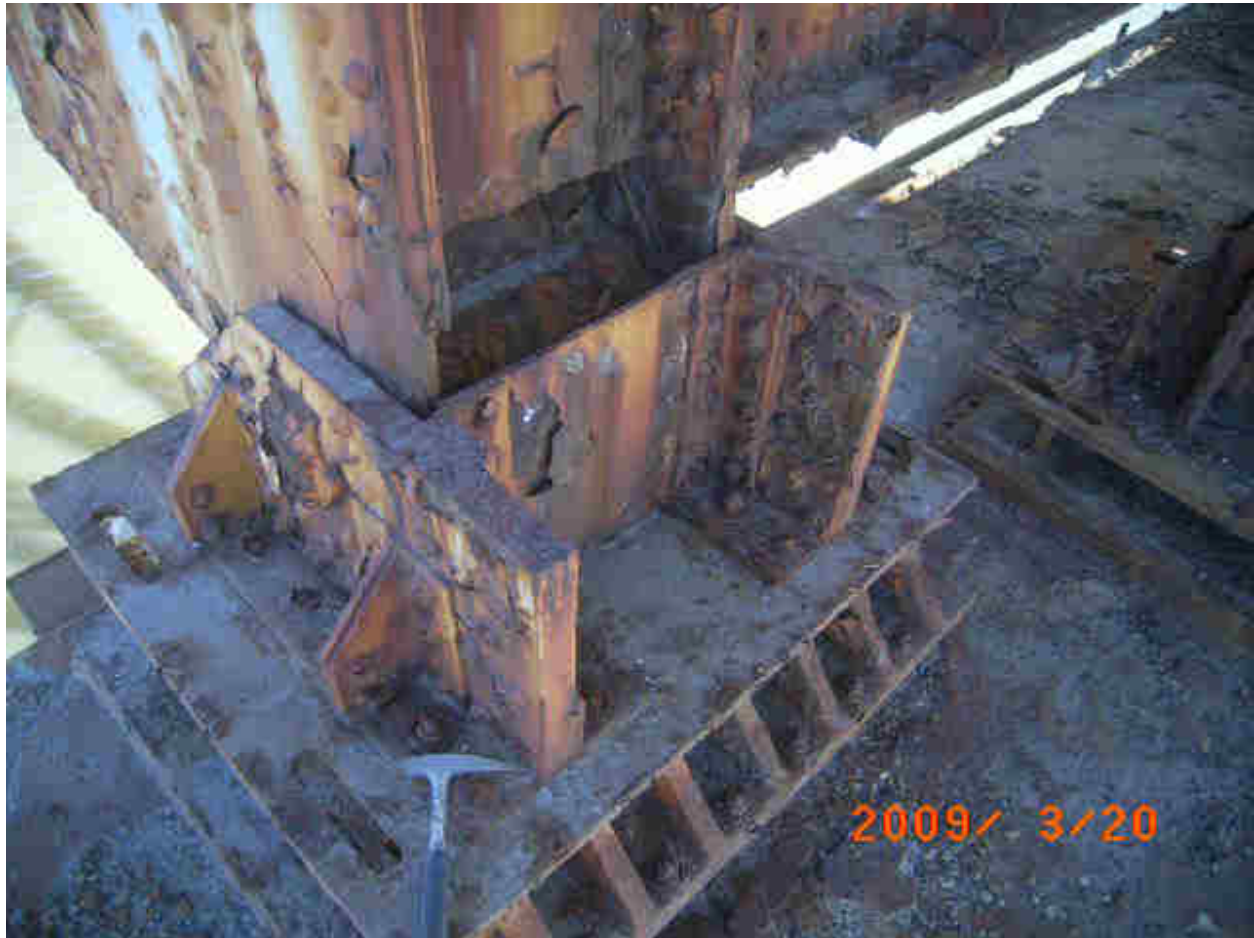
Figure 127. Span 6 at Pier 5, left truss roller bearing.

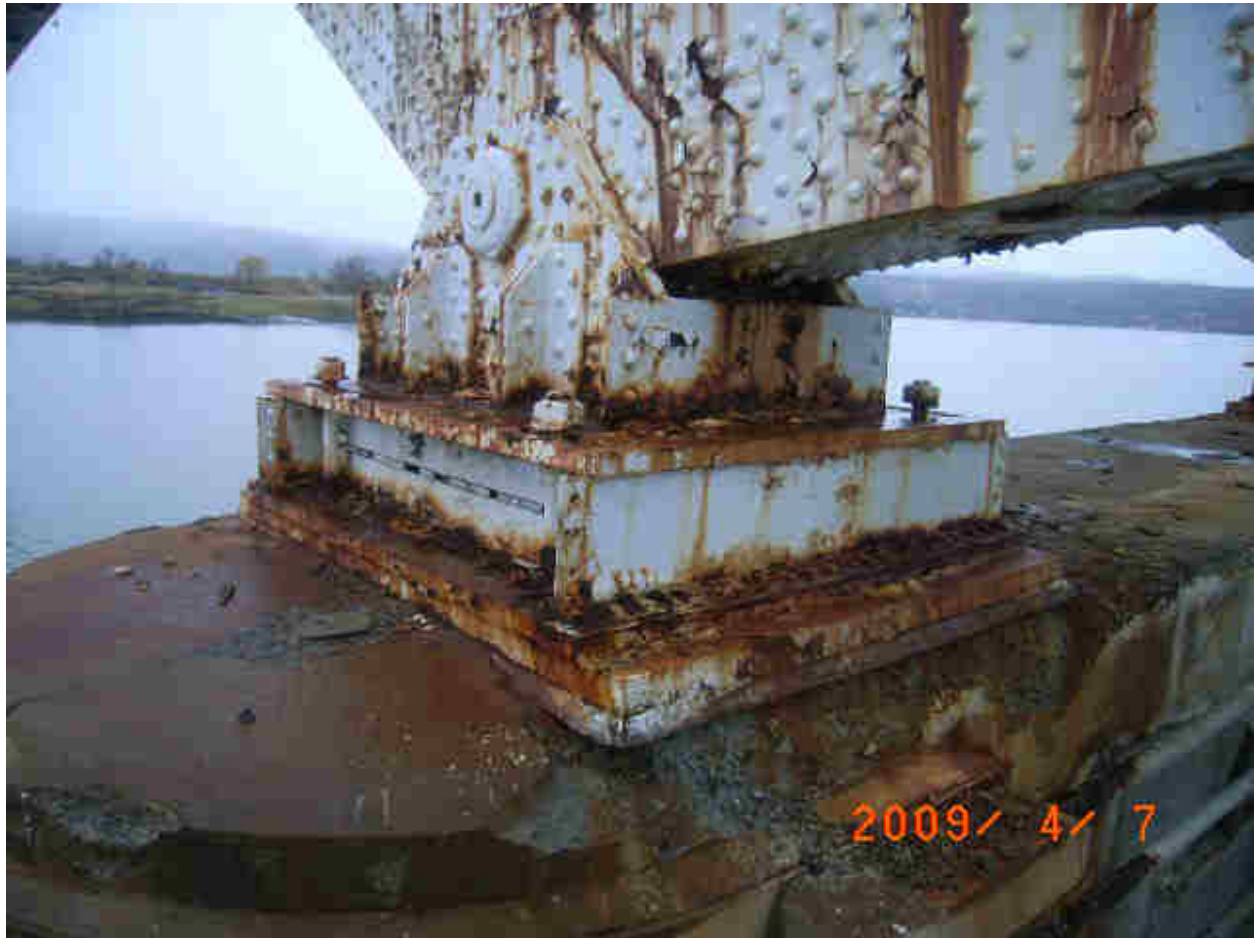
Figure 128. Spans 7/8 at Pier 7, right truss rocker bearing.
