APPENDIX 3. 2009 Inspection Photographs by the New York State Department of Transportation

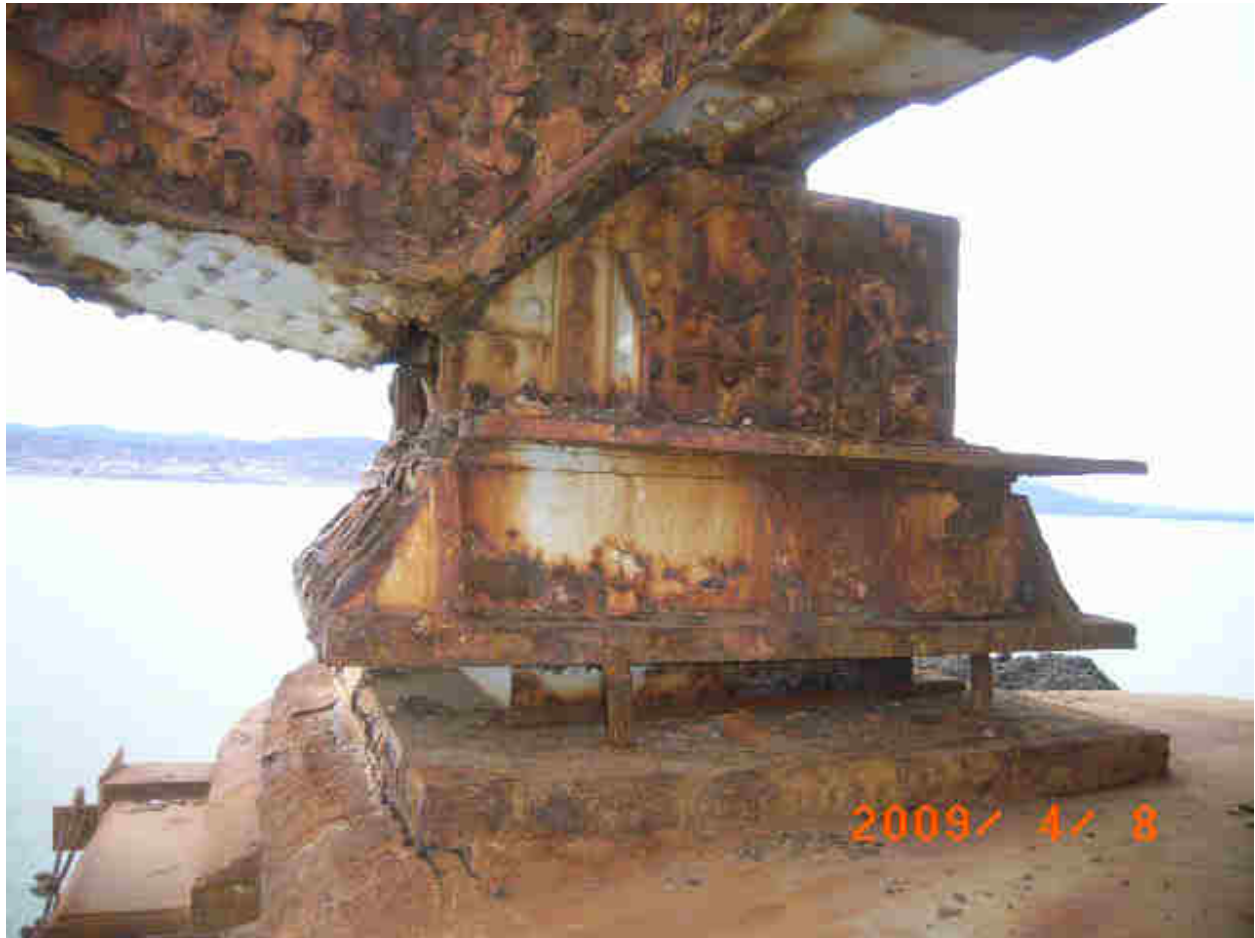
Figure 129. Span 8 at Pier 8, left truss roller bearing.

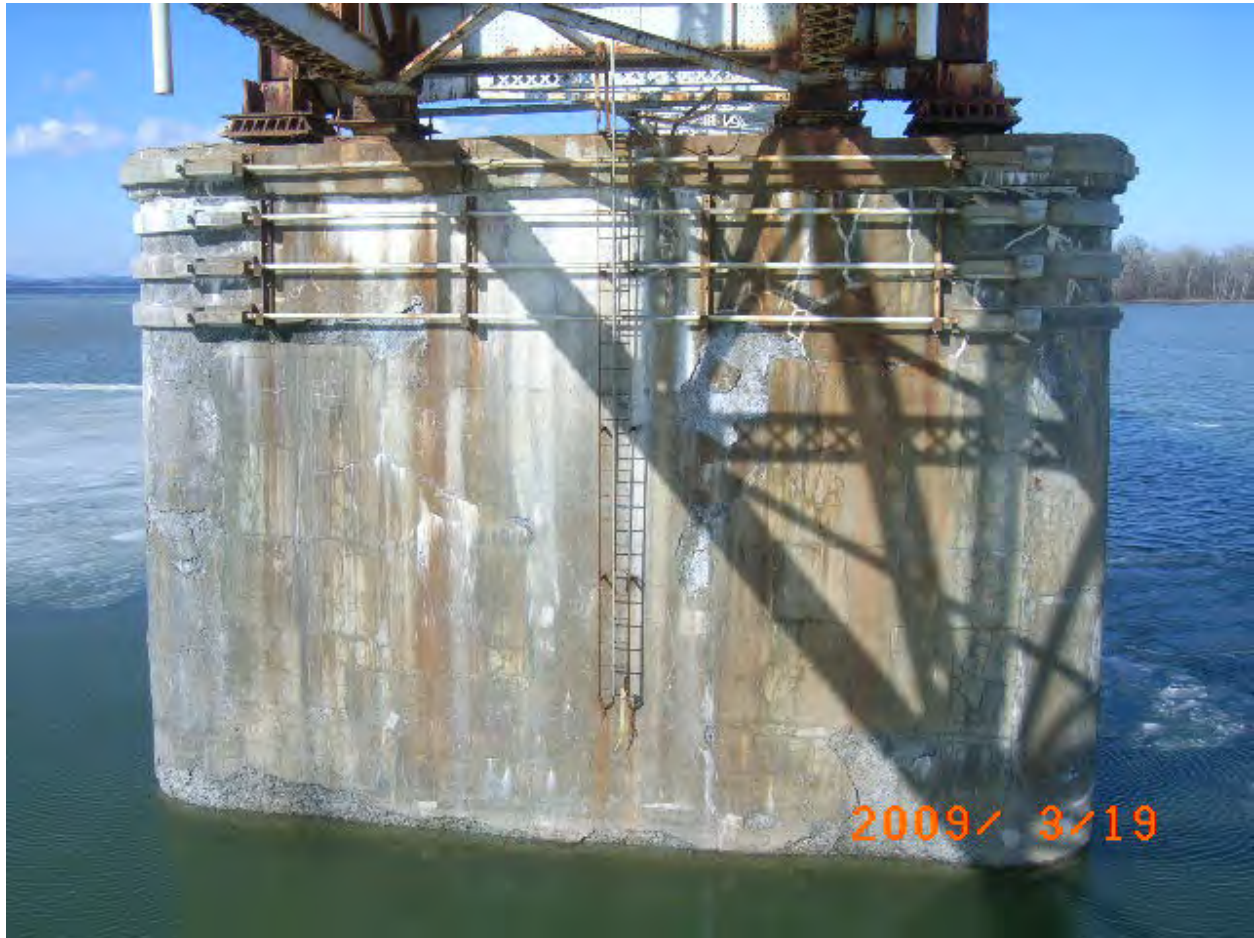
Figure 130. Pier 5, south side of stem. The potential failure of this pier resulted in the permanent closure of the Lake Champlain Bridge.

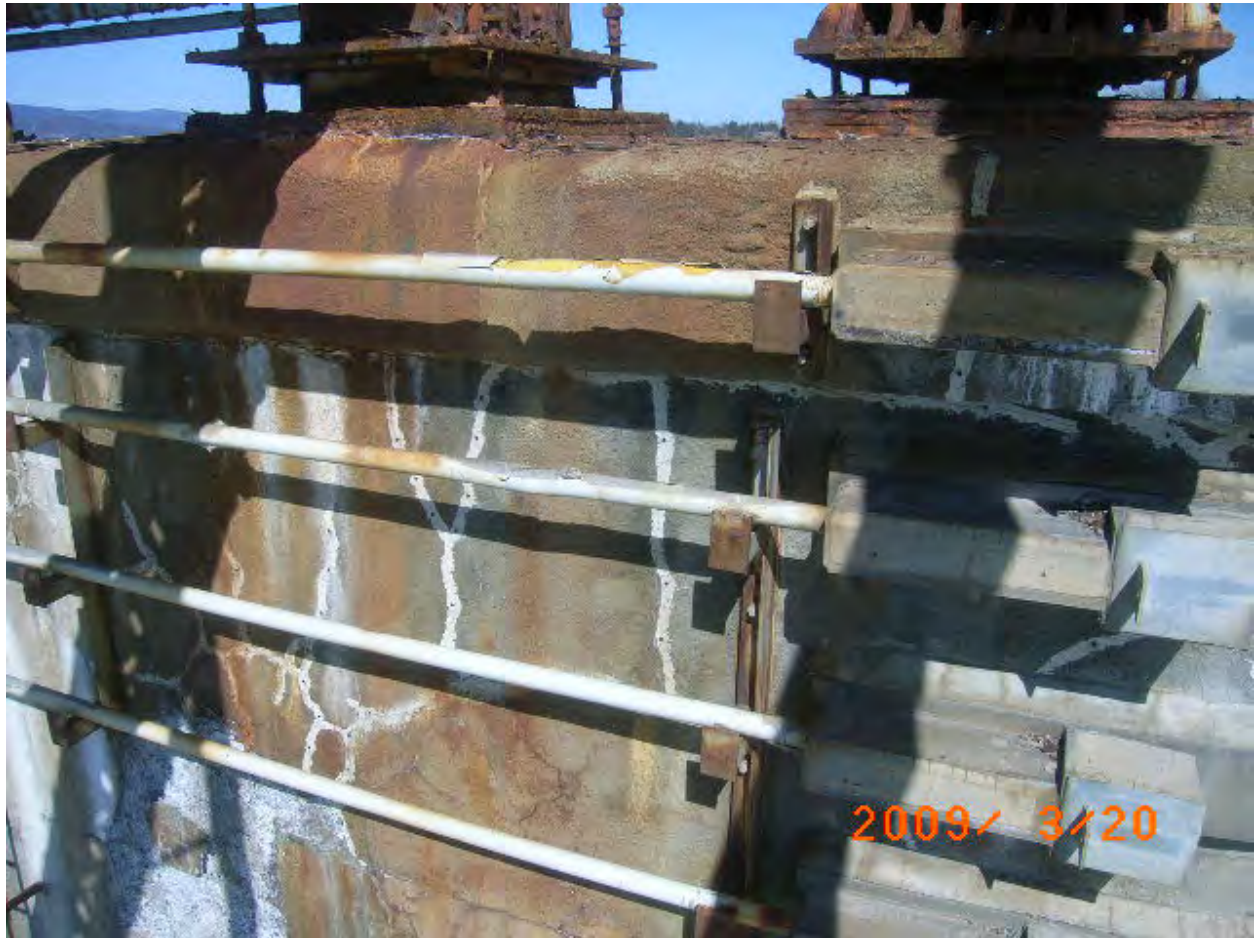
Figure 131. Pier 5 upper south side of stem, cap and tensioners.
