HISTORIC AMERICAN ENGINEERING RECORD

LAKE CHAMPLAIN BRIDGE

HAER No. NY-541

Structural Type: Steel continuous through and deck truss span

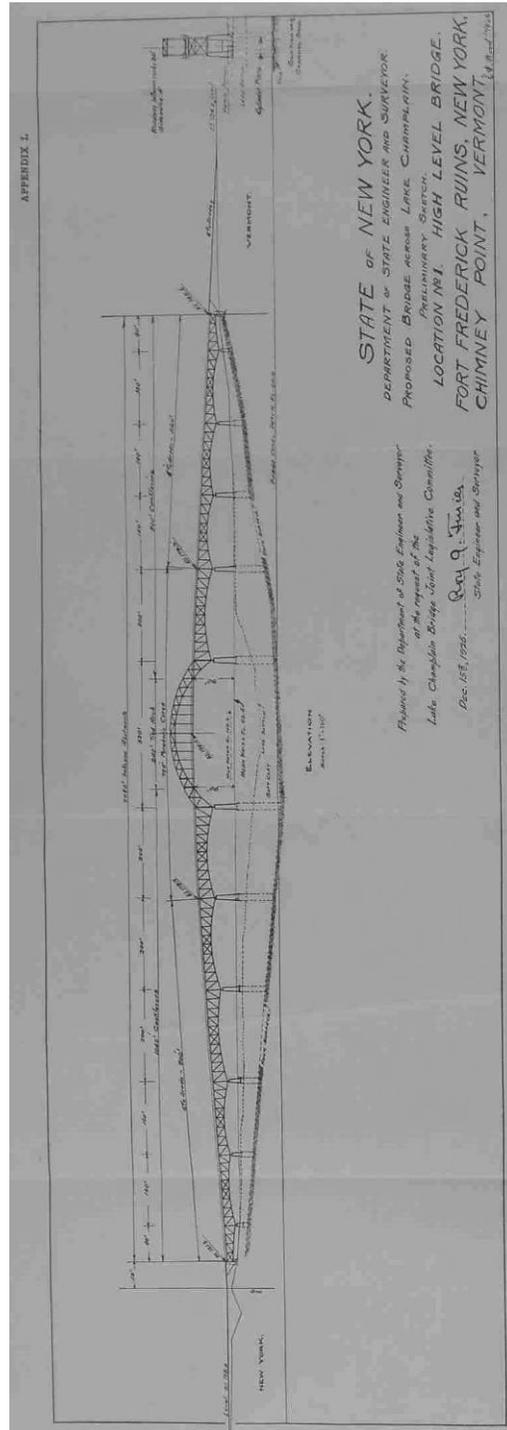
Figure 6. Proposed Bridge Across Lake Champlain, Preliminary Sketch. High Level Bridge. Location 1. Fort Frederick Ruins, New York. Chimney Point, Vermont. Prepared by the Department of State Engineer and Surveyor, December 1, 1926. Image courtesy Vermont State Archives.

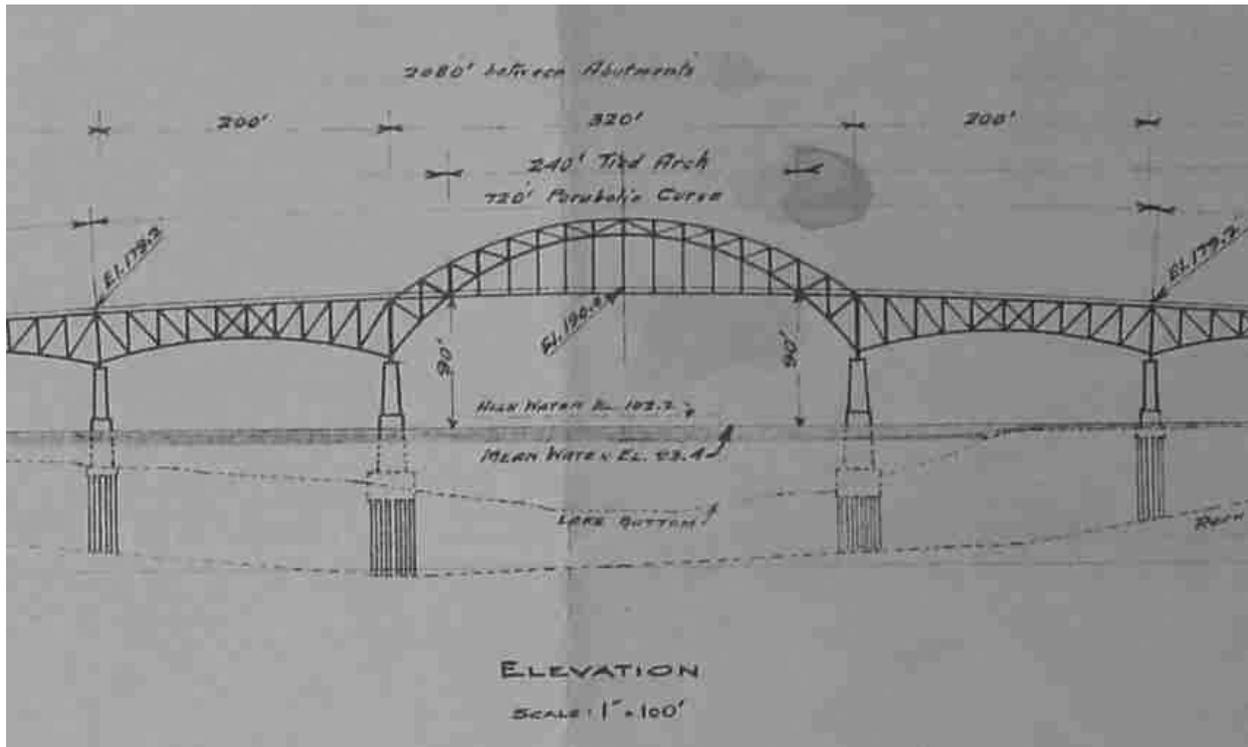
Figure 7. Proposed Bridge Across Lake Champlain, Preliminary Sketch. High Level Bridge. Location 1. Fort Frederick Ruins, New York. Chimney Point, Vermont. Prepared by the Department of State Engineer and Surveyor, December 1, 1926. Enlarged view of the channel span. Image courtesy Vermont State Archives.

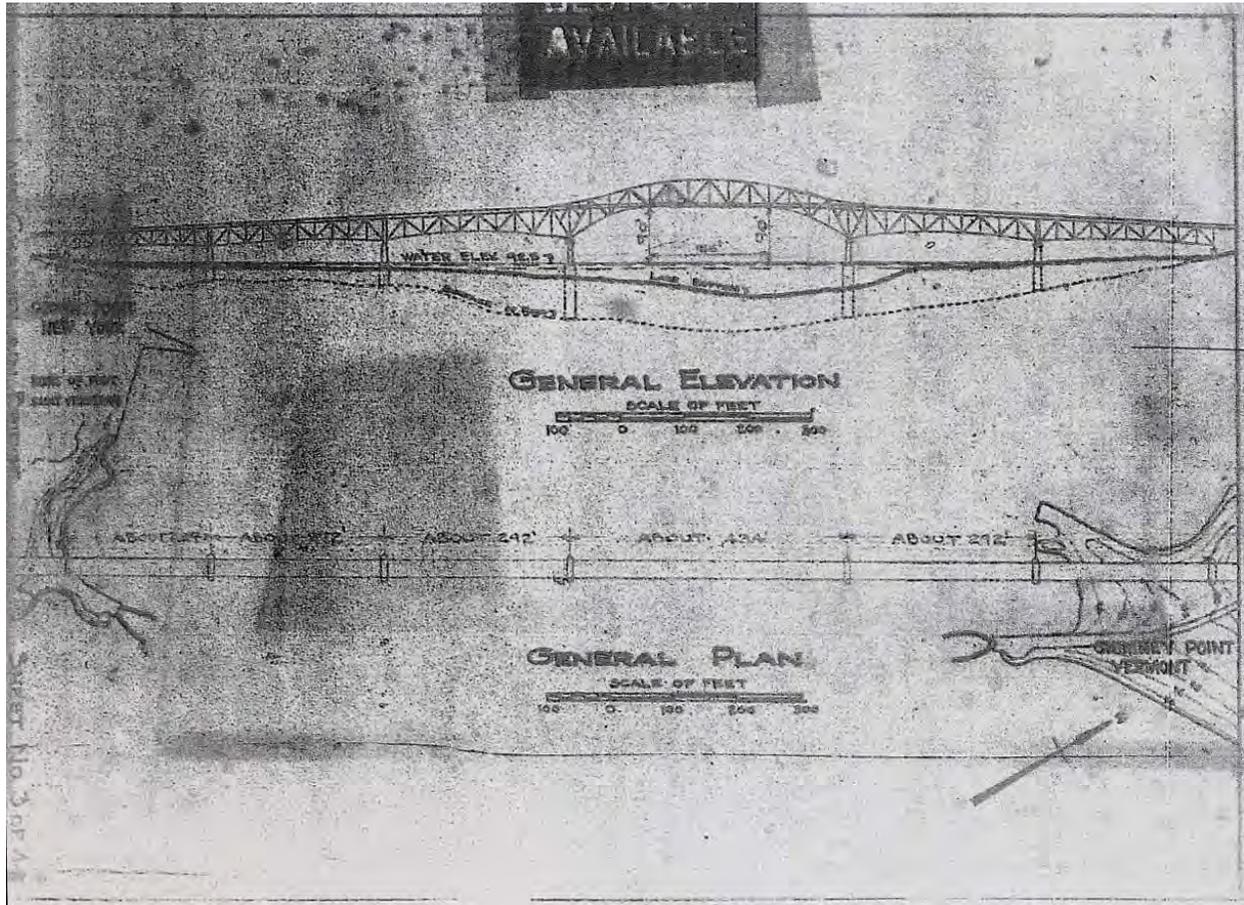
Figure 9. Final design of the Lake Champlain Bridge by Fay, Spofford and Thorndike, submitted to the United States Engineer Office, December 6, 1927, General Elevation and Plan. Image courtesy New York State Archives.

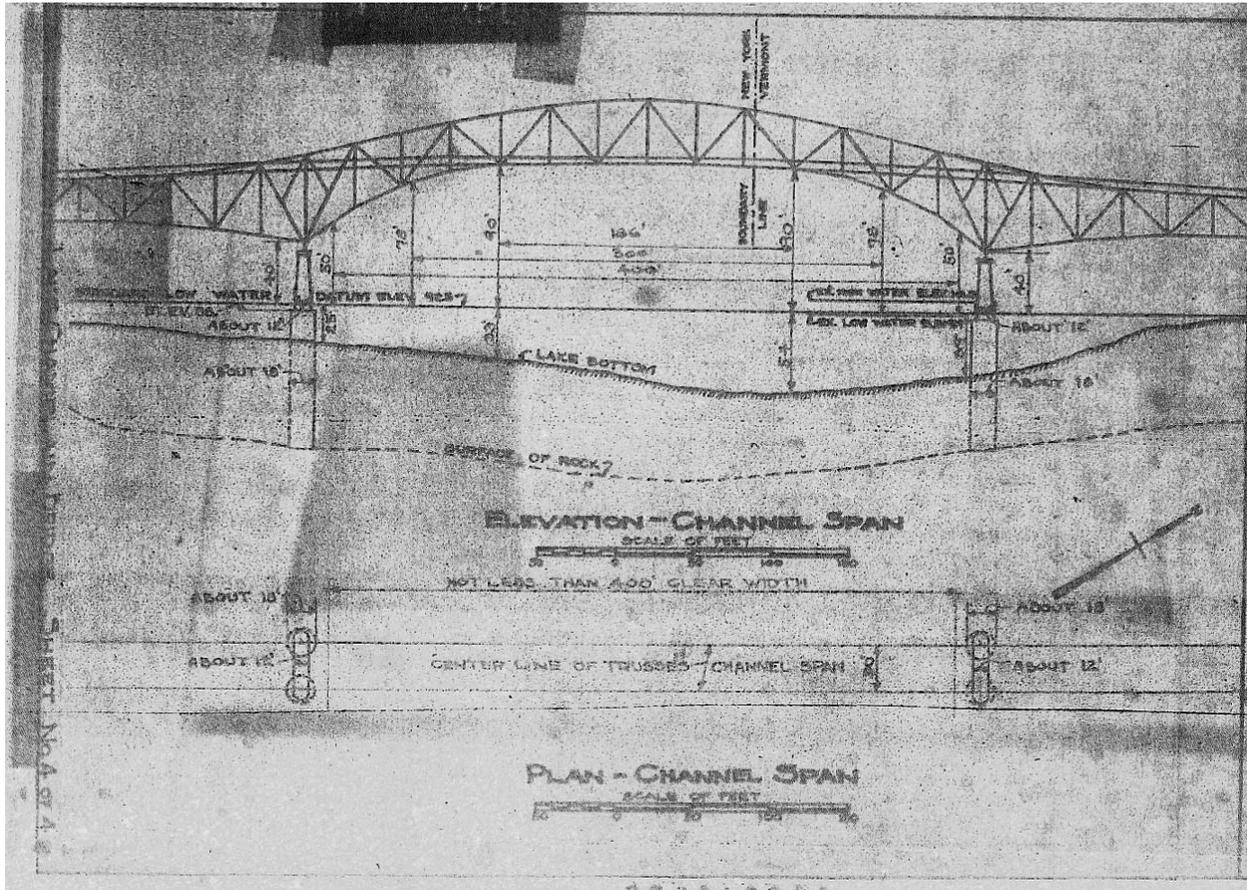
Figure 10. Final design of the Lake Champlain Bridge by Fay, Spofford and Thorndike, submitted to the United States Engineer Office, December 6, 1927, Elevation and Plan - Channel Span. Image courtesy New York State Archives.

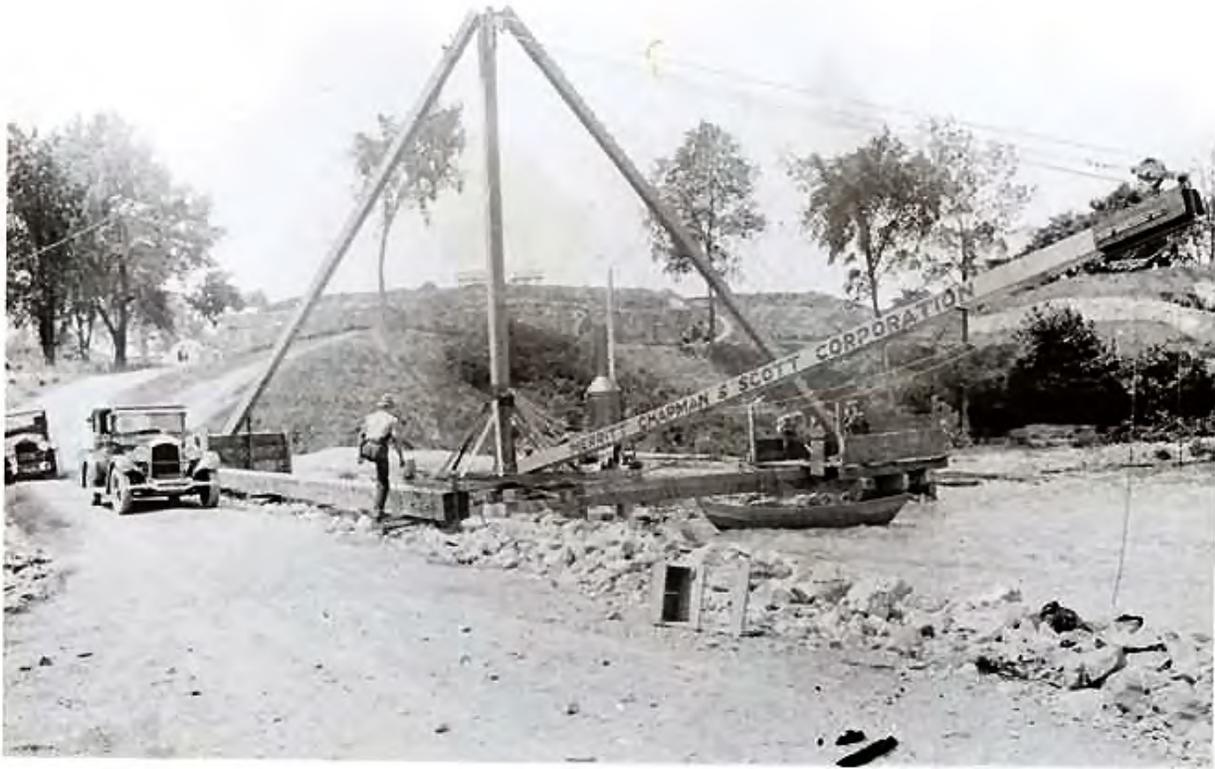
Figure 13. View from the New York ferry landing toward Fort St. Frederic, showing early pier work by Merritt-Chapman and Scott Corporation, summer 1928. Image courtesy Crown Point State Historic Site, Crown Point, New York.

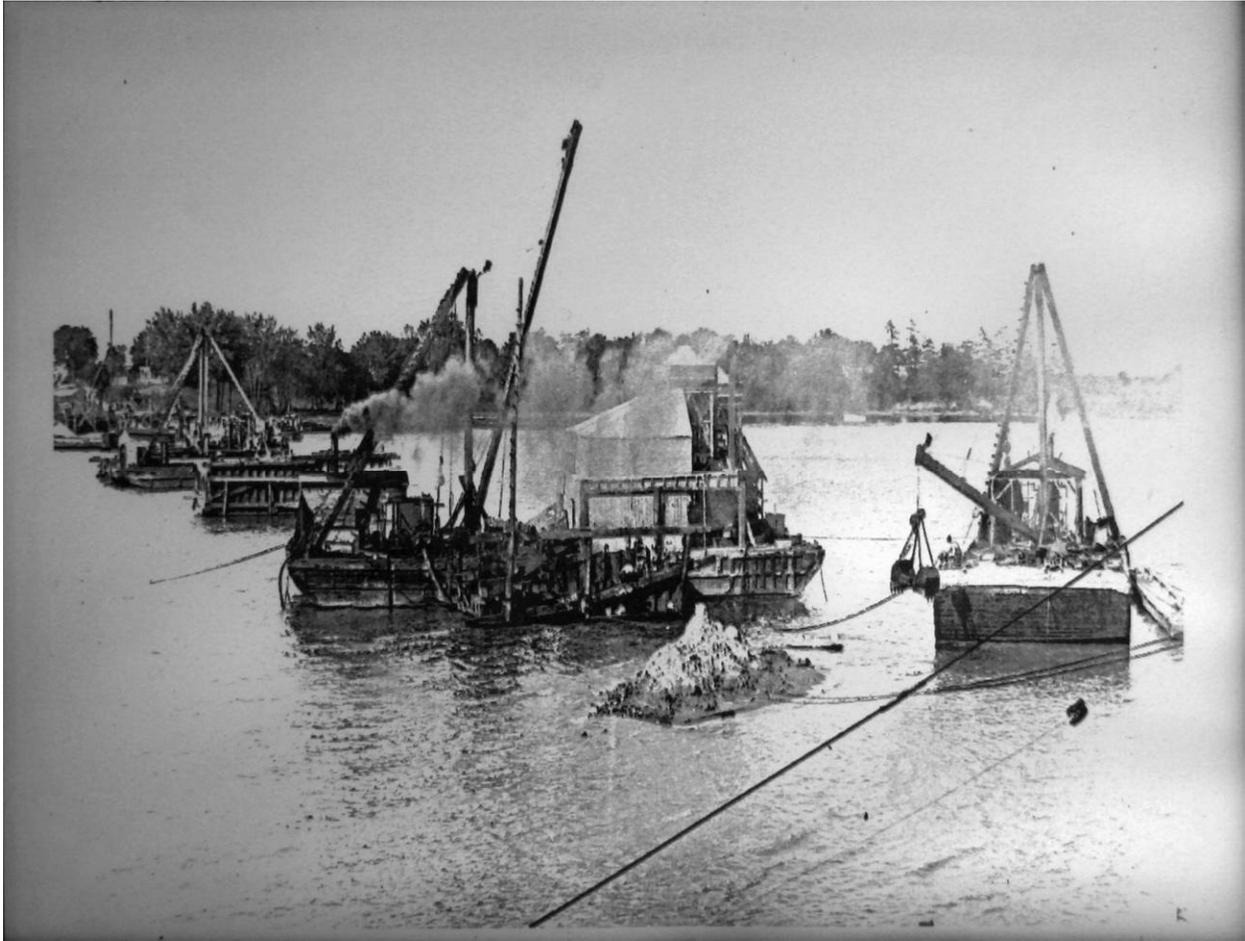
Figure 15. Pier construction by the Merritt-Chapman and Scott Corporation, summer 1928. Shows a derrick clamshell excavator and a floating cement plant on the nearest barges. Image courtesy Bill Bodette, Crown Point, New York.

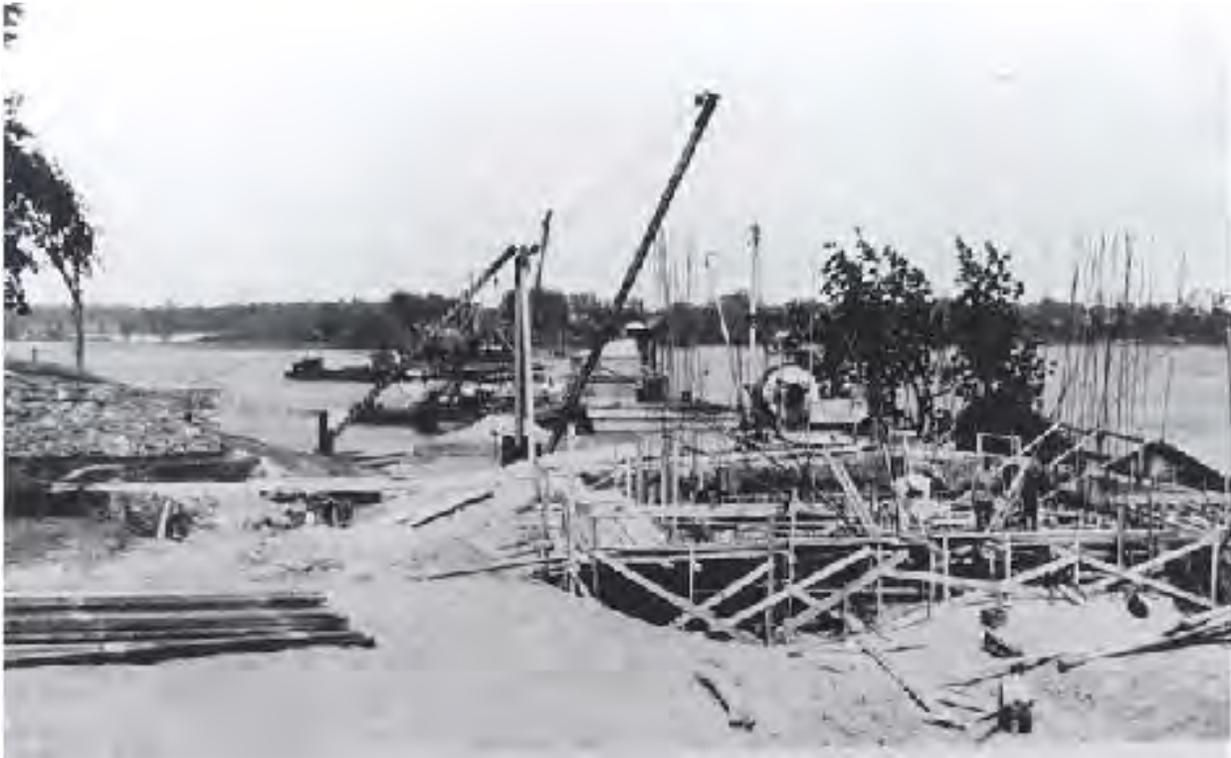
Figure 16. Construction of the New York abutment and piers by the Merritt-Chapman and Scott Corporation, showing proximity of the southeast bastion of Fort St. Frederic at left. Image courtesy Crown Point State Historic Site, Crown Point, New York.

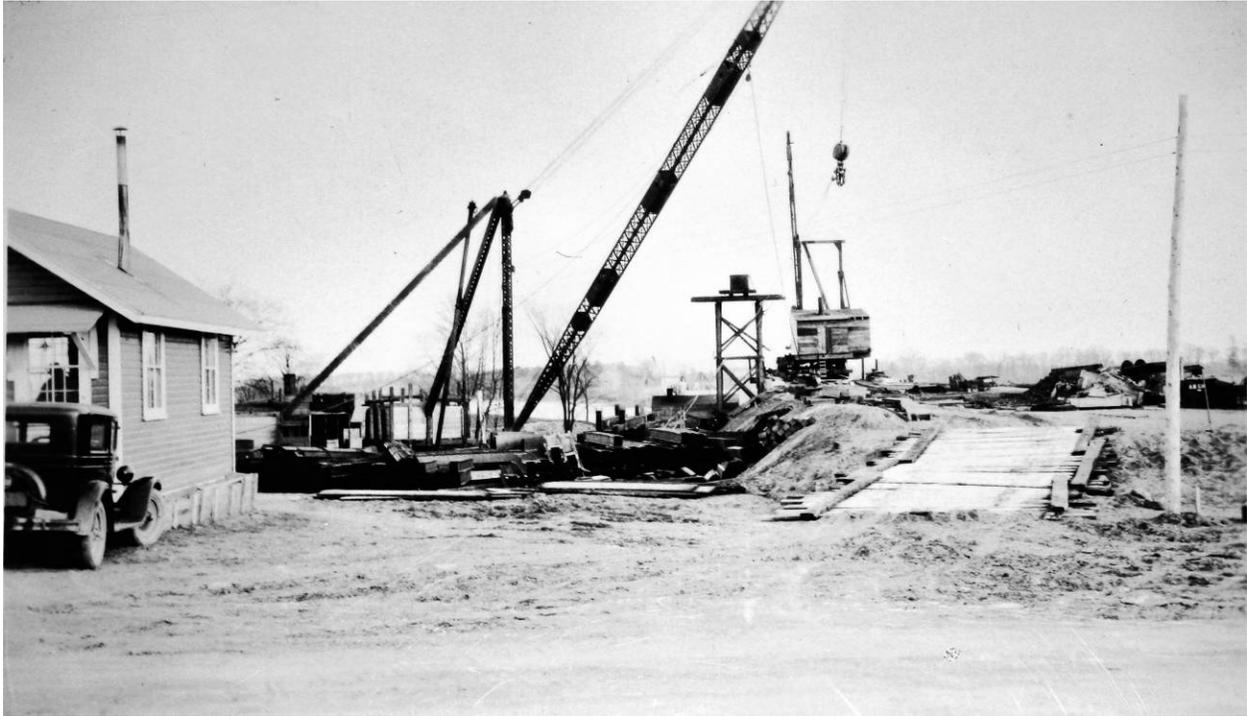
Figure 17. "General View of American Bridge Company's stiff leg 110' beam derrick and traveling erecting derrick just ready to go on first span of viaduct," December 21, 1928. Image courtesy Penfield Homestead Museum, Ironville, New York.

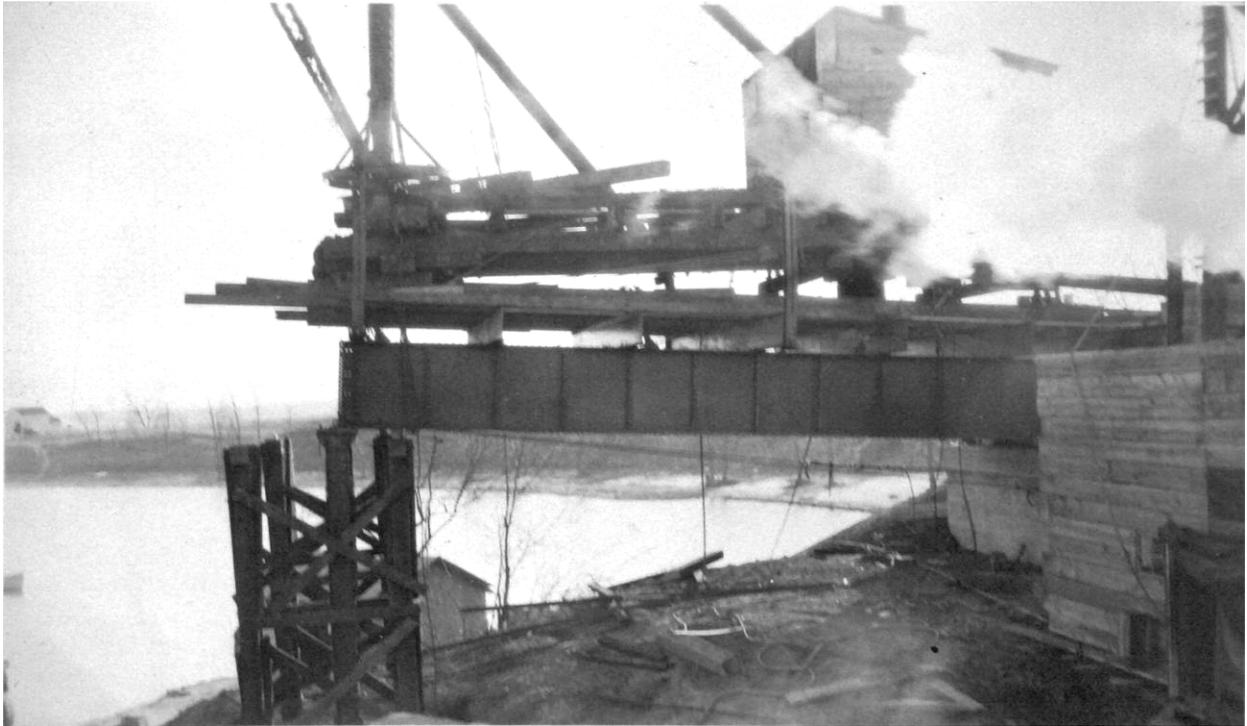
Figure 18. "Traveling derrick on first span of viaduct, view from Fort St. Frederick," December 21, 1928. Image courtesy Penfield Homestead Museum.

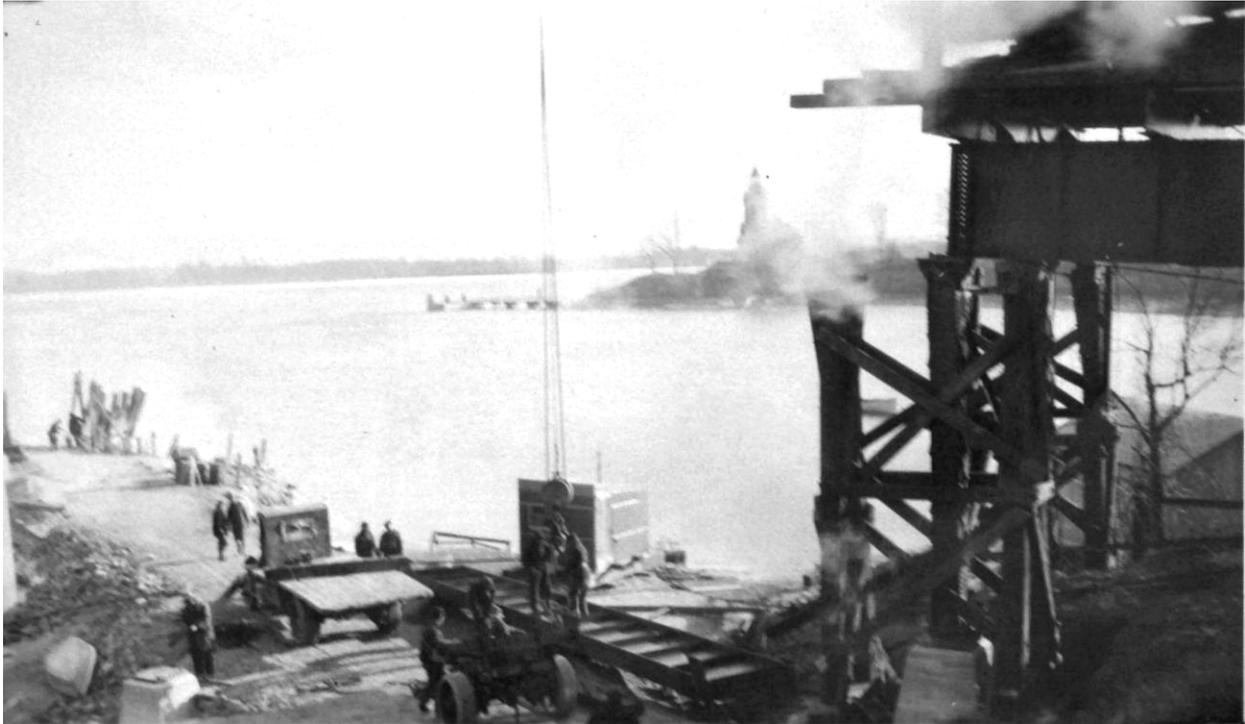
Figure 19. "Picking girder from trailer with 60-foot boom traveling derrick," December 21, 1928. (View looks southeast along the old ferry road near Fort St. Frederic, showing the beginning of construction of New York viaduct Span 2. Image courtesy Penfield Homestead Museum.

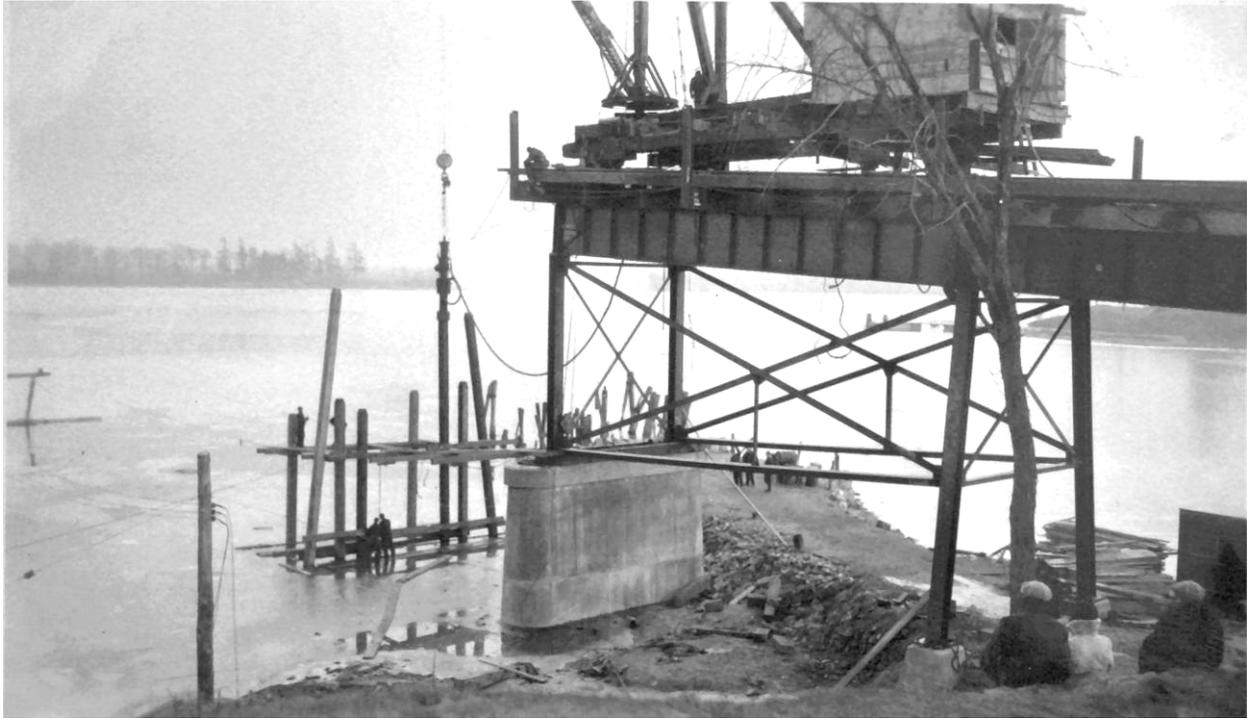
Figure 20. "American Bridge Company's traveling derrick at end of New York viaduct, Pier 3, driving piles for first temporary bent," December 28, 1928. Image courtesy Penfield Homestead Museum.

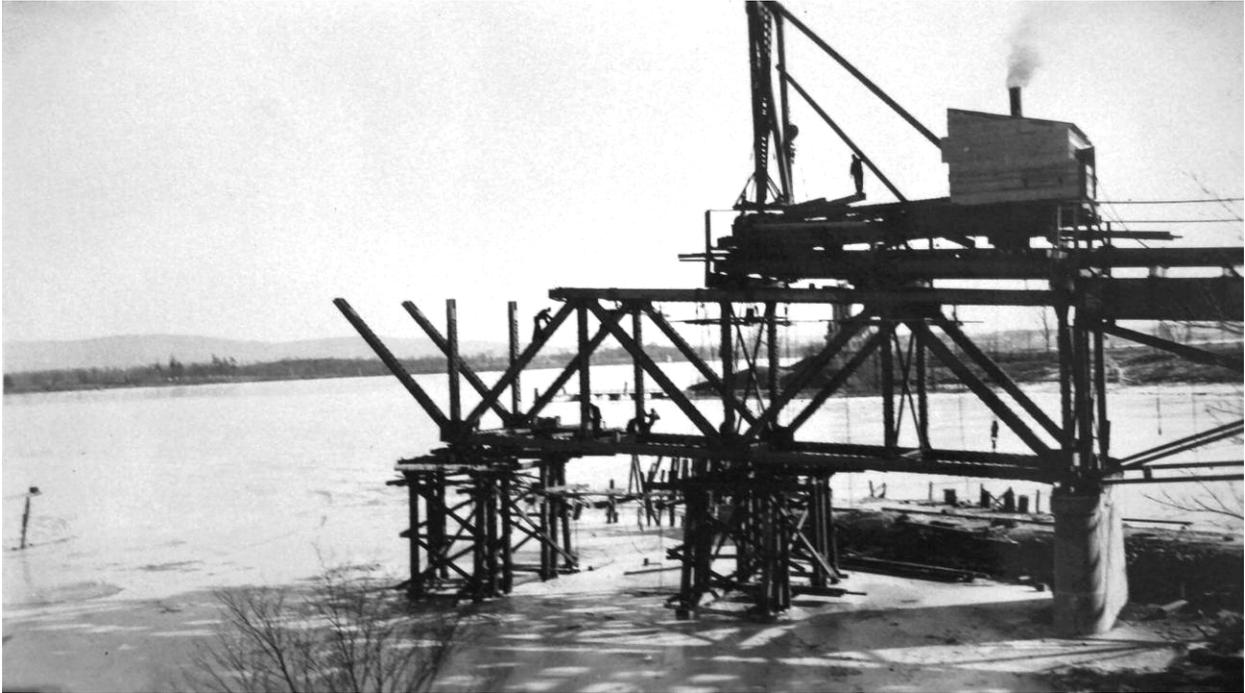
Figure 21. "Second bent falsework and second panel nearly in place" January 15, 1929. View of Span 4 from Fort St. Frederic. Image courtesy Penfield Homestead Museum.

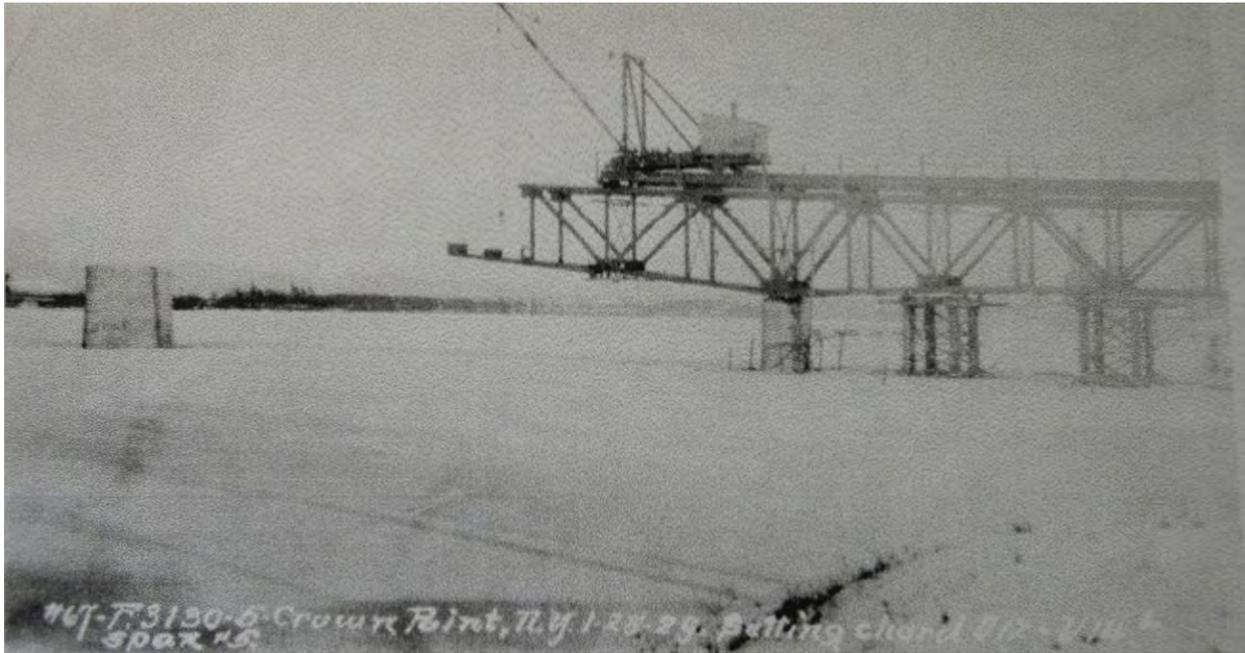
Figure 22. "Setting chord U12-U14, Span #5," January 28, 1929. (LCBC Photo #67- F3130-5). Image courtesy Moriah Historical Society, Port Henry, New York.

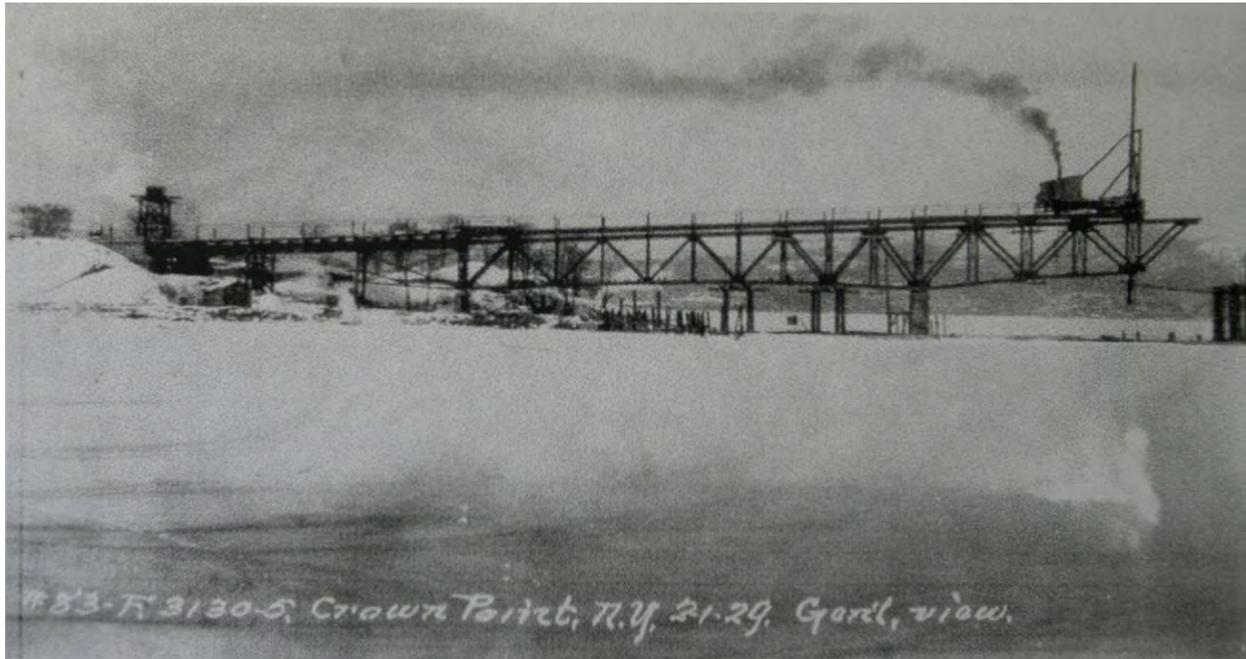
*Figure 23. February 2, 1929. "Gen'l View." (LCBC Photo #83, F3130-5, Crown Point, N.Y).
View of Spans 1-4 and Span 5 under construction. Image courtesy Moriah Historical Society.*

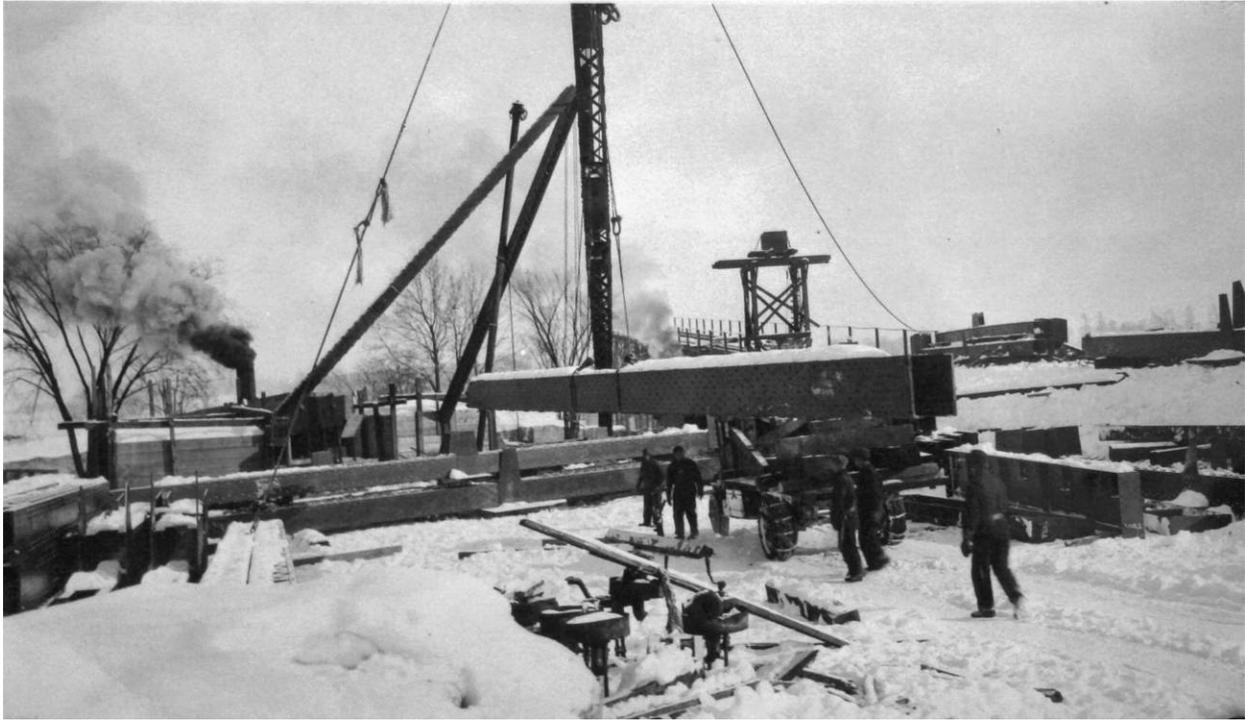
Figure 24. "Unloading long truss members U10 to U-F with trailer. Weight 9 tons on a 5-ton Mack truck," February 12, 1929. Image courtesy Penfield Homestead Museum.

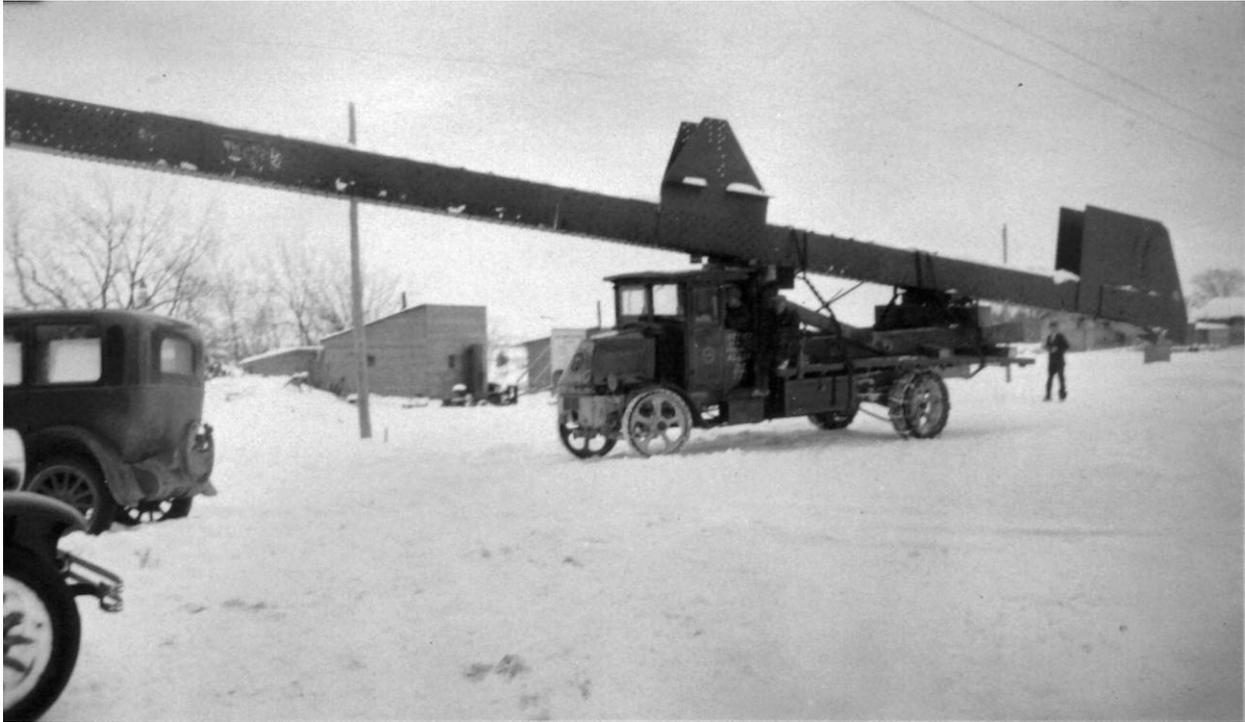
Figure 25. "Trucking L8-10, Weight 14-tons 1780 lbs, this with the timber carriage estimated at approximately 1-ton makes a 16-ton load on a 5-ton Mack truck," February 12, 1929. Image courtesy Penfield Homestead Museum.

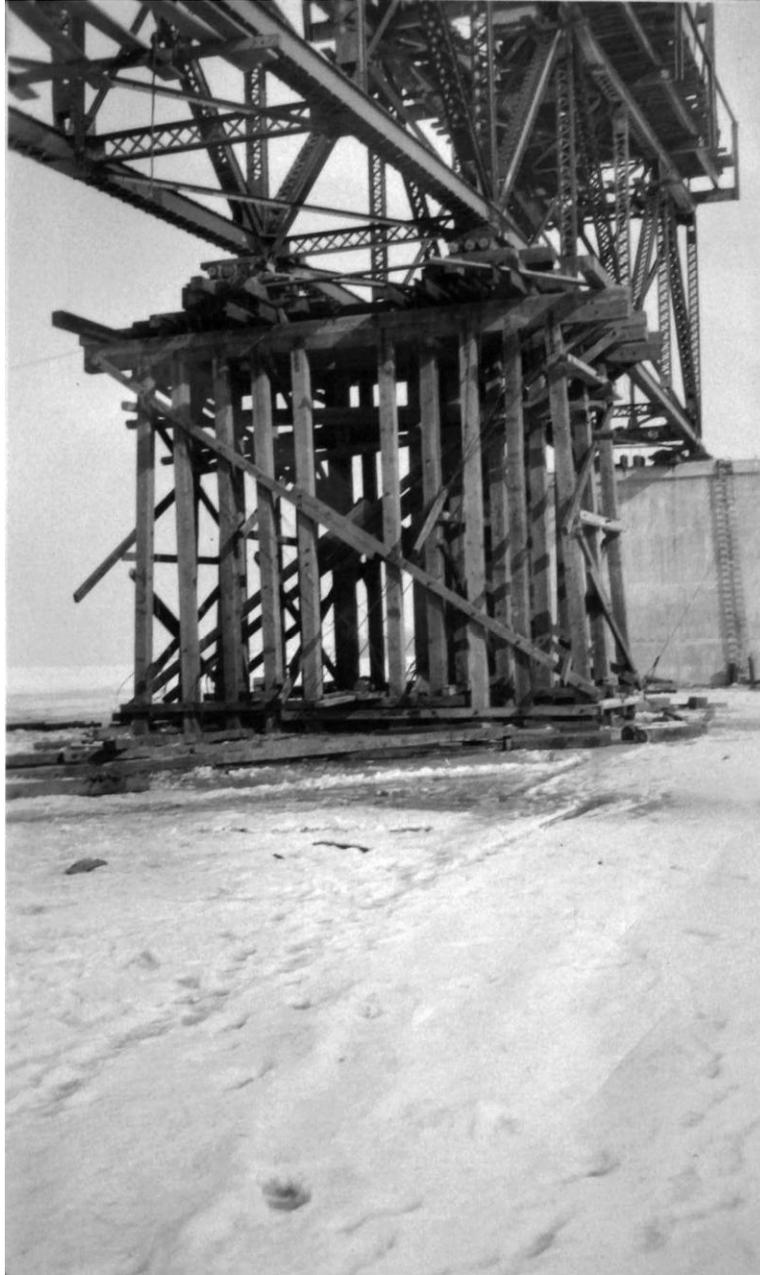
Figure 26. "Close-up view of ice for temporary bent of 12-inch x 12-inch square timbers, Span 5," February 18, 1929. Image shows the use of ice to support falsework for some of the truss spans. Image courtesy Penfield Homestead Museum.

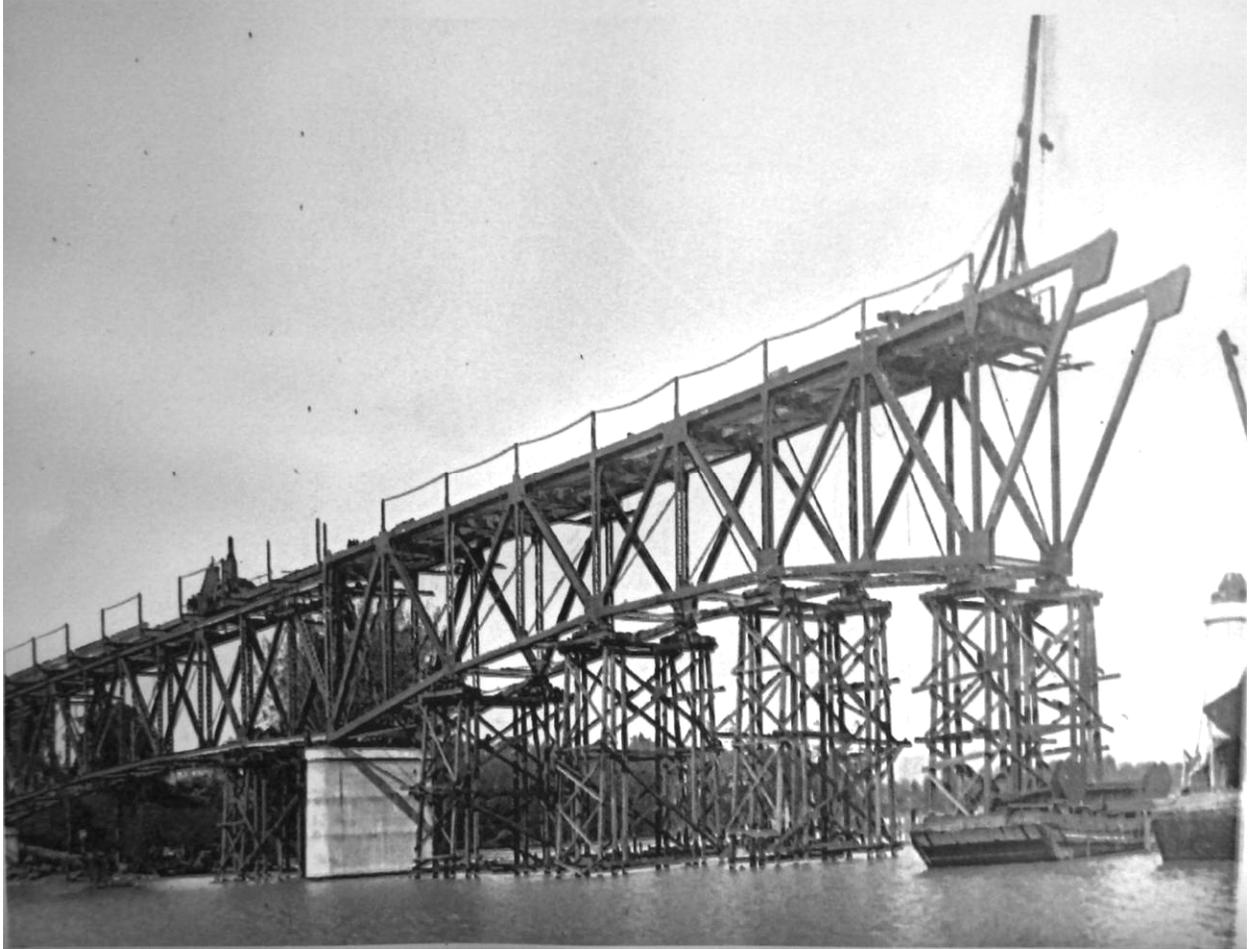
Figure 29. View showing Span 6 nearing completion, early April, 1929. Image courtesy Bill Bodette.

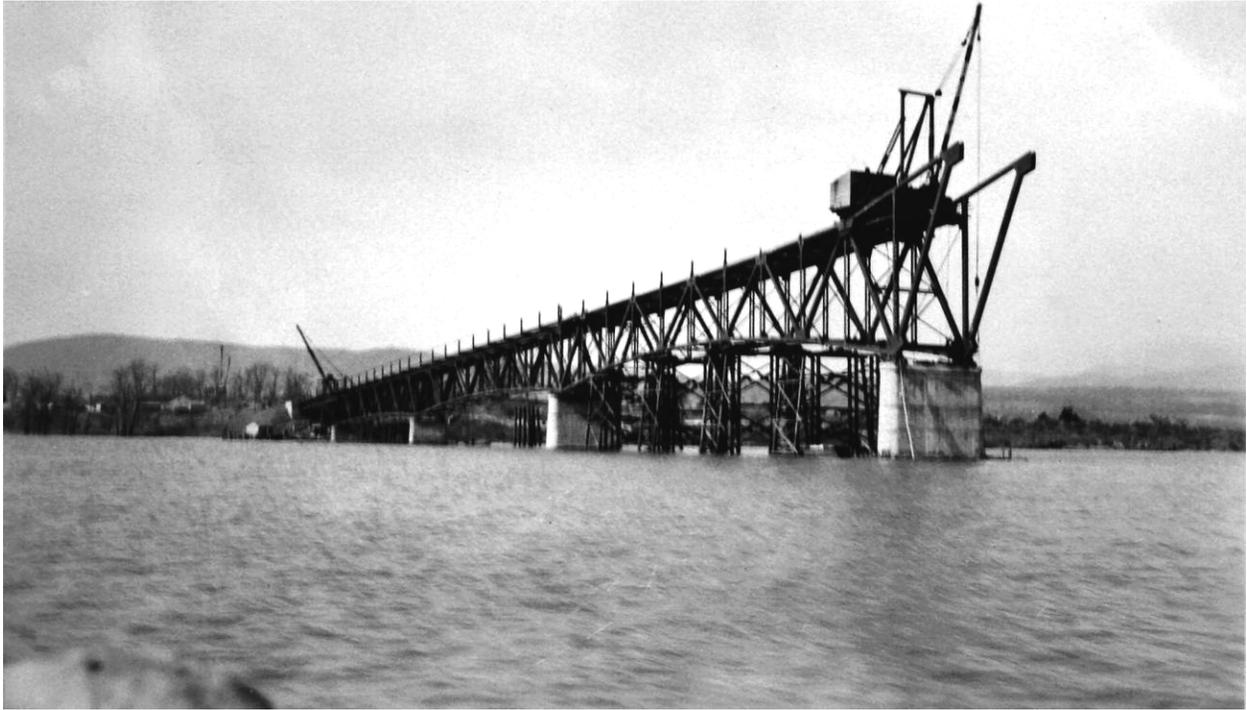
Figure 30. "Bridge from water looking westerly," April 9, 1929. View shows a completed Span 6 and early work on Span 7. Image courtesy Penfield Homestead Museum.

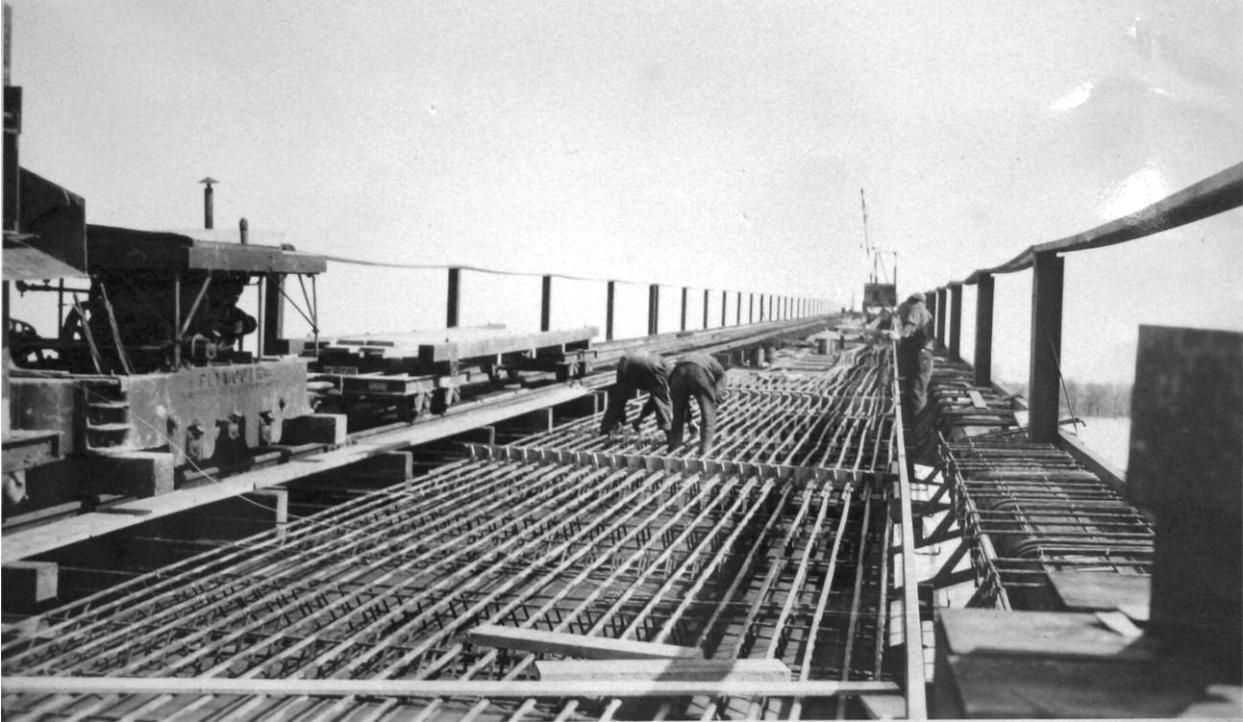
Figure 31. "On easterly curb line of New York end of bridge showing curb angle and rivet grid steel in place. Southwest forms not yet finished.," April 23, 1929. View shows workers from Scott Brothers Construction Company preparing to pour concrete for the bridge deck. Image courtesy Penfield Homestead Museum.

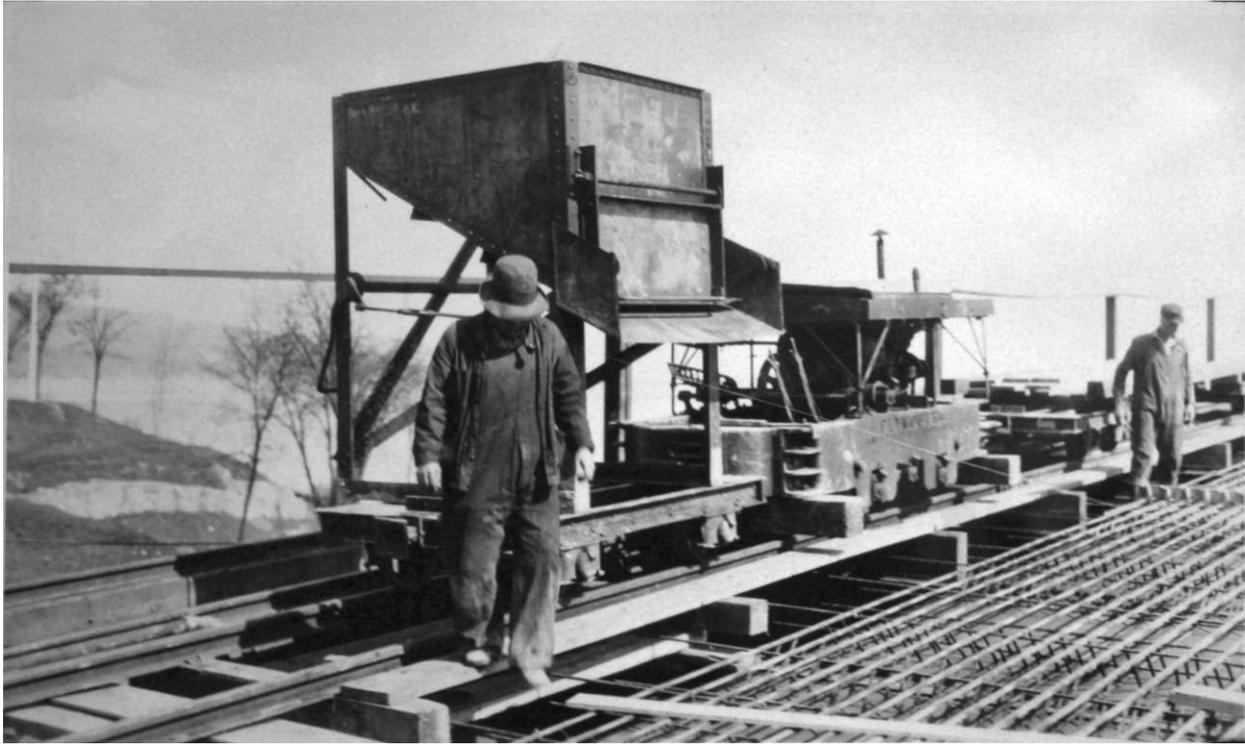
Figure 33. "Scott Brothers material car Plymouth Gasoline Locomotive and concrete car with side discharge," April 23, 1929. Image courtesy Penfield Homestead Museum.

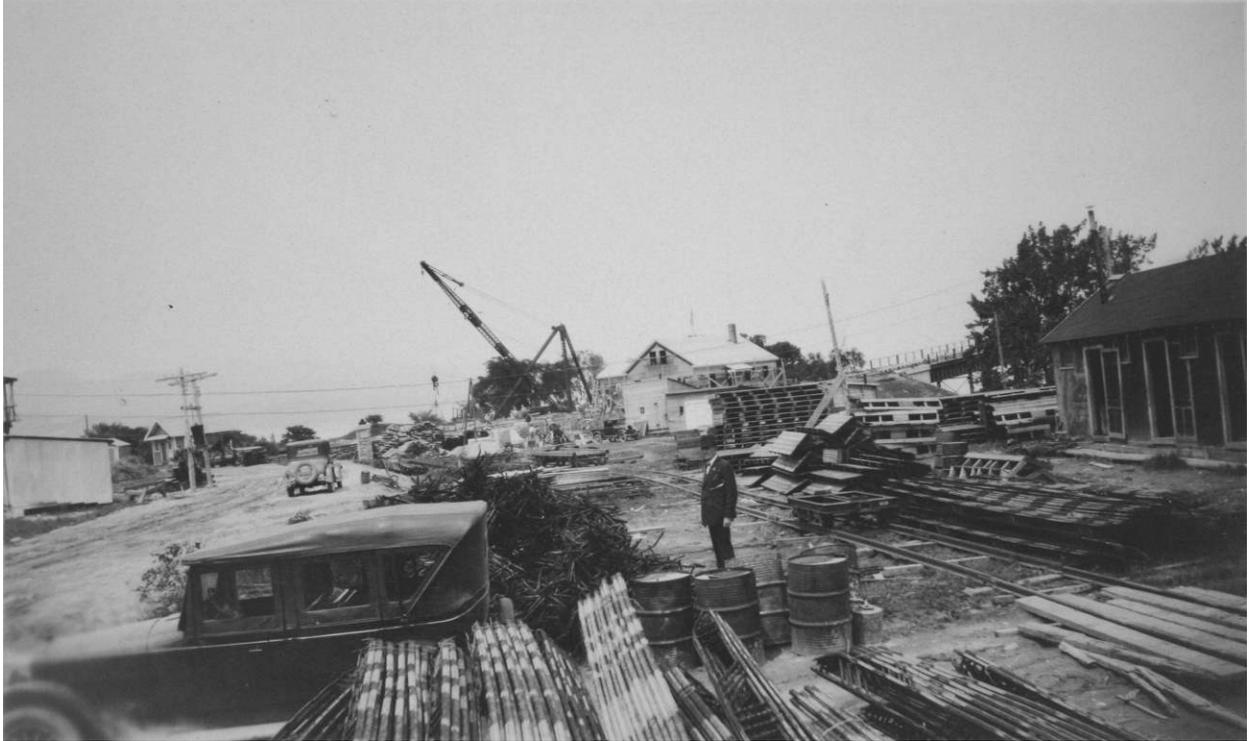
Figure 34. View of the staging area for the Scott Brothers Construction Company south of the bridge on the New York end. Shows the temporary rail line used to bring materials and scaffolding stacked in front of the company storehouse, at right. The bridge toll house is under construction in the distance. The road at left was the original entrance to the Crown Point Reservation. Image courtesy Vermont State Archives, Middlesex, Vermont.

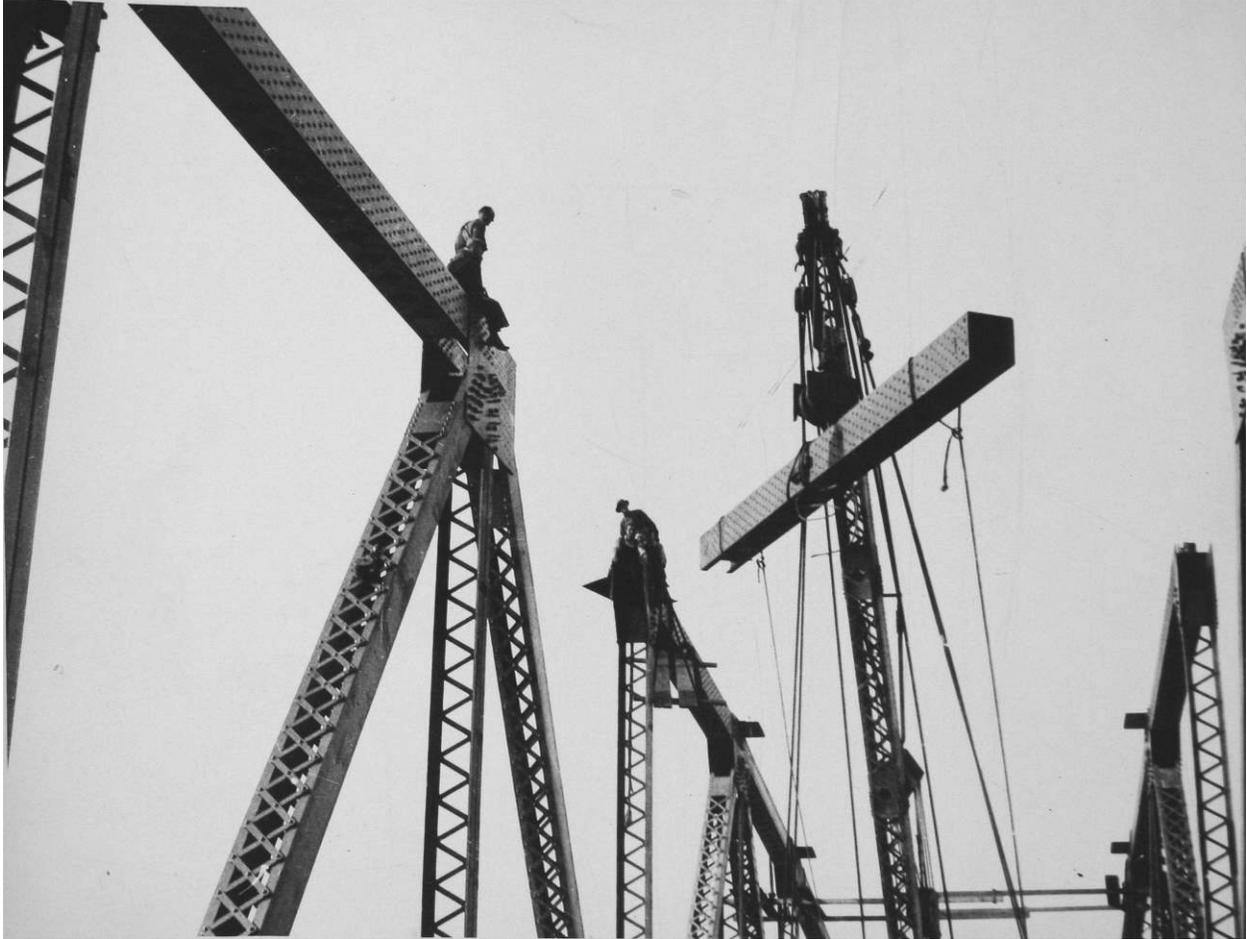
Figure 36. "Bridge from Barnes lawn," May 1, 1929. View shows the completed Span 9, with Spans 7 and 8 still to be built. Image courtesy Penfield Homestead Museum.
