HISTORIC AMERICAN ENGINEERING RECORD

LAKE CHAMPLAIN BRIDGE

HAER No. NY-541

Structural Type: Steel continuous through and deck truss span

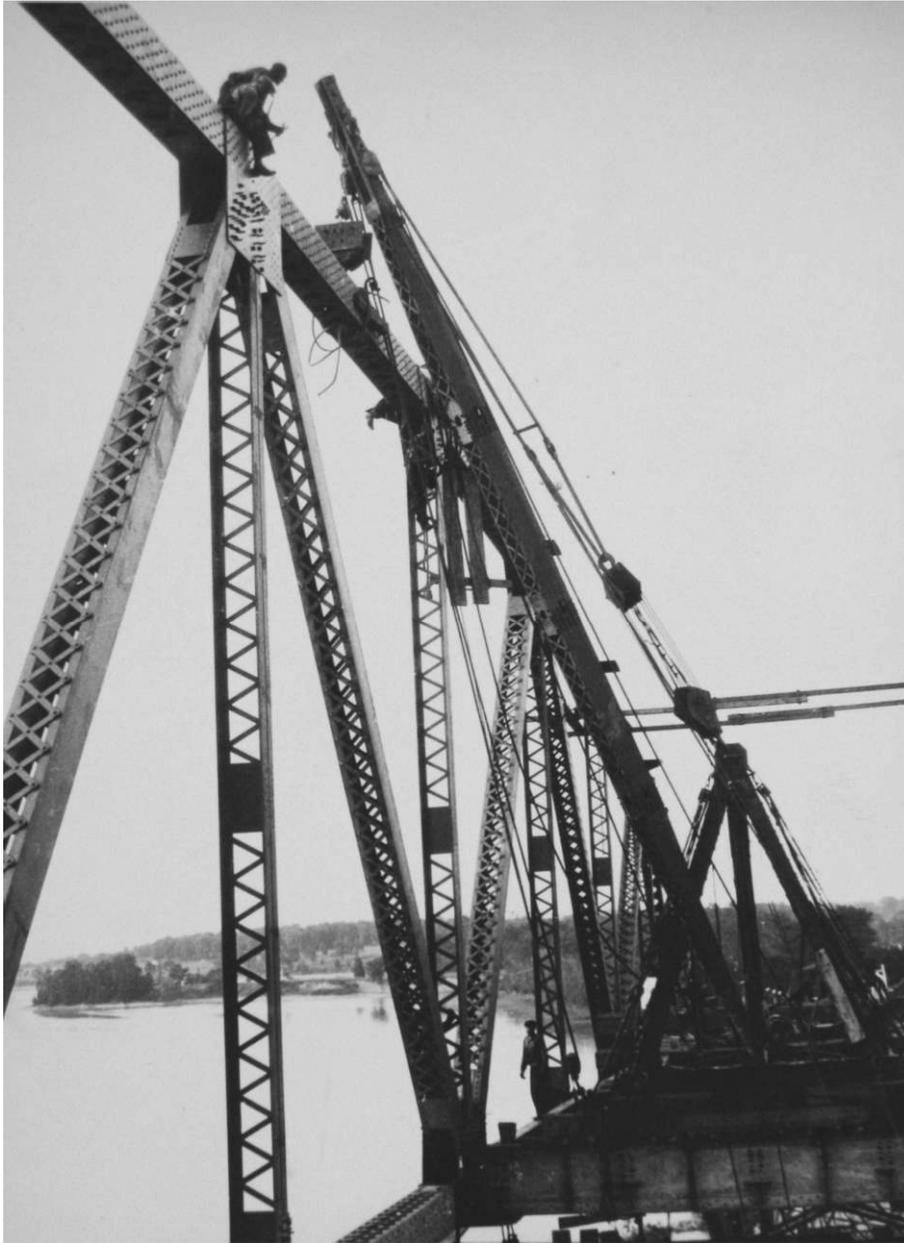
Figure 38. Workers joining the top chord on Span 7, mid-June, 1929. Image courtesy Vermont State Archives.

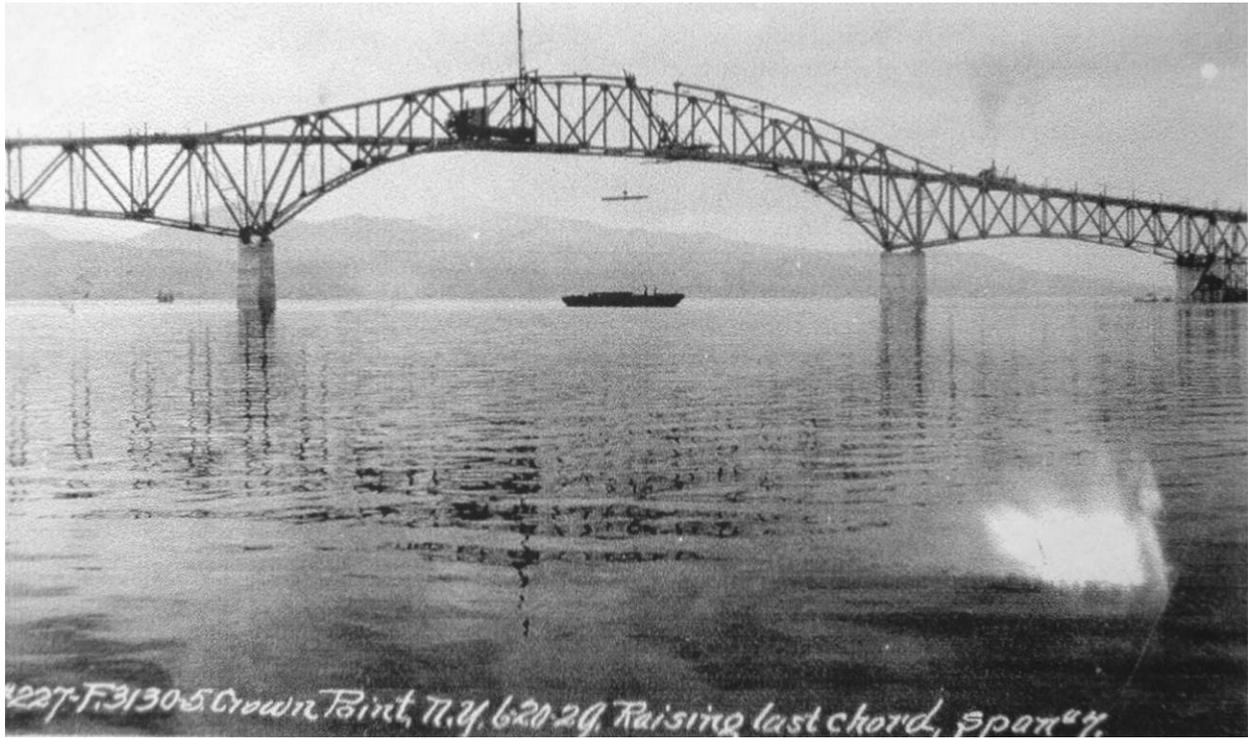
Figure 39. "Raising last chord, Span 7," June 20, 1929. (LCBC Photo #227, F3130-5). Image courtesy Moriah Historical Society.

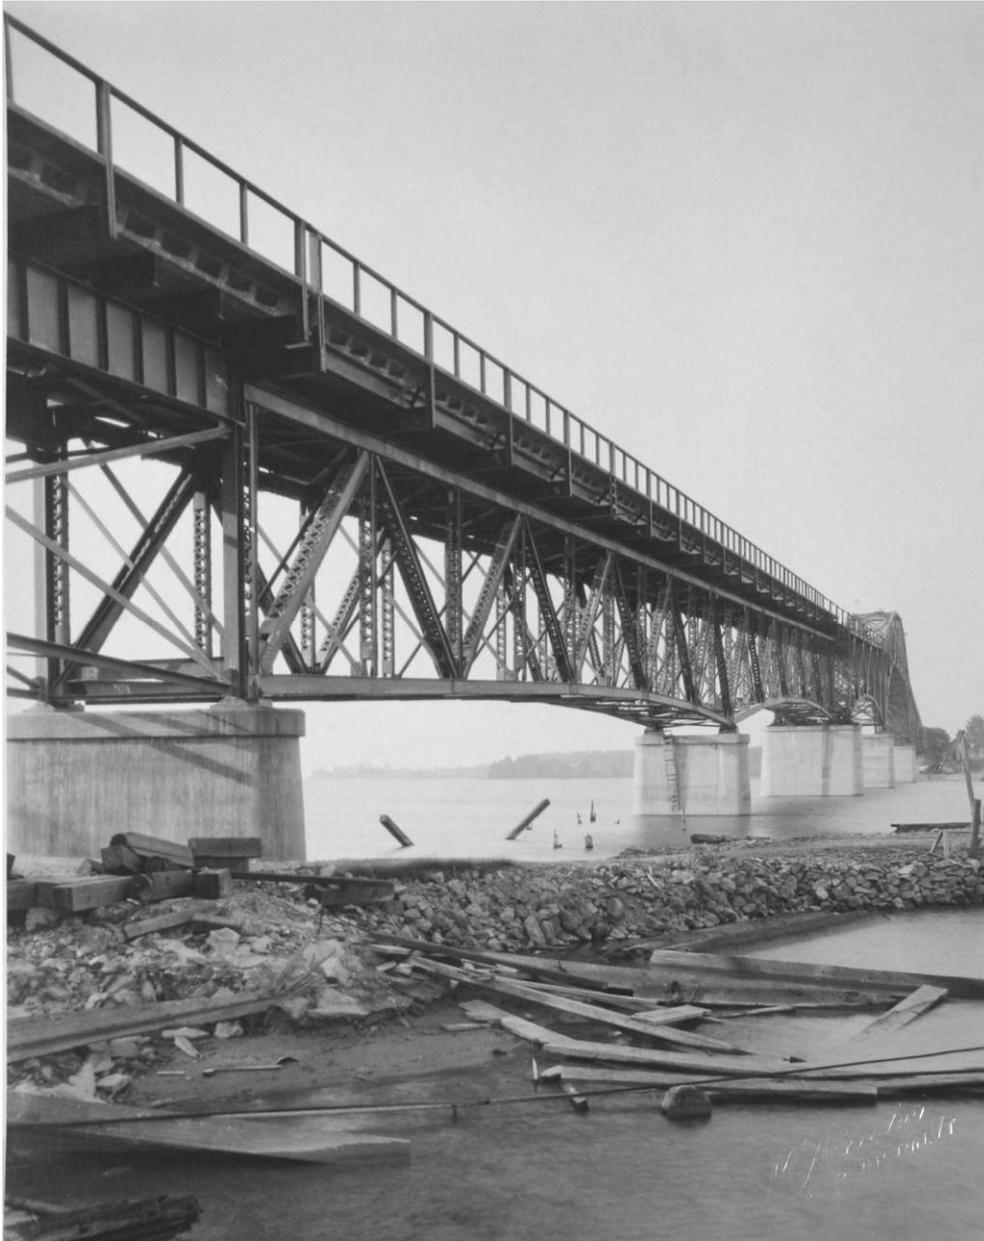
Figure 41. View of the almost completed bridge, west side, from Fort St. Frederic, showing Span 7 under construction, July 1929. Image courtesy Vermont State Archives.

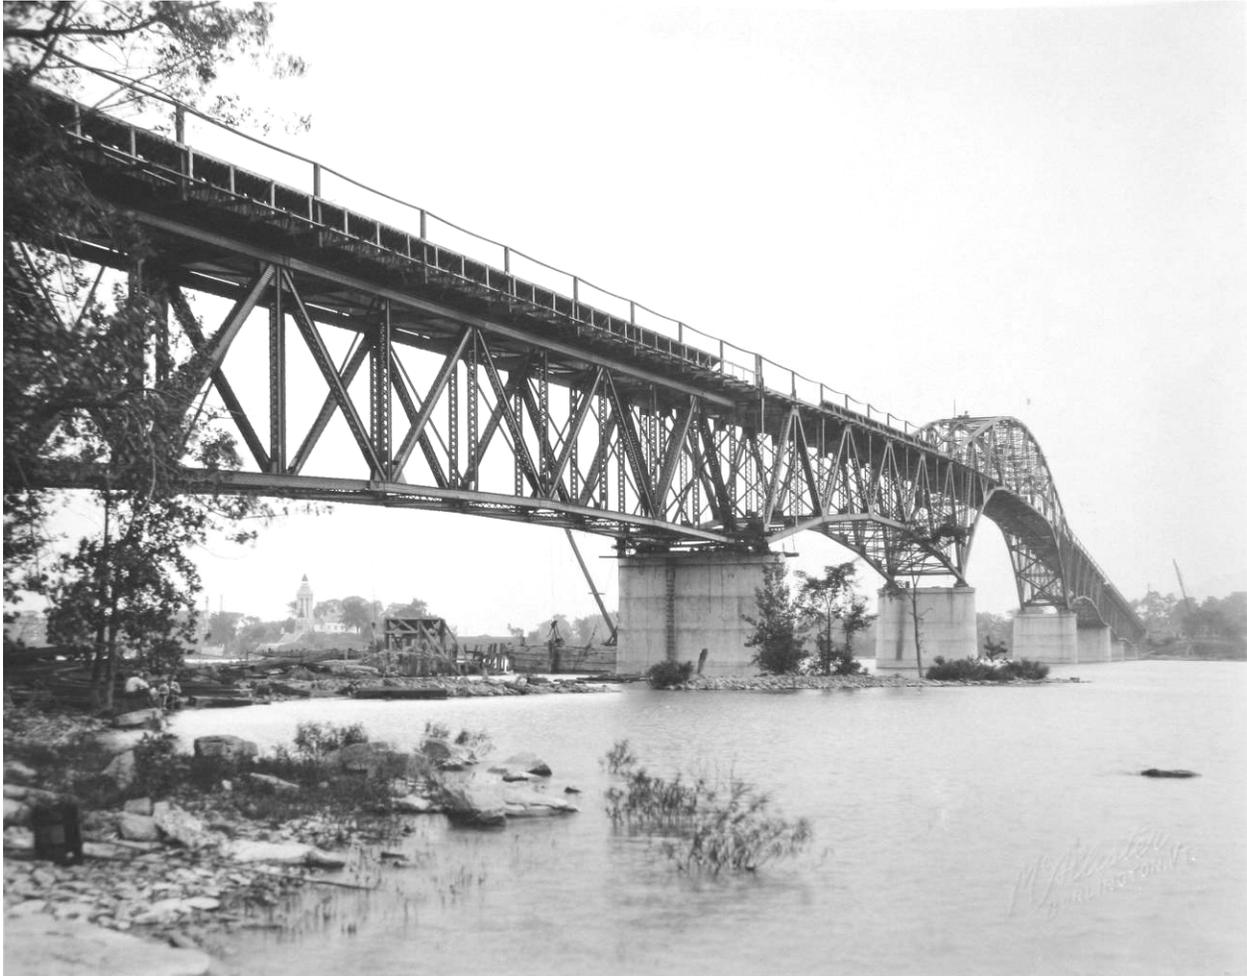
Figure 43. View of the almost completed bridge, west side, from Vermont, showing the temporary rail structure for the deck construction still in place, July 1929. The Champlain Memorial lighthouse is just visible in the distance at left. Image courtesy Vermont State Archives.

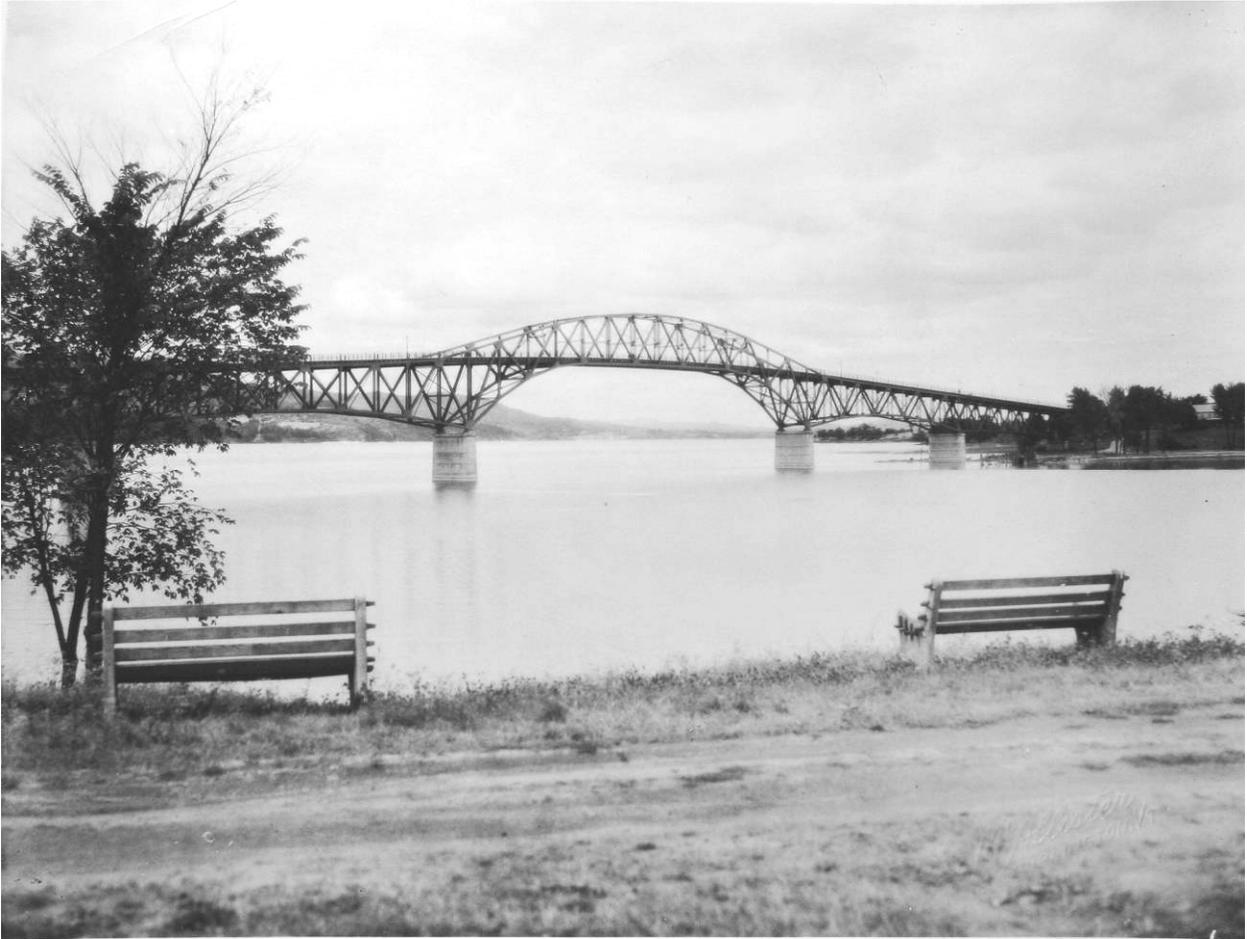
Figure 46. View of the completed bridge from Fort St. Frederic, showing streetlamps along the deck. Image courtesy Vermont State Archives.

The original light standards and extension arms remained on the bridge in 2009, and a few of the original concrete light standards, with the extension arms, remain on the New York (two standards) and Vermont approaches (three standards). Records show that the original acorn globes were replaced with similar globes, G. E. Catalog No. 166, beginning with six new globes

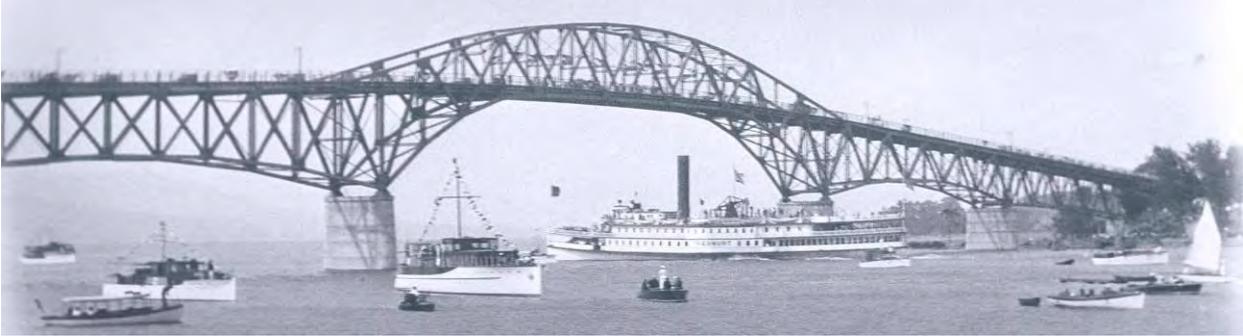
Figure 60. View of the steamship Vermont heading to the bridge, prior to opening day. The top of the smokestack on this ship was used to determine the height of Span 7 over the navigation channel. Image courtesy Bill Bodette.

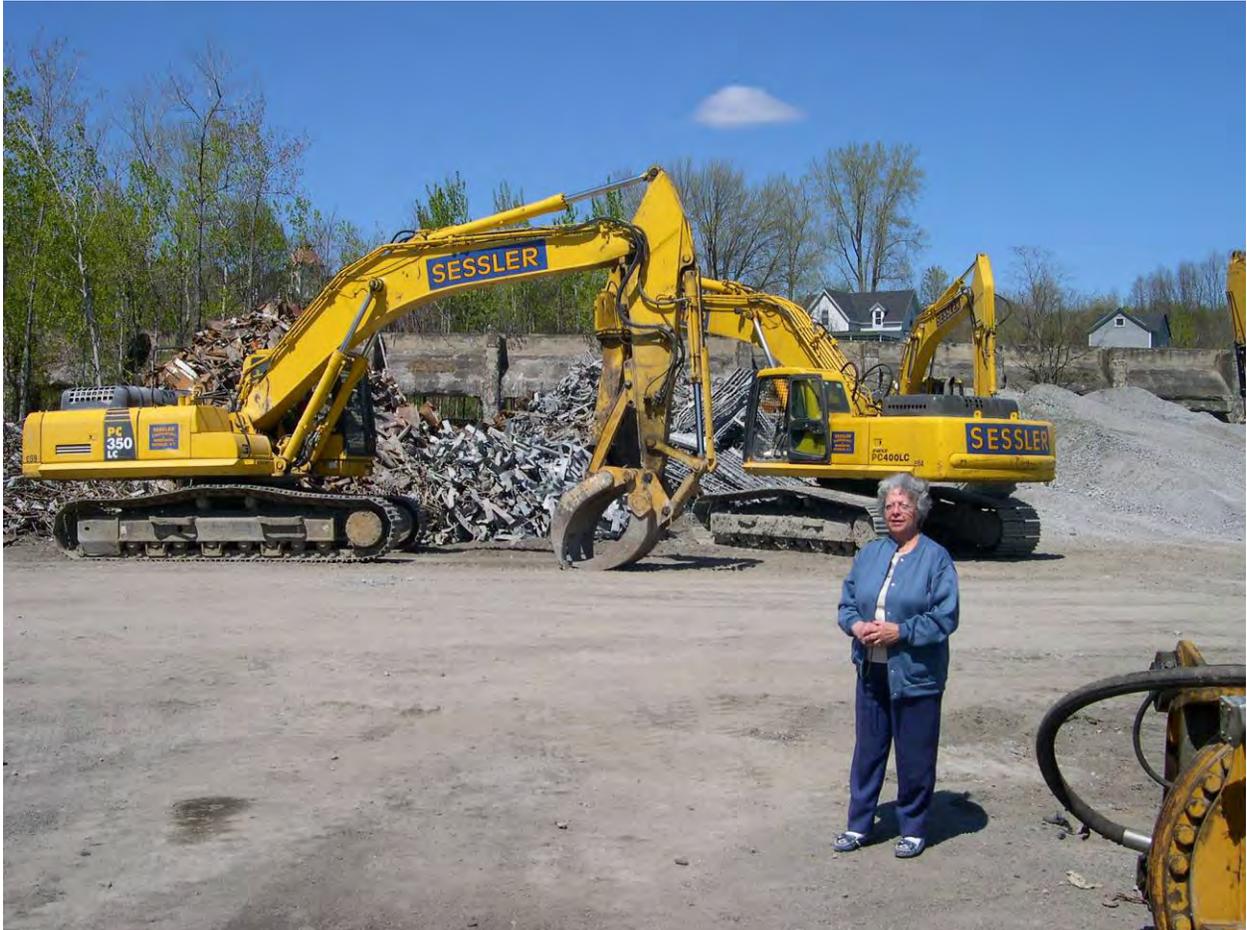
Figure 76. View of backhoe piling salvaged bridge members onto a barge on the New York end of the bridge. The barge will be unloaded at a scrap yard in Port Henry. Photograph by New York State Department of Transportation.

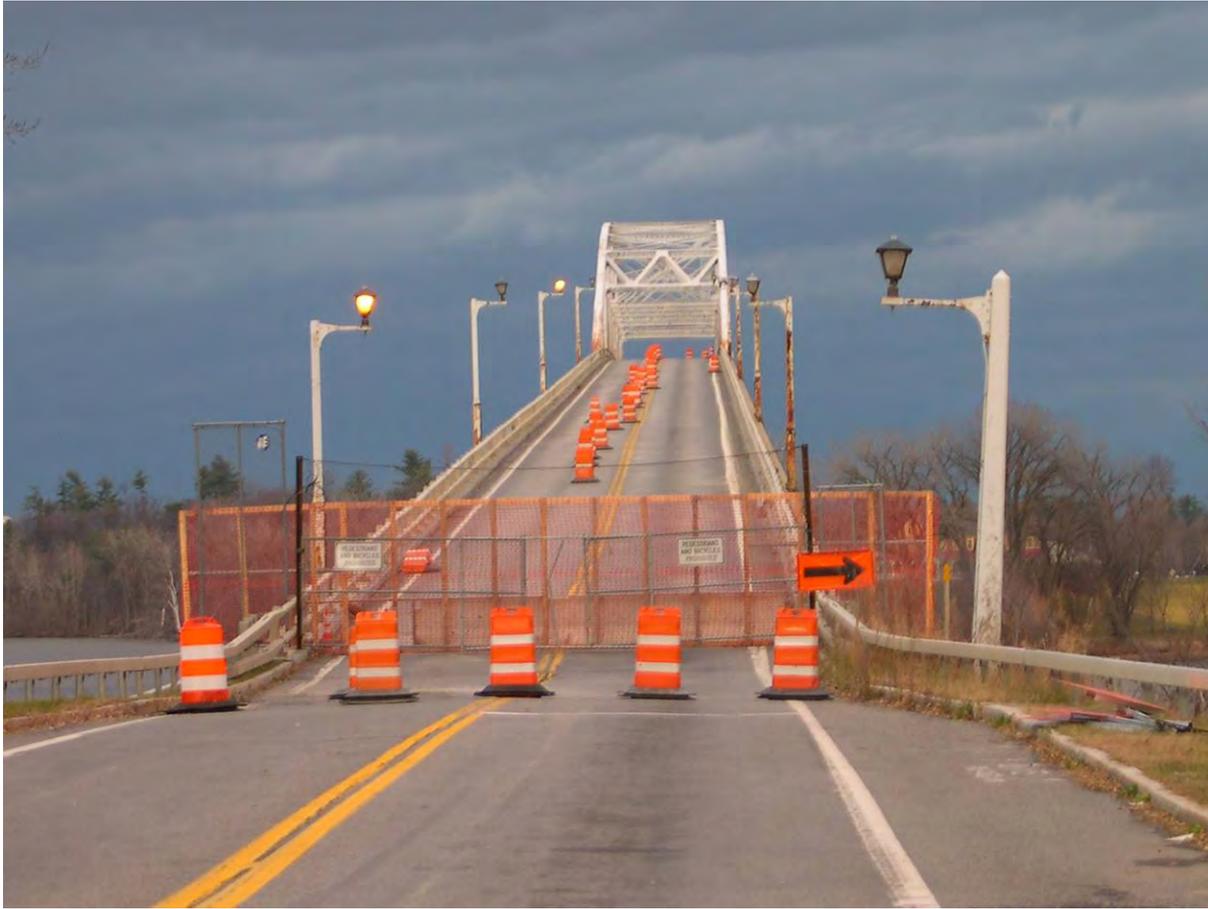
Figure 80. View of the bridge from the New York approach. Photograph by New York State Department of Transportation, March 18, 2009.

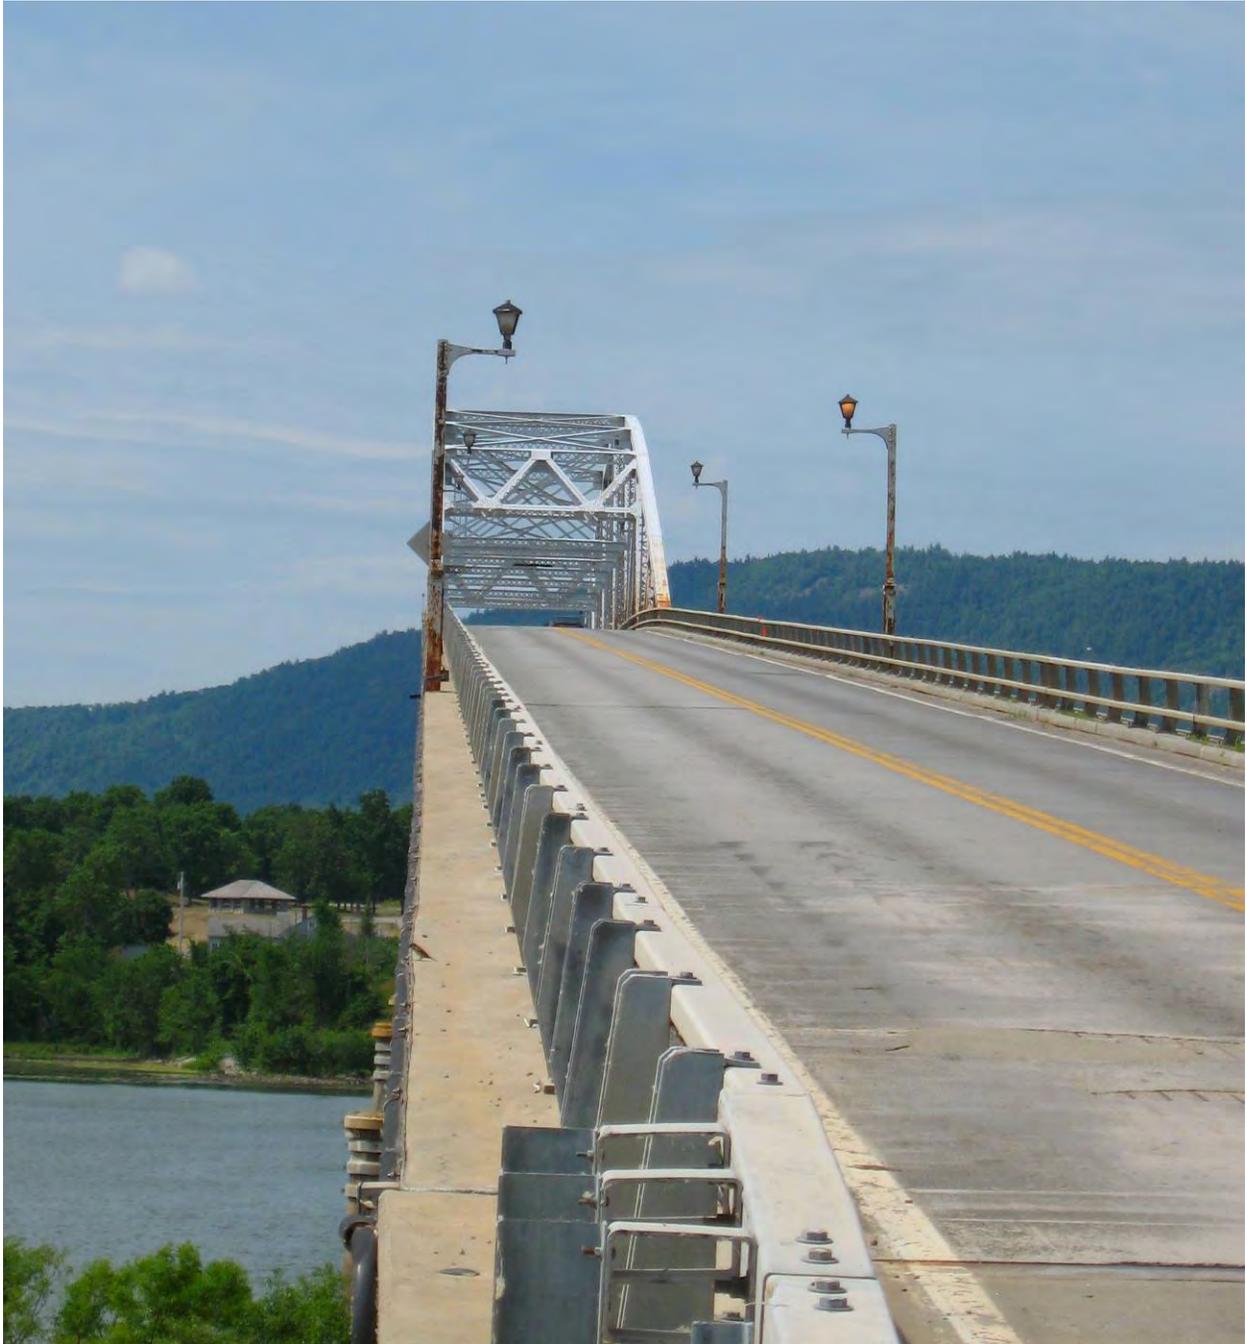
Figure 81. View of the closed bridge from the New York approach. Photograph by recording team, New York State Museum, November 2009.

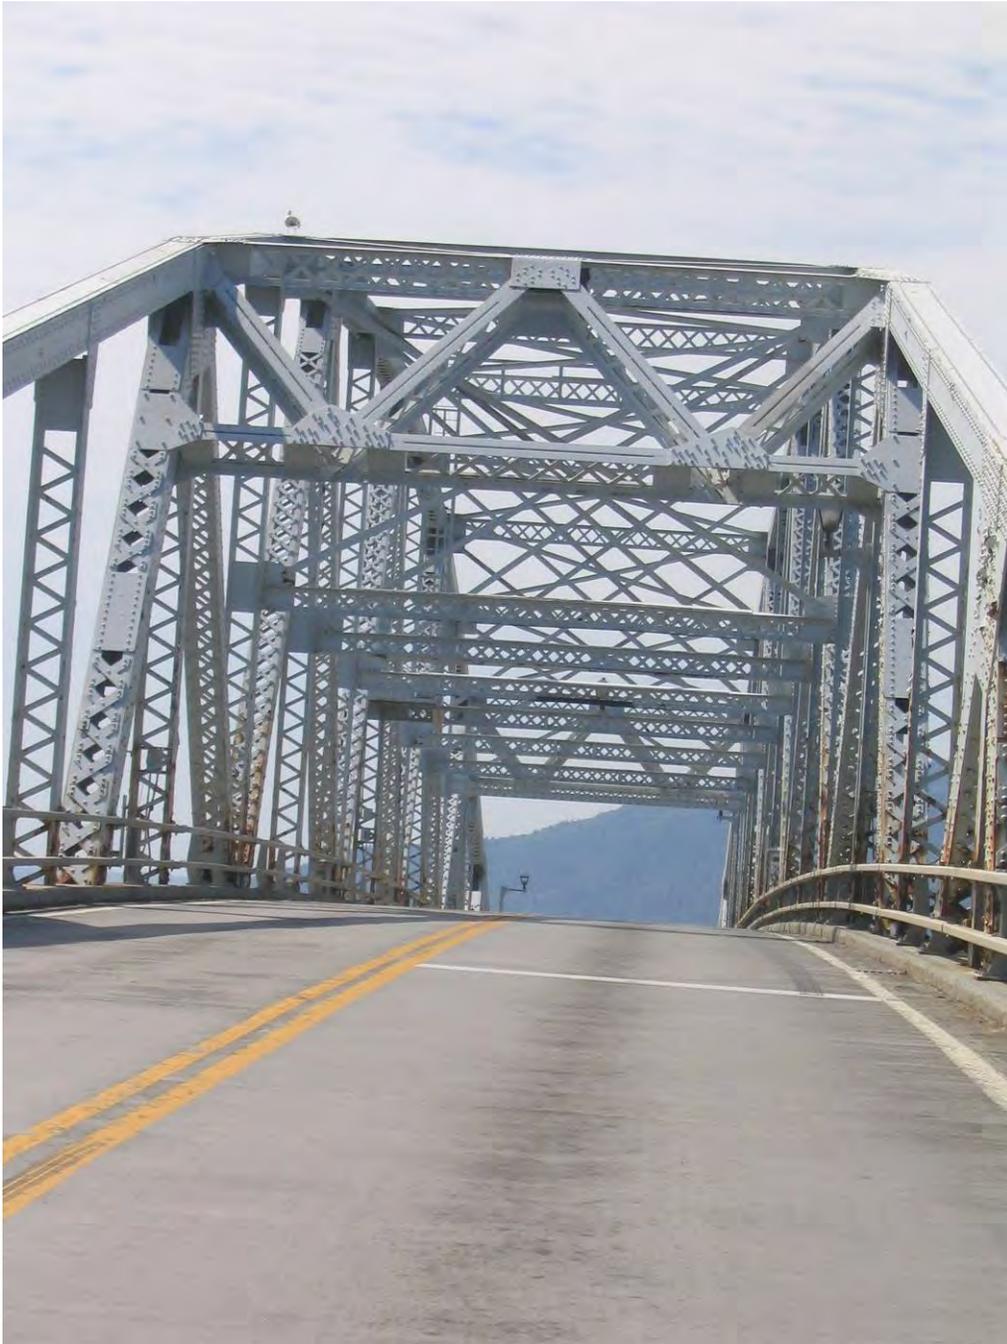
Figure 82. View of the north portal from Span 8. Photograph by New York State Department of Transportation, July 2009.

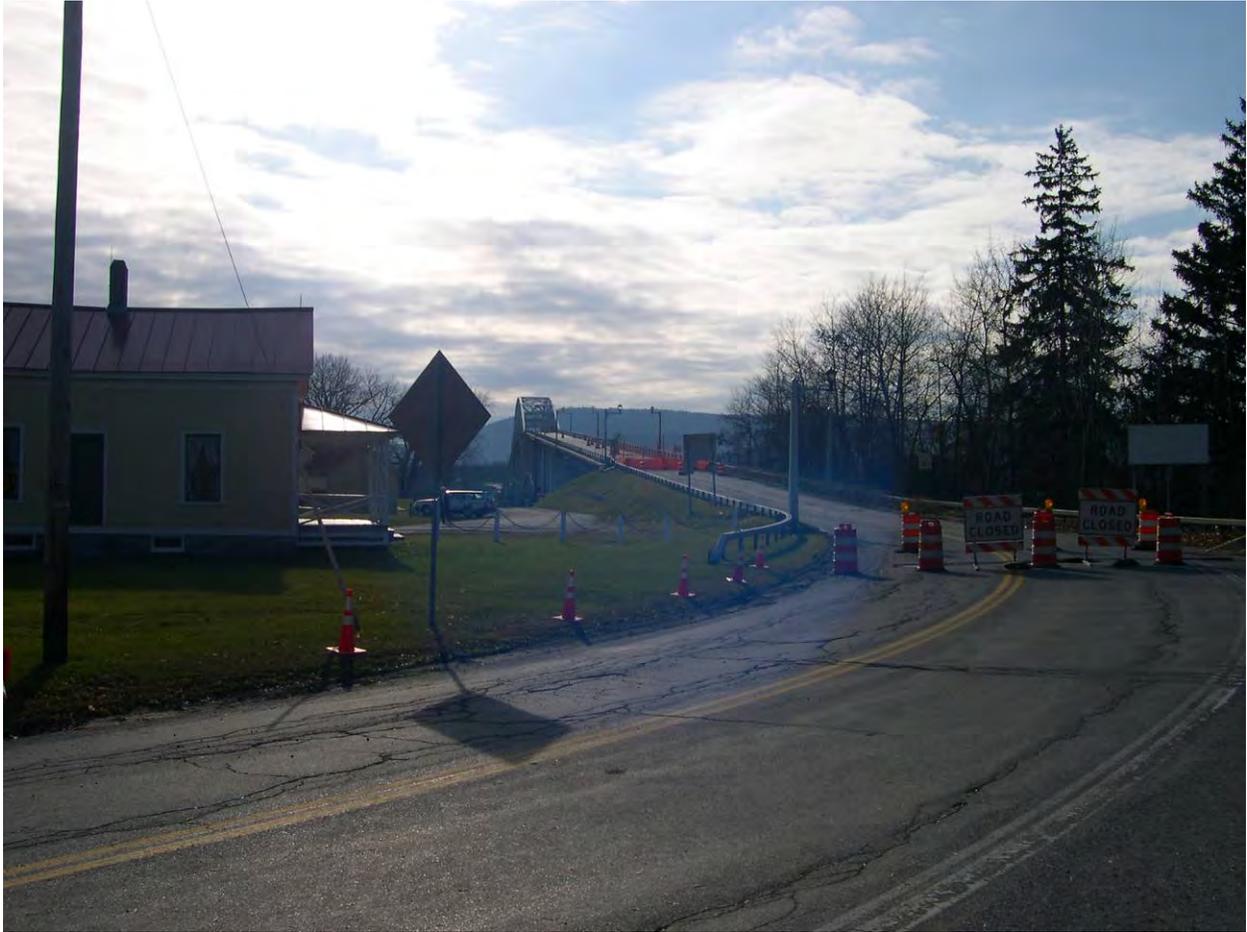
Figure 83. View of the north (Vermont) portal. Photograph by New York State Department of Transportation, July 2009.

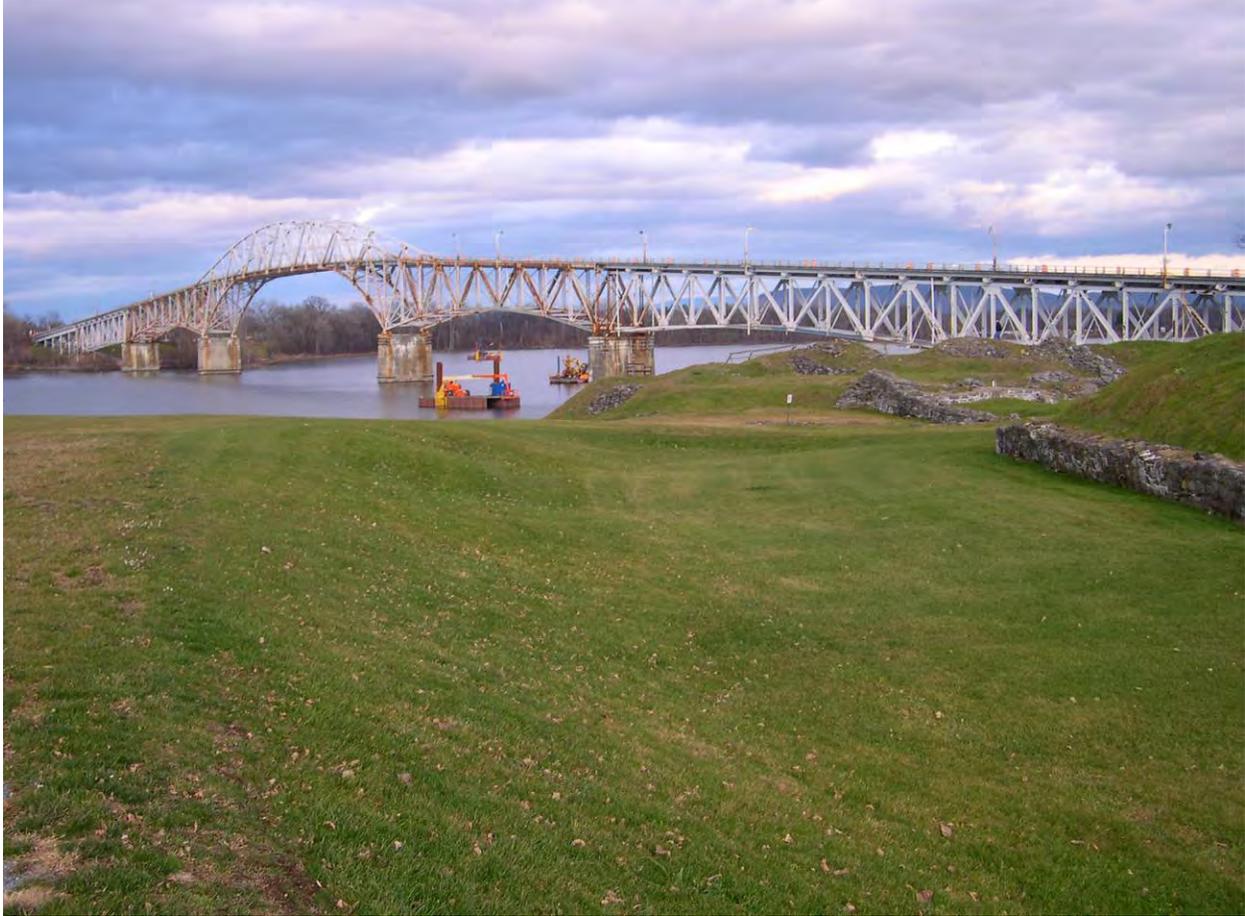
Figure 84. View of the closed bridge from the Vermont approach. Photograph by recording team, New York State Museum, November 2009.

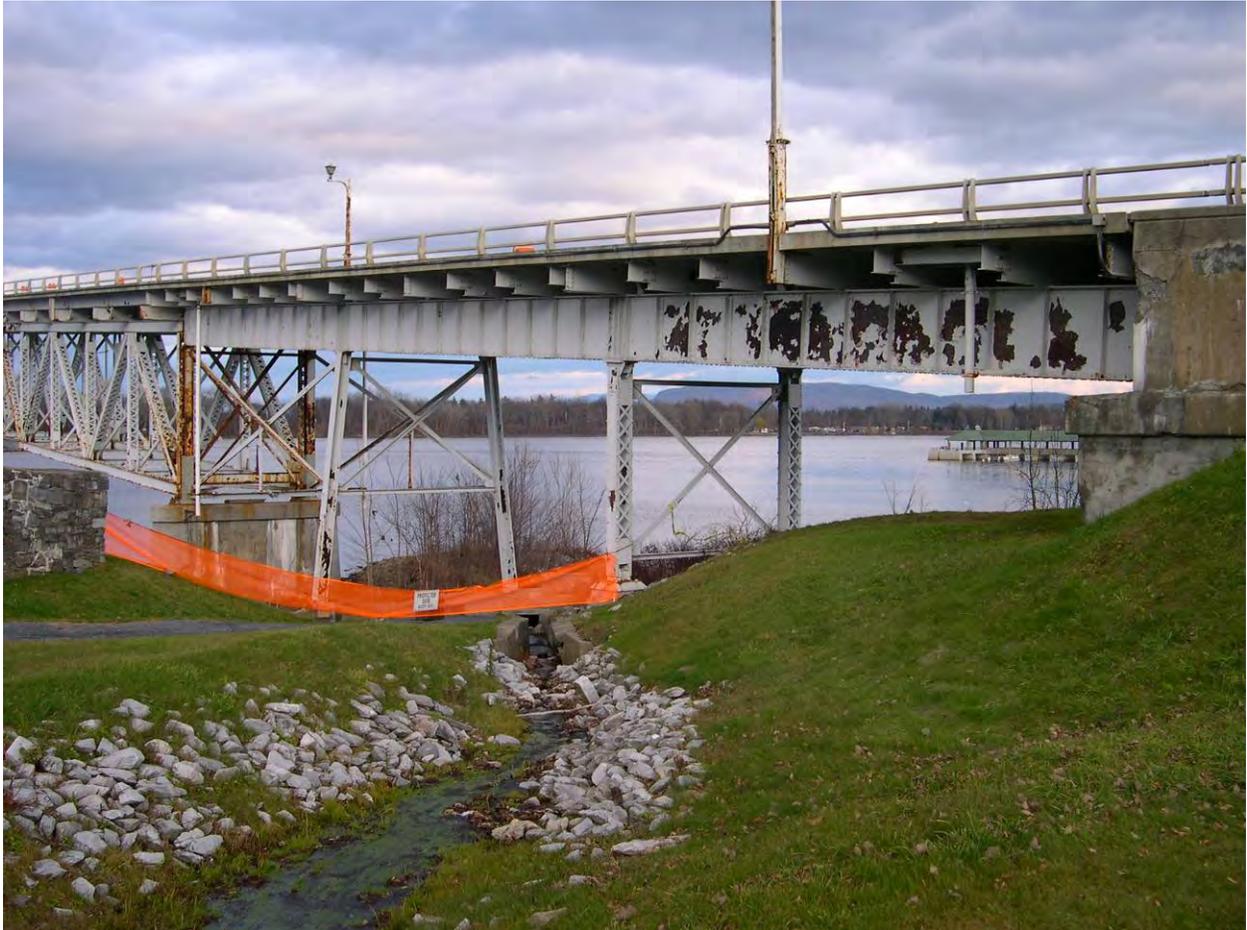
Figure 85. View of the bridge looking east from Fort St. Frederic. Photograph by recording team, New York State Museum, November 2009.

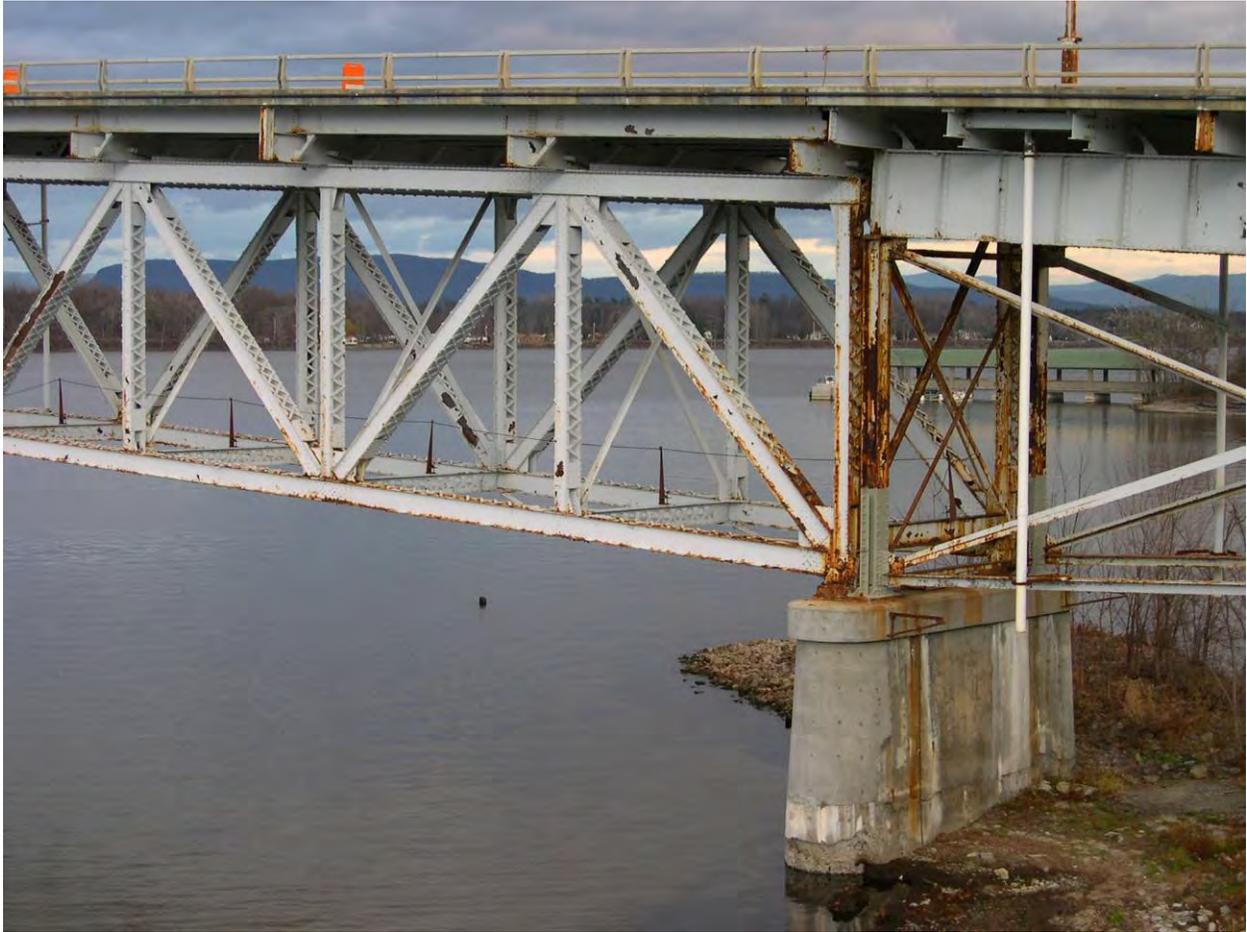
Figure 87. View of Spans 3 and 4 at Pier 3, west side. Photograph by recording team, New York State Museum, November 2009.

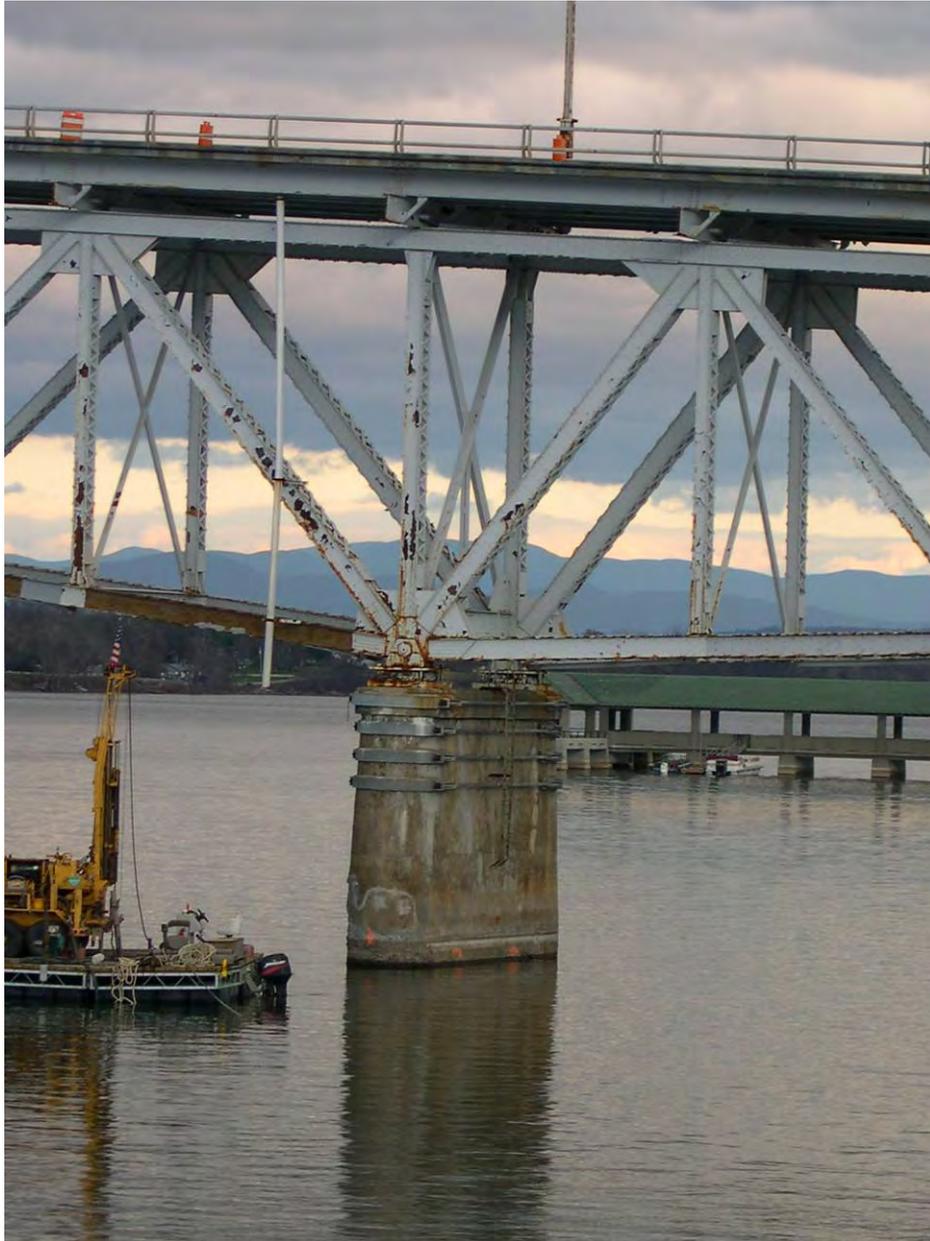
Figure 88. View of Span 4, west side. Photograph by recording team, New York State Museum, November 2009.

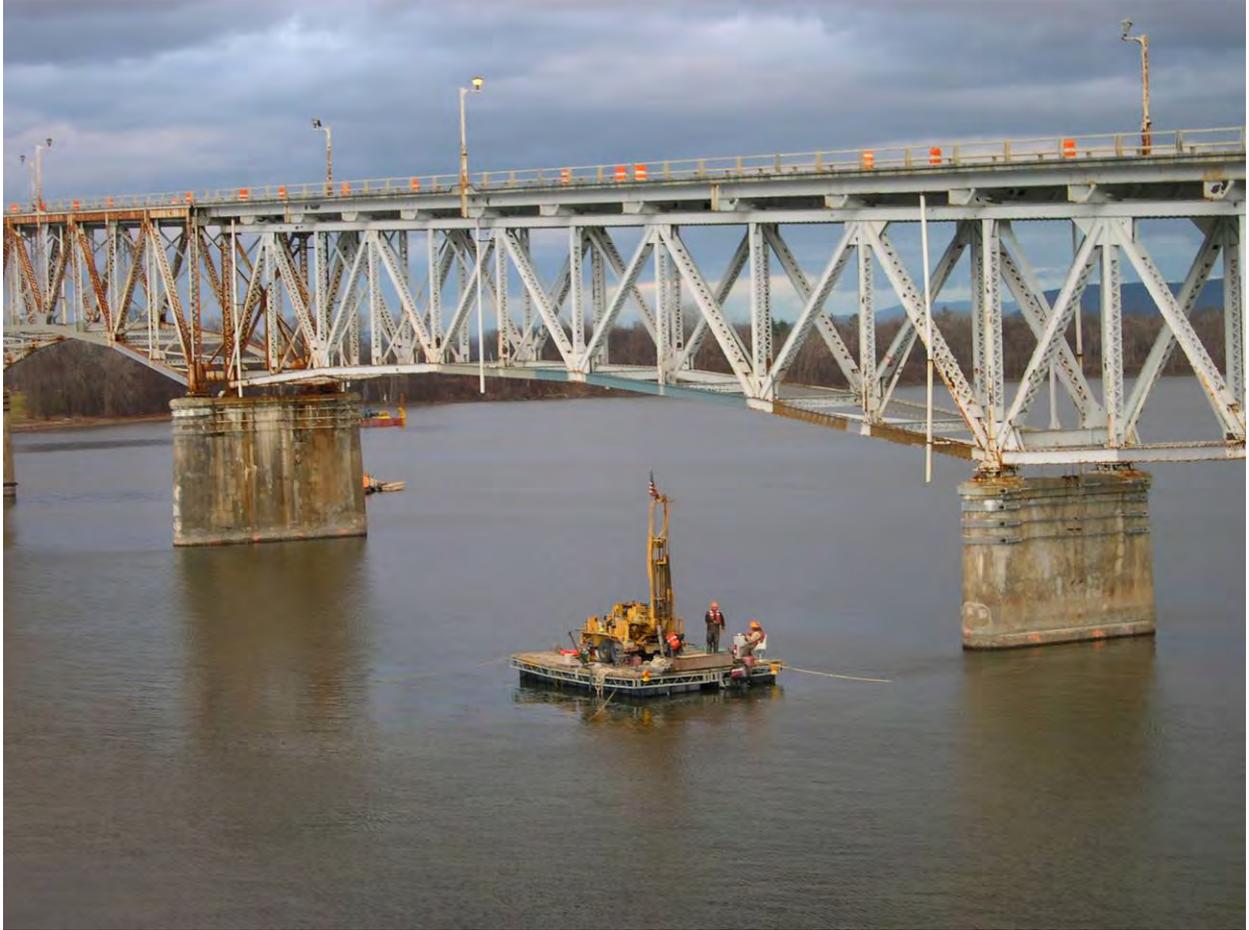
Figure 89. View of Spans 4 and 5 at Pier 4, west side. Photograph by recording team, New York State Museum, November 2009.

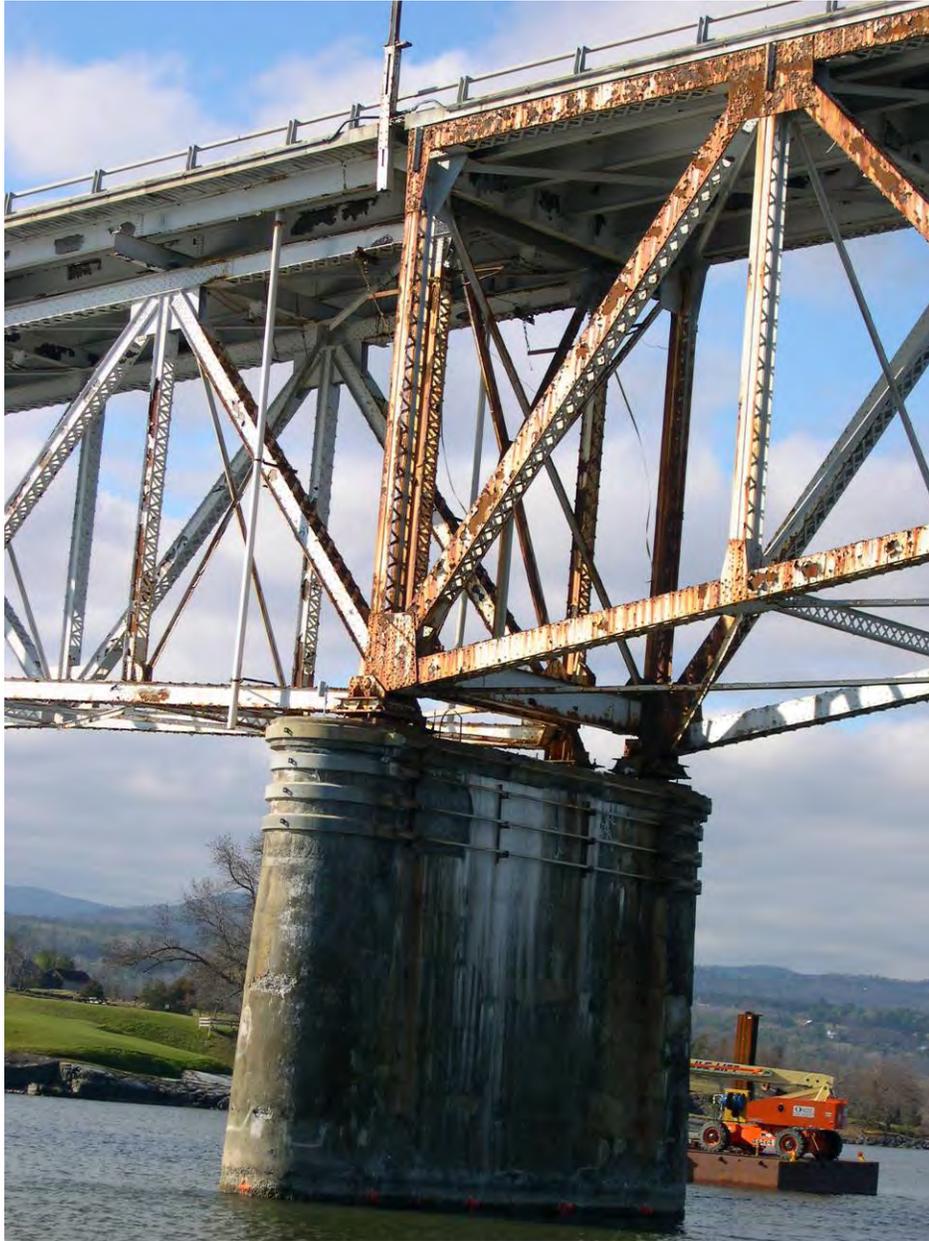
Figure 90. View of Span 5, west side, November 2009. Photograph by recording team, New York State Museum, November 2009.

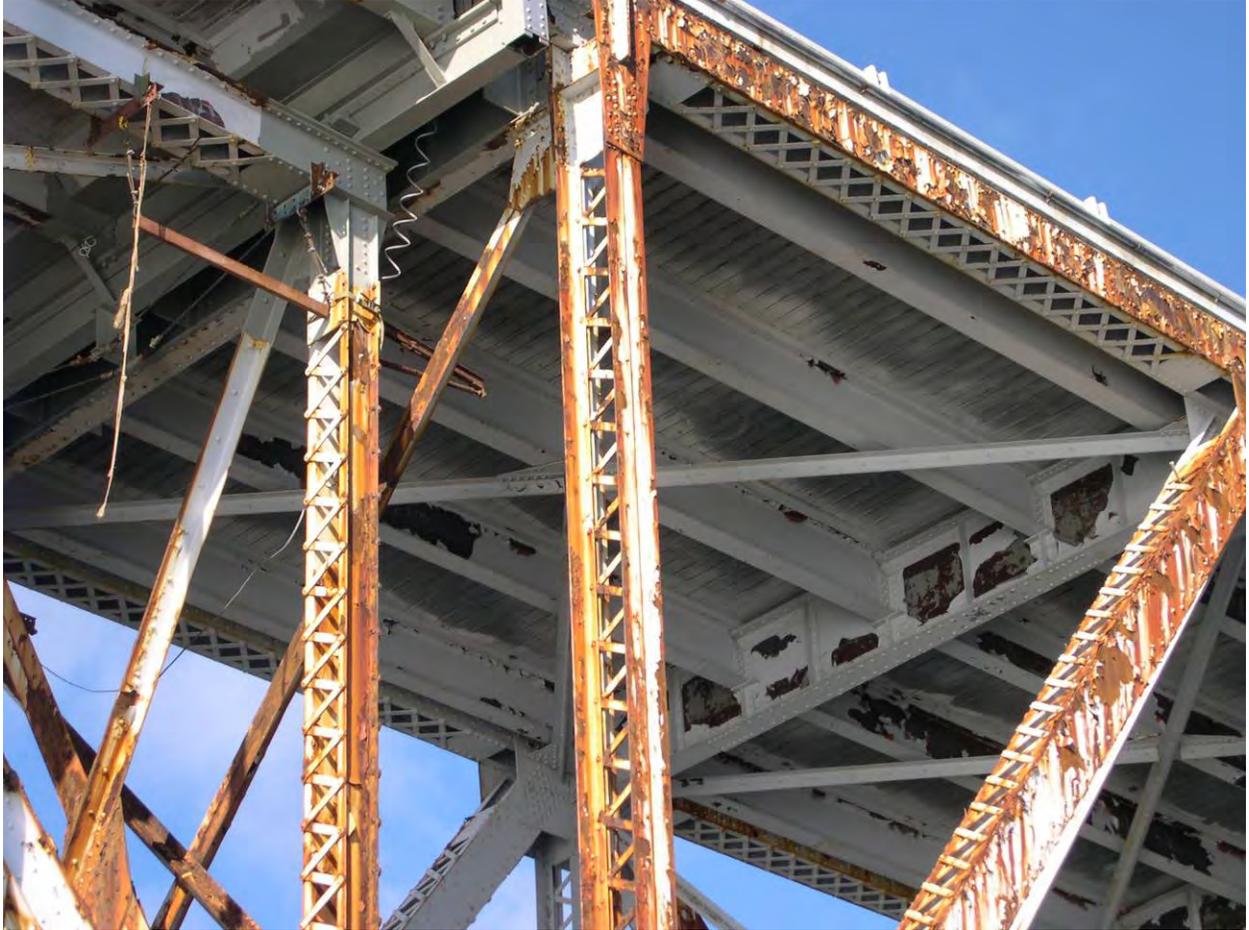
Figure 91. View of Spans 5 and 6 at Pier 5, east side. Photograph by recording team, New York State Museum, November 2009.

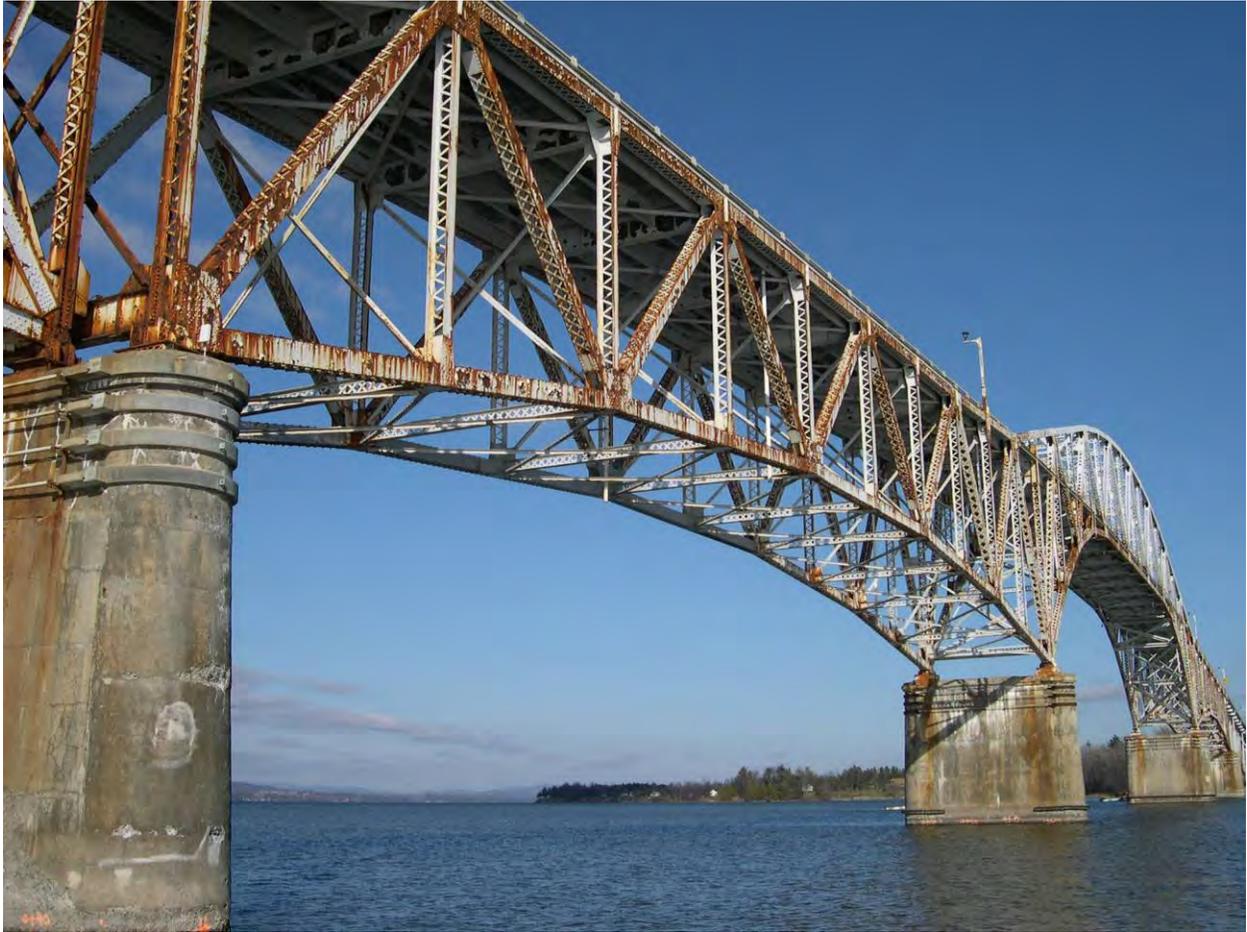
Figure 93. View of Span 6, east side. Photograph by recording team, New York State Museum, November 2009.
