HISTORIC AMERICAN ENGINEERING RECORD

LAKE CHAMPLAIN BRIDGE

HAER No. NY-541

Structural Type: Steel continuous through and deck truss span

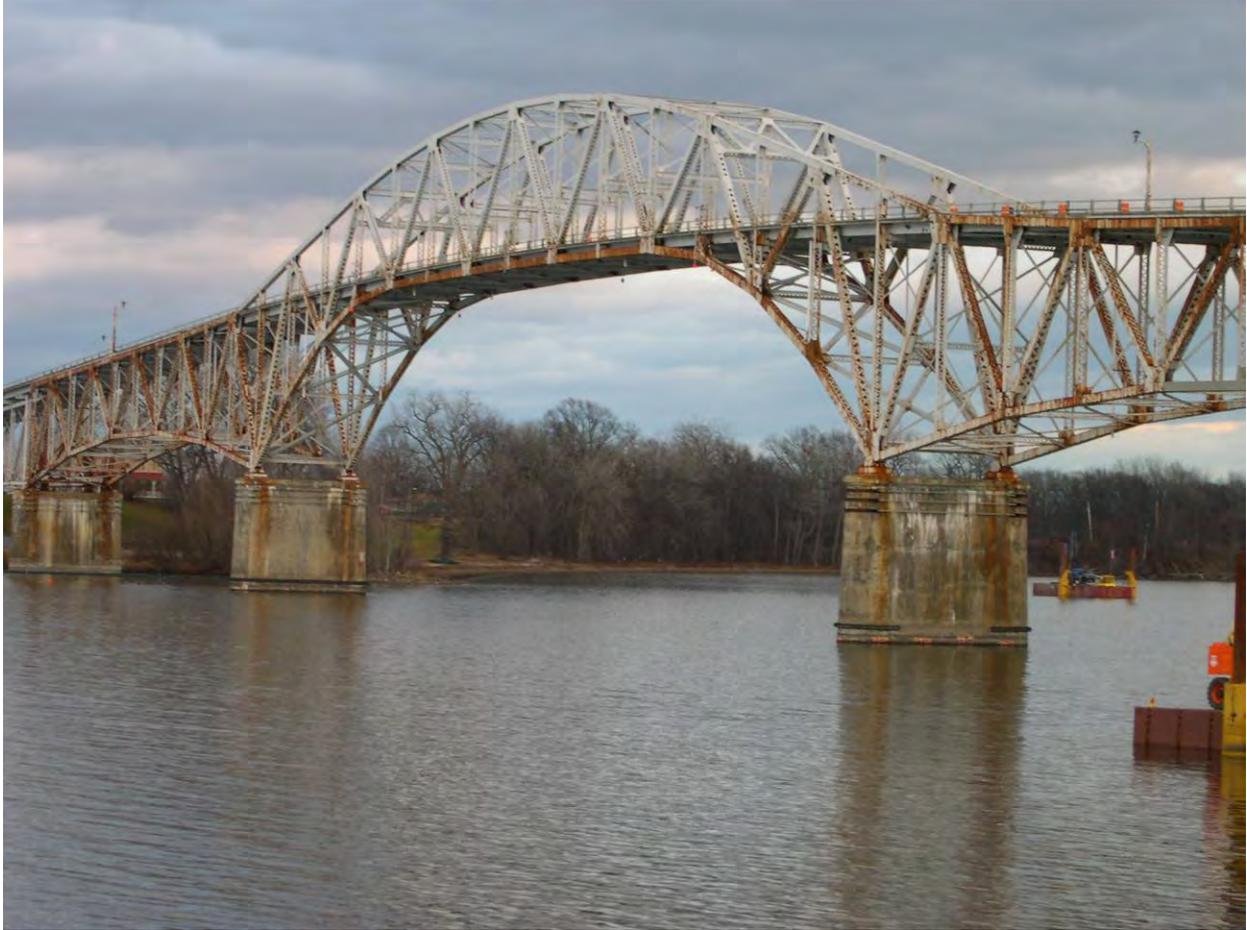
Figure 94. View of Spans 6 and 7 at Pier 6, east side. Photograph by recording team, New York State Museum, November 2009.

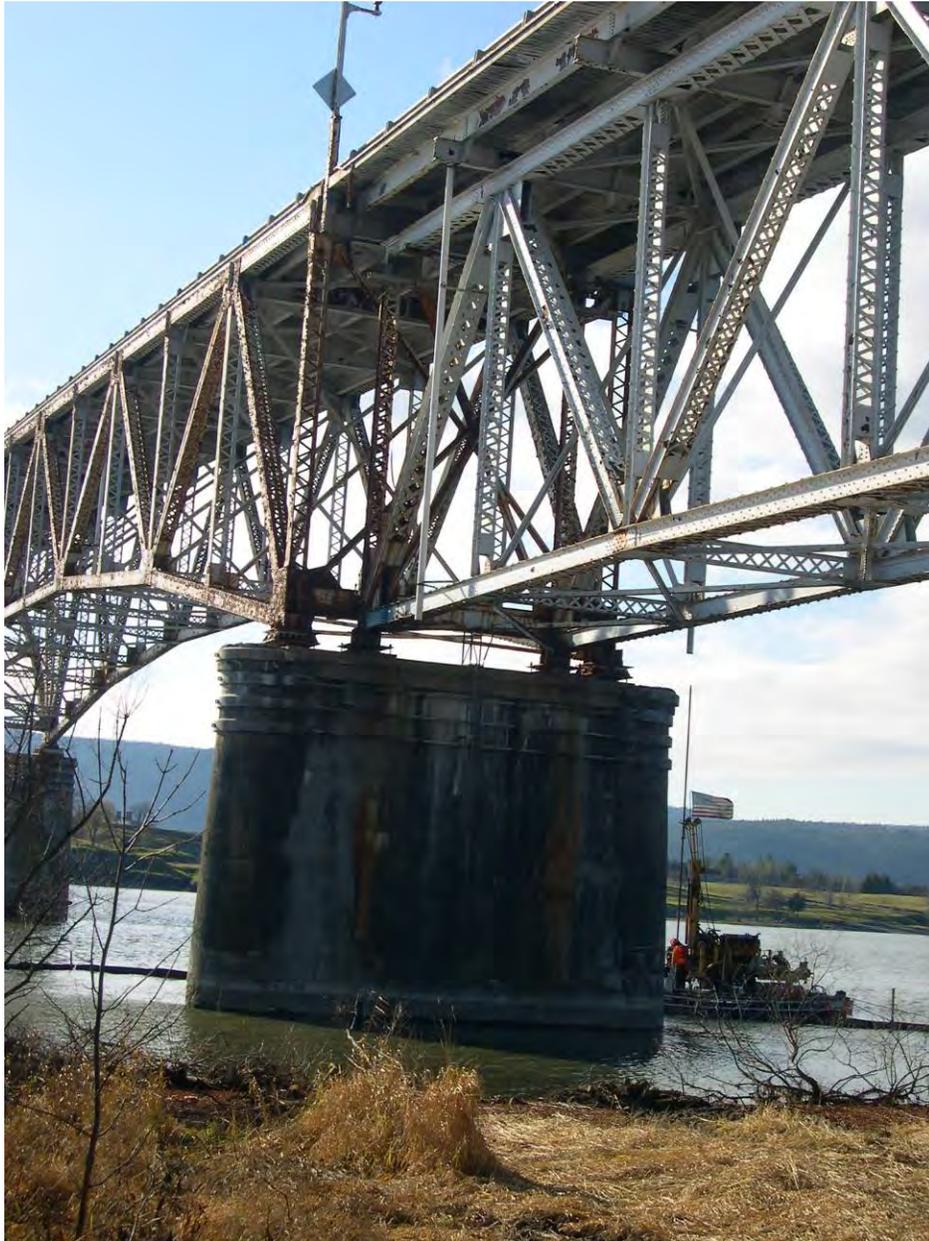
Figure 97. View of Spans 8 and 9, east side. Photograph by recording team, New York State Museum, November 2009.

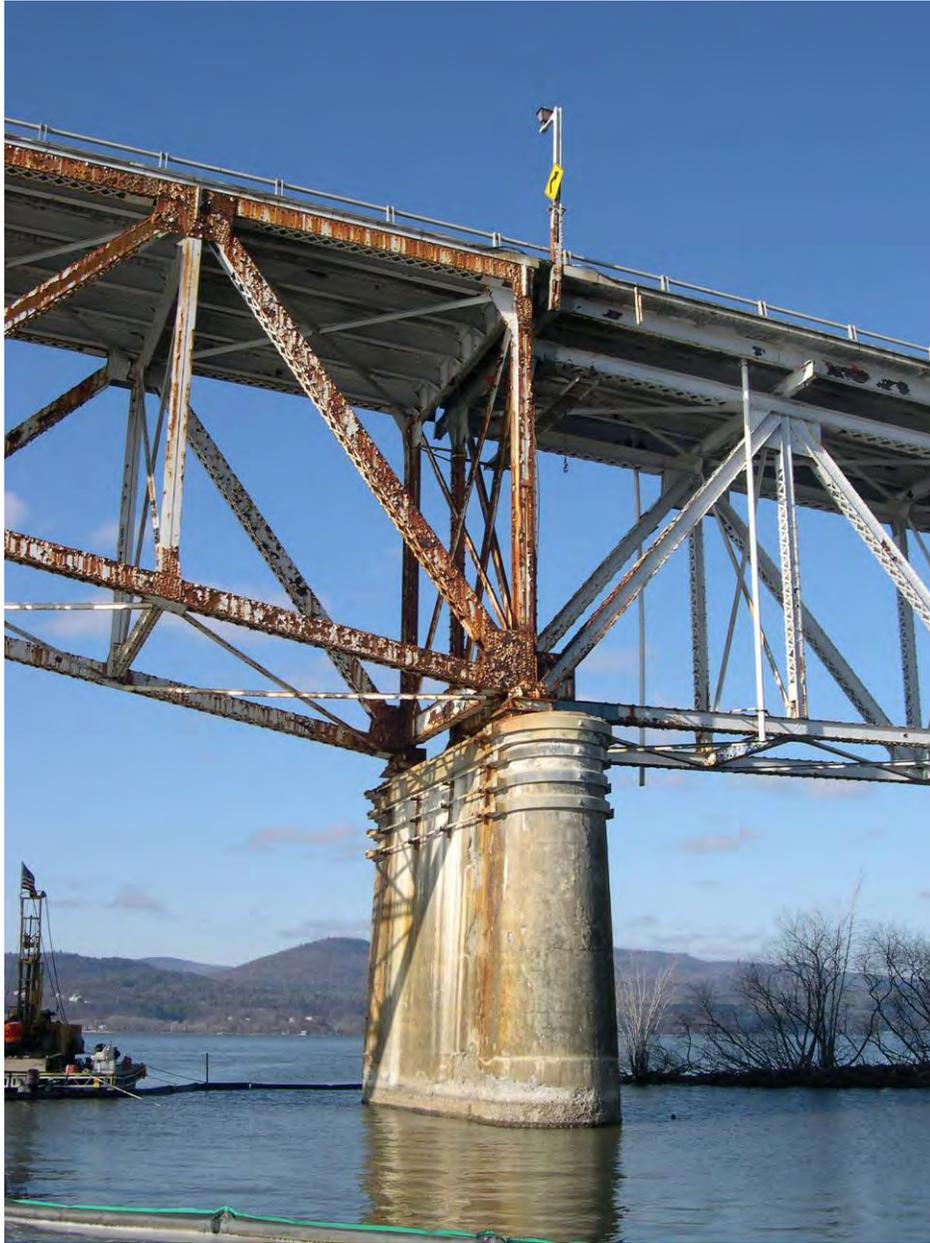
Figure 98. View of Spans 8 and 9 at Pier 8, east side. Photograph by recording team, New York State Museum, November 2009.

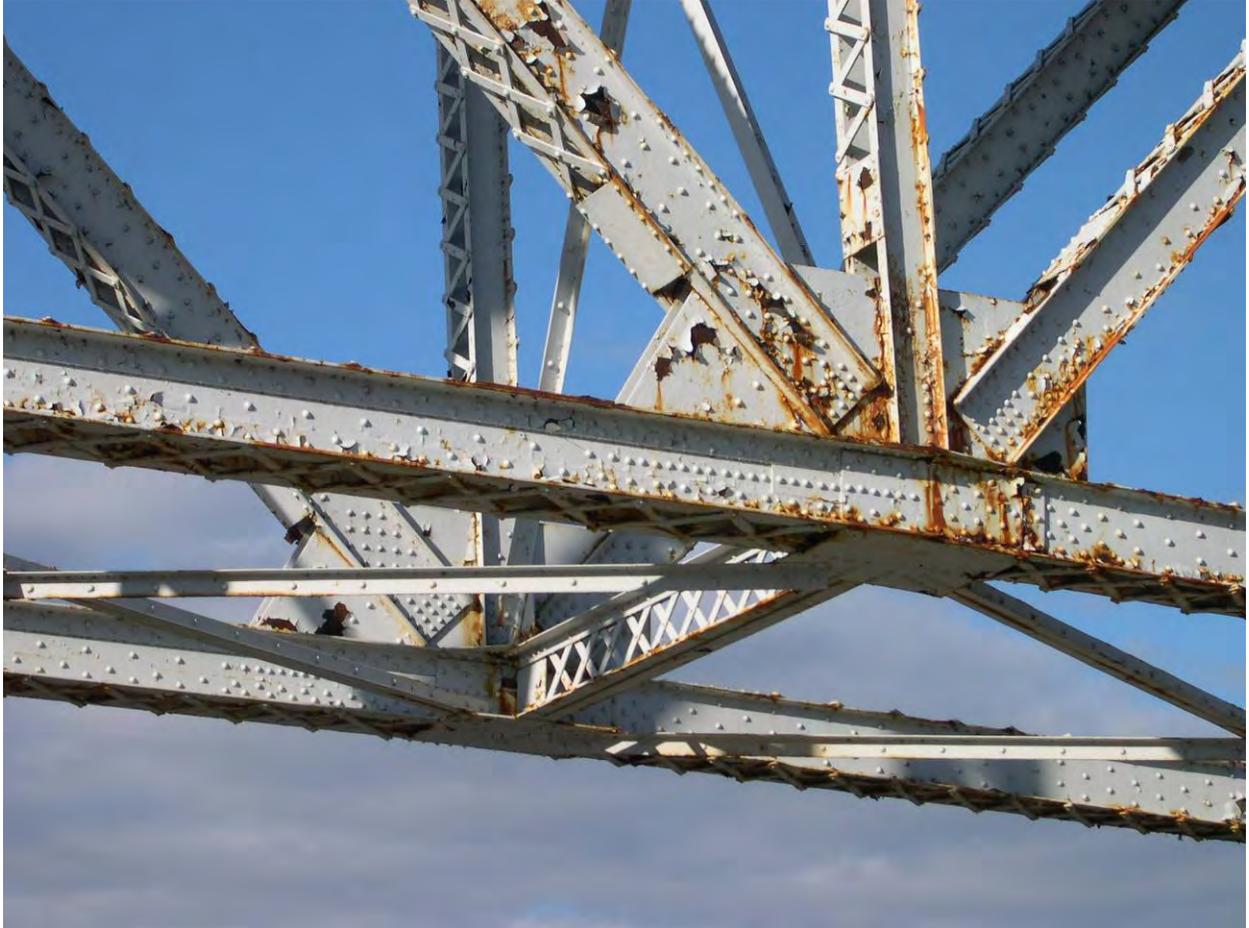
Figure 99. View of Spans 8 and 9 at Pier 8, east side. Photograph by recording team, New York State Museum, November 2009.

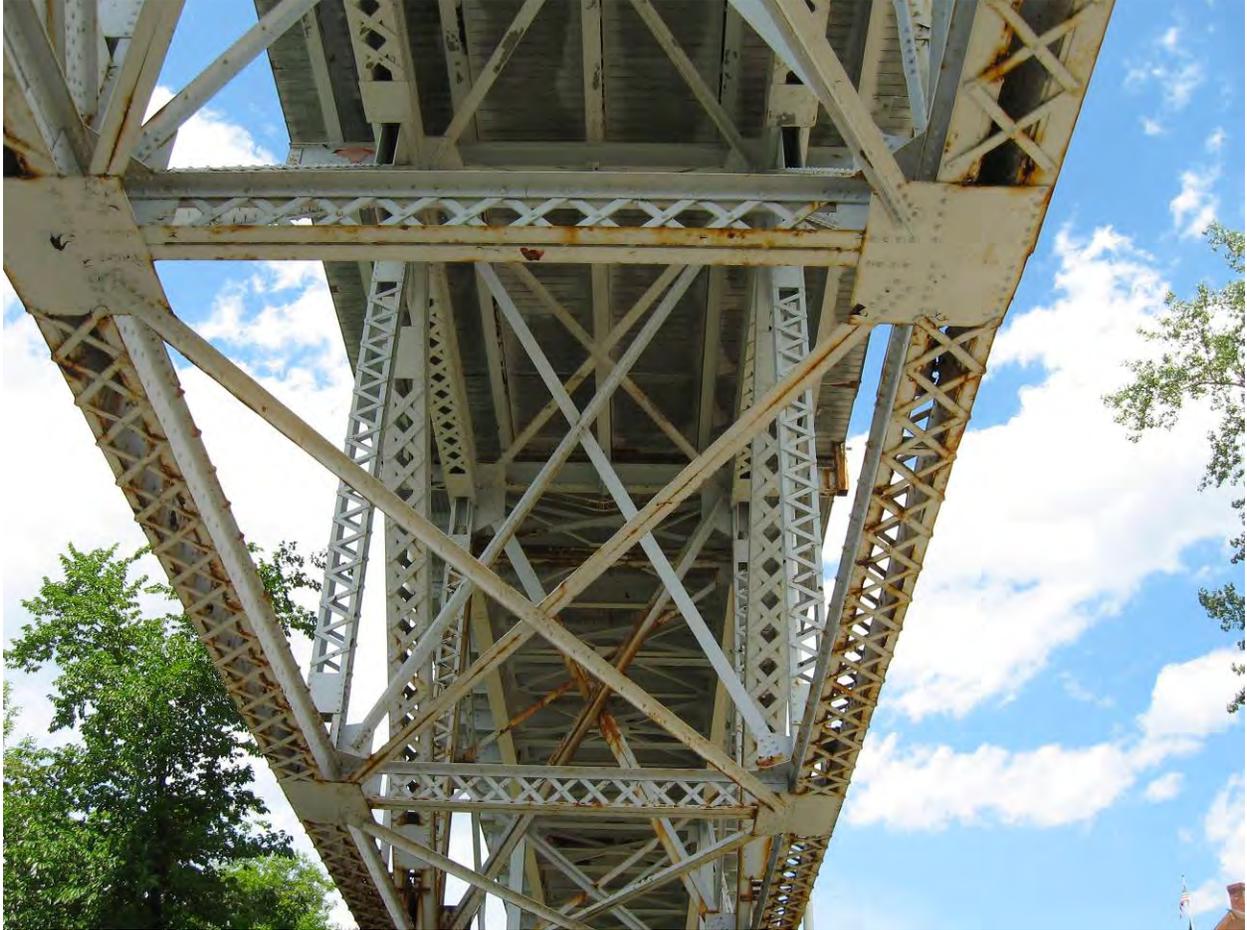
Figure 100. Span 9 east side, lower chord detail. Photograph by recording team, New York State Museum, November 2009.

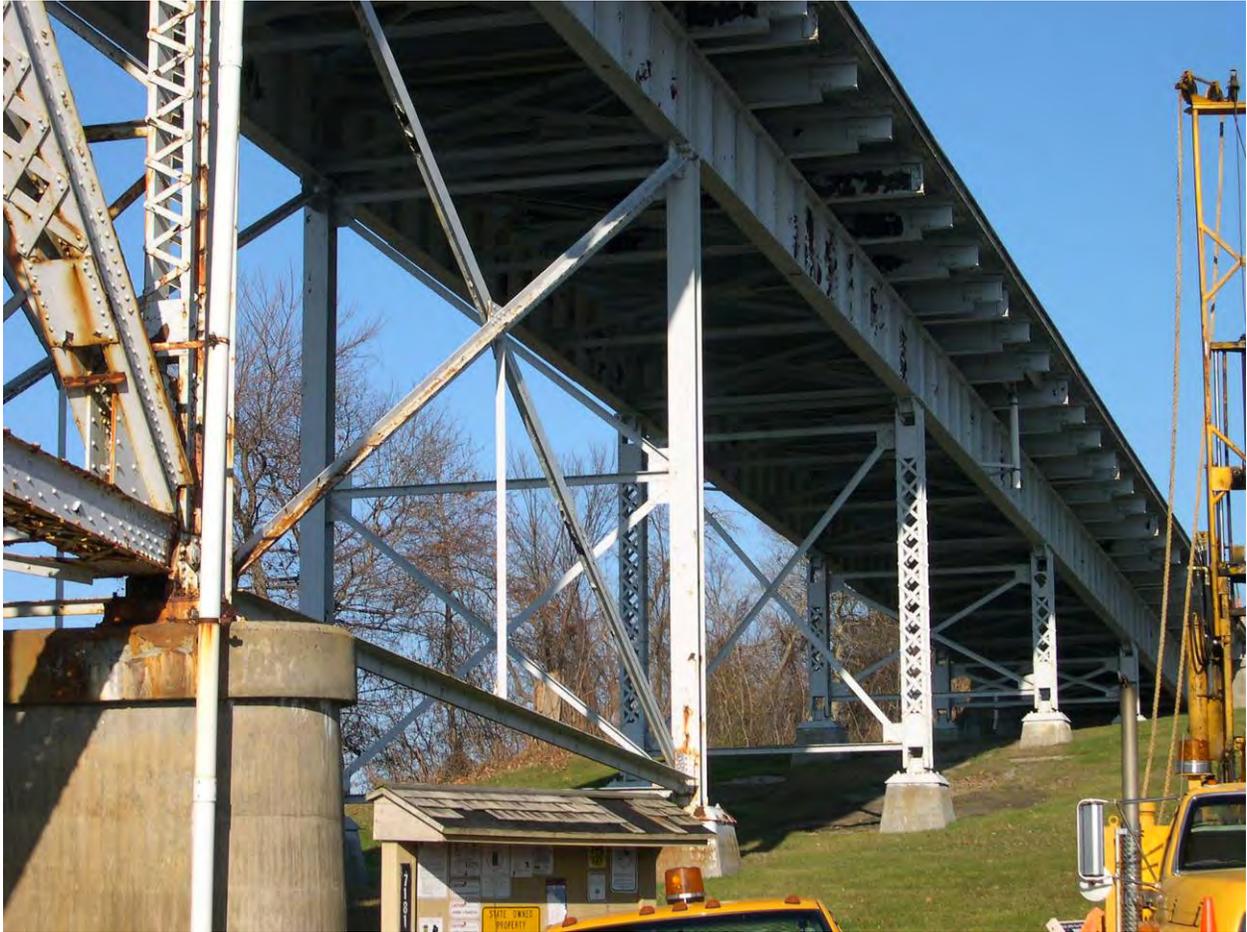
Figure 101. Underside of Span 9, showing cross bracing and laterals. Photograph by New York State Department of Transportation, June 2007.

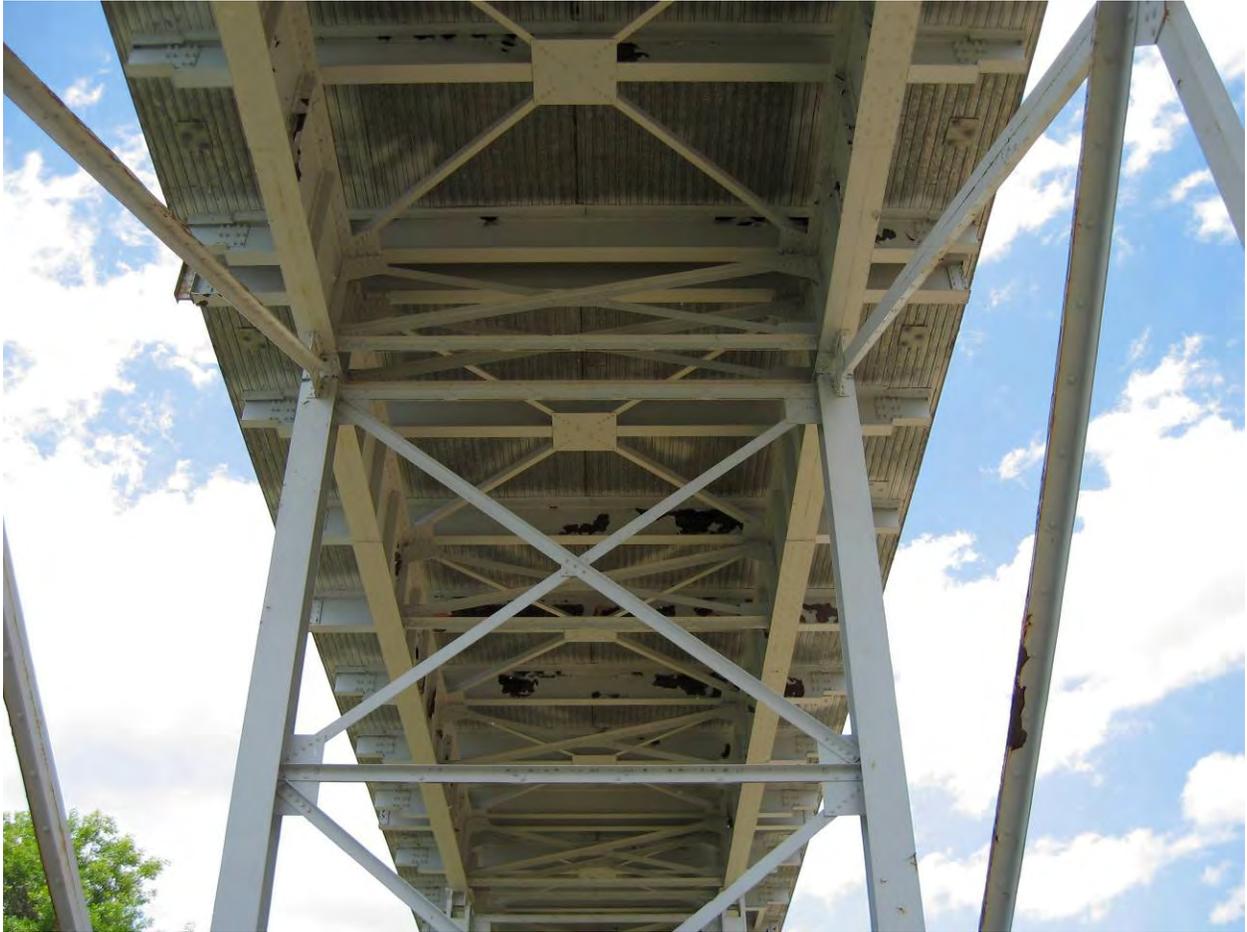
Figure 103. Underside of Span 10, showing cross bracing and laterals. Photograph by New York State Department of Transportation, June 2007.

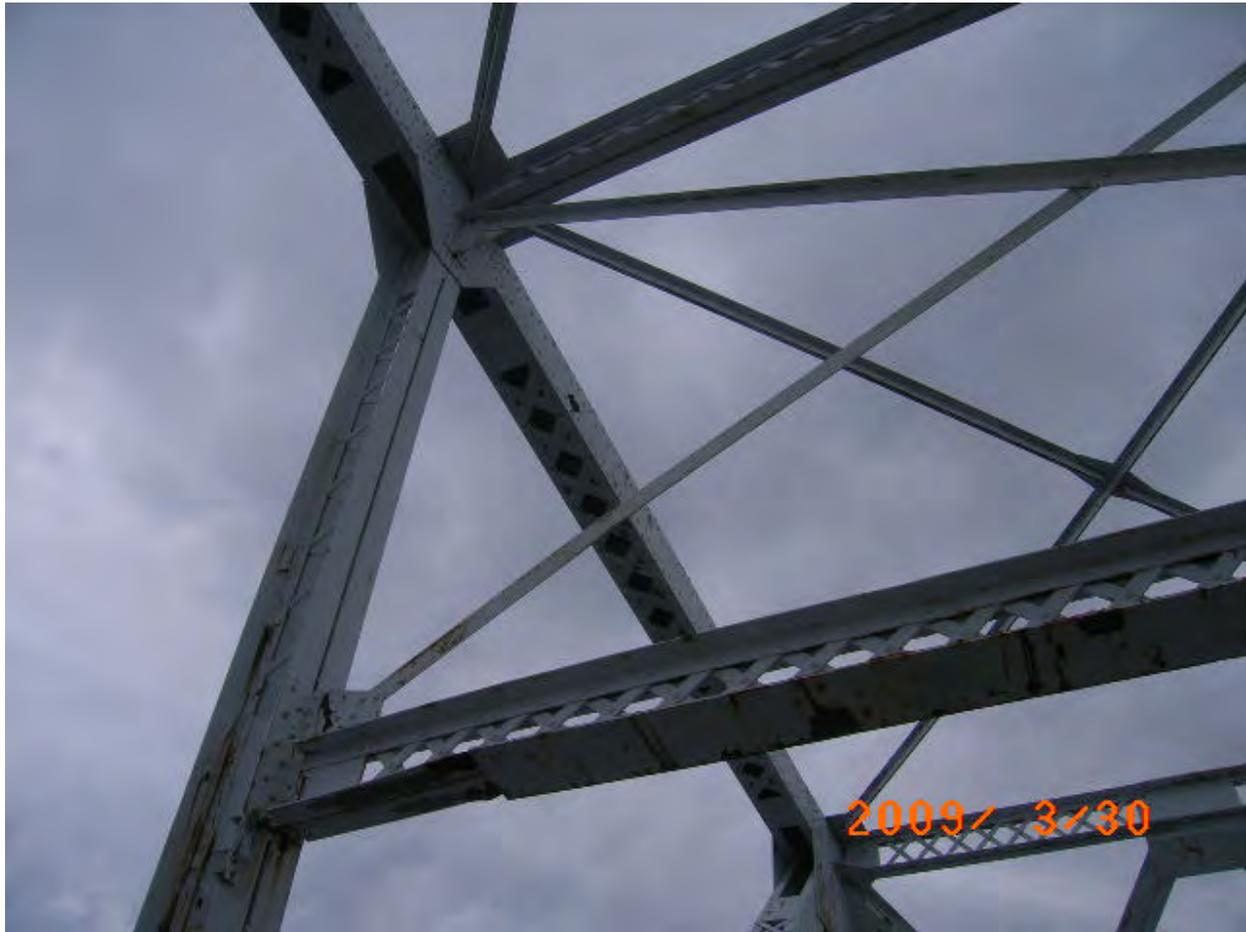
Figure 110. Span 7 strut at Panel Point 16.

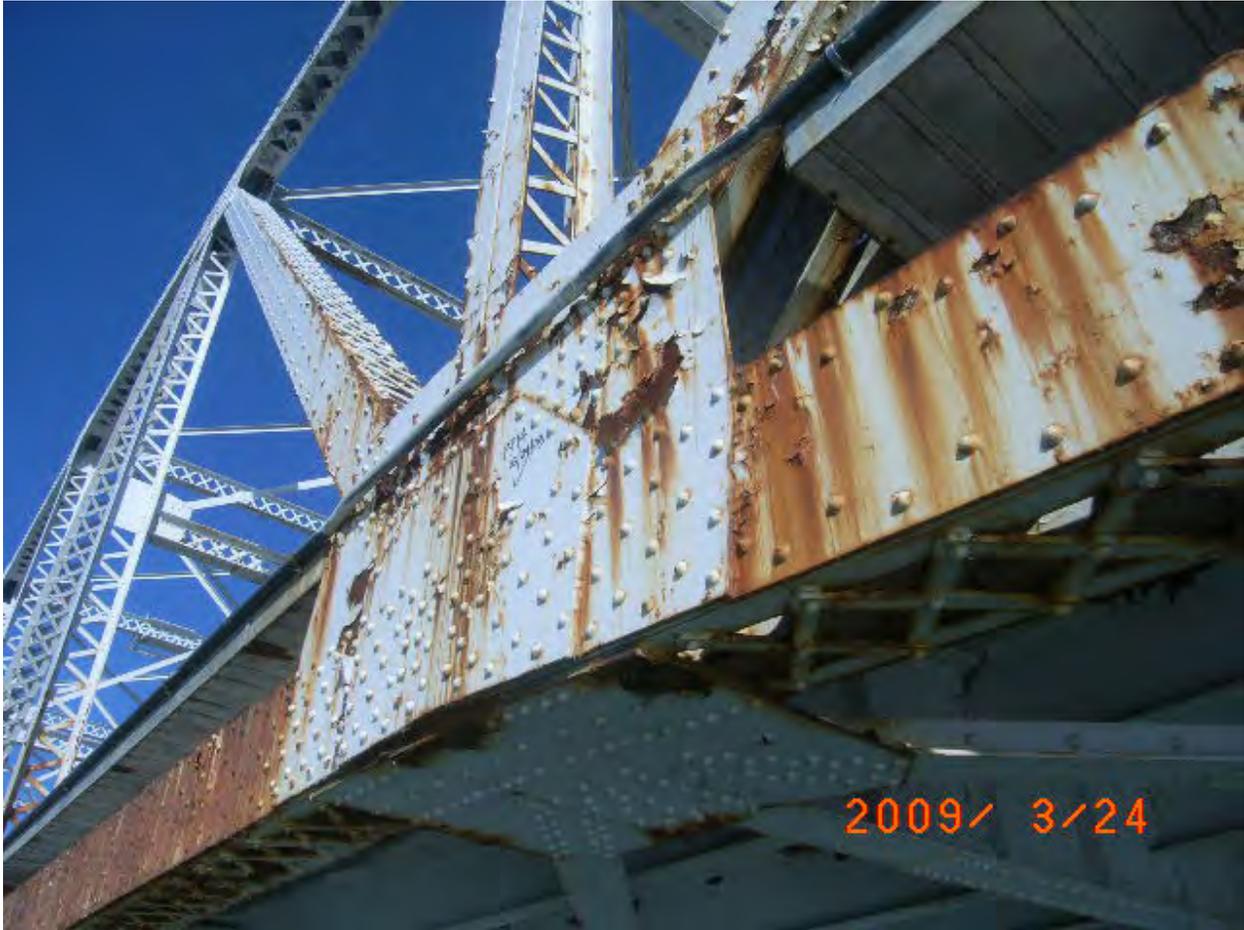
Figure 112. Span 7 deck at connection L16.

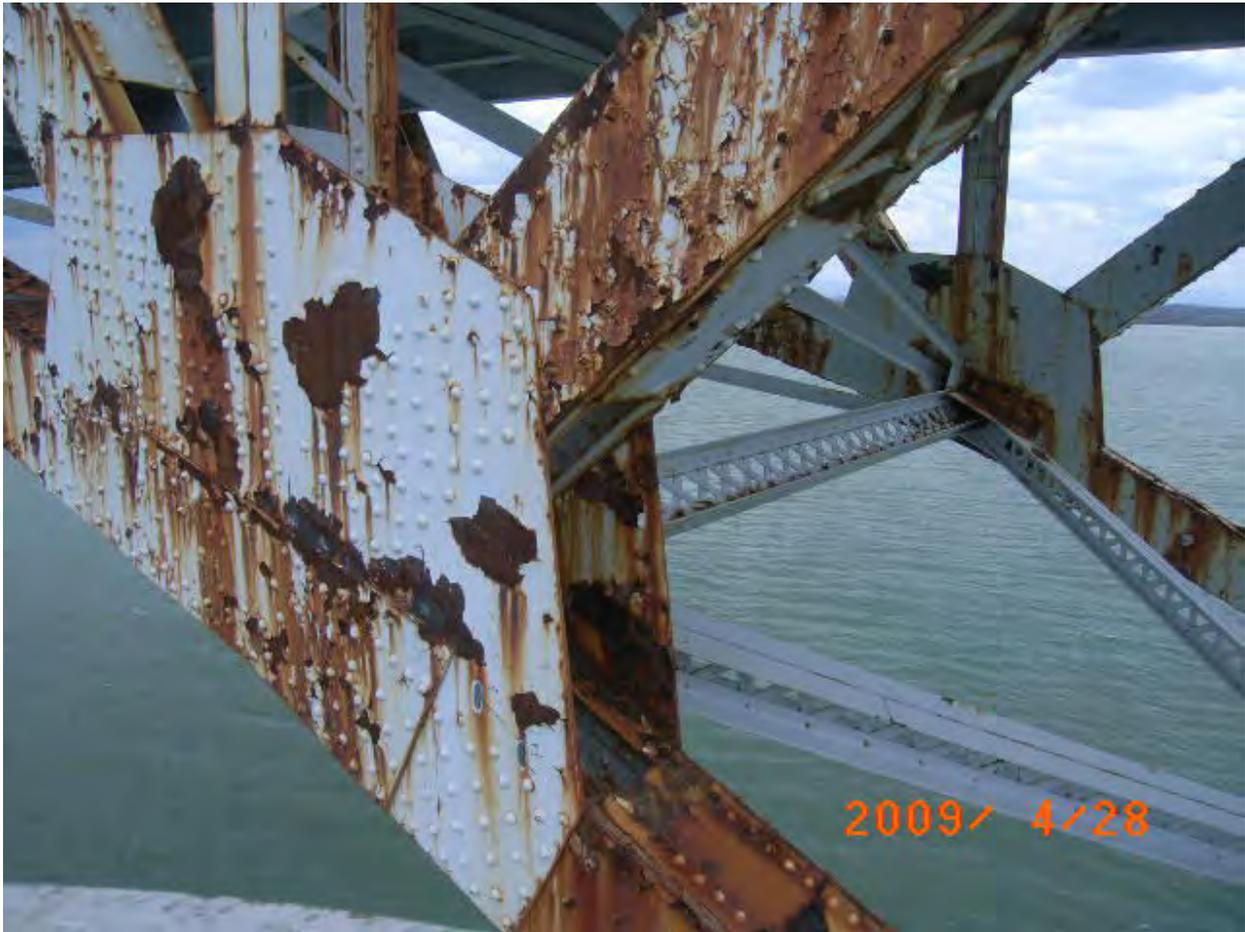
Figure 113. Span 7 lower chord connection at L14.

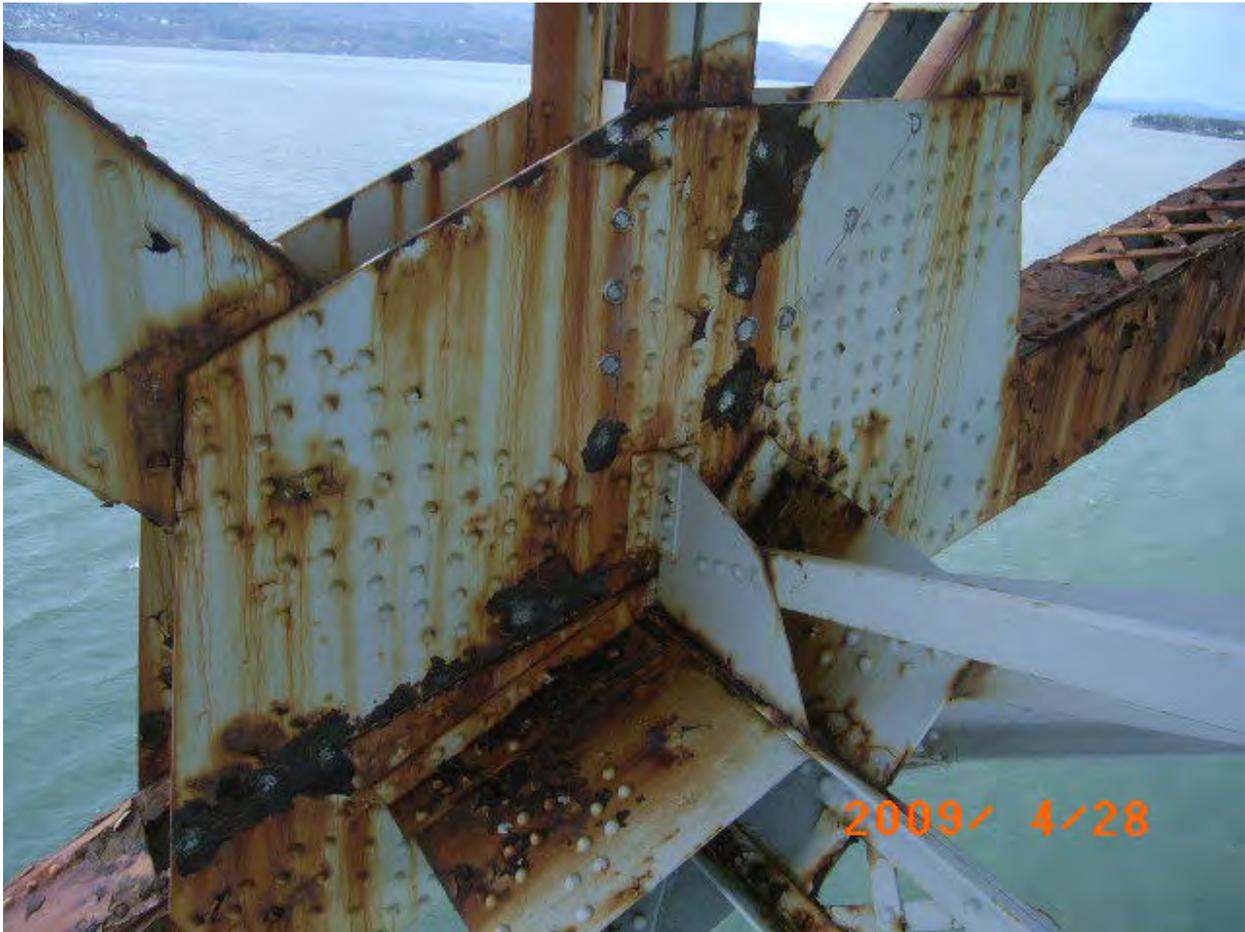
Figure 114. Span 7, lower chord connection at L12.

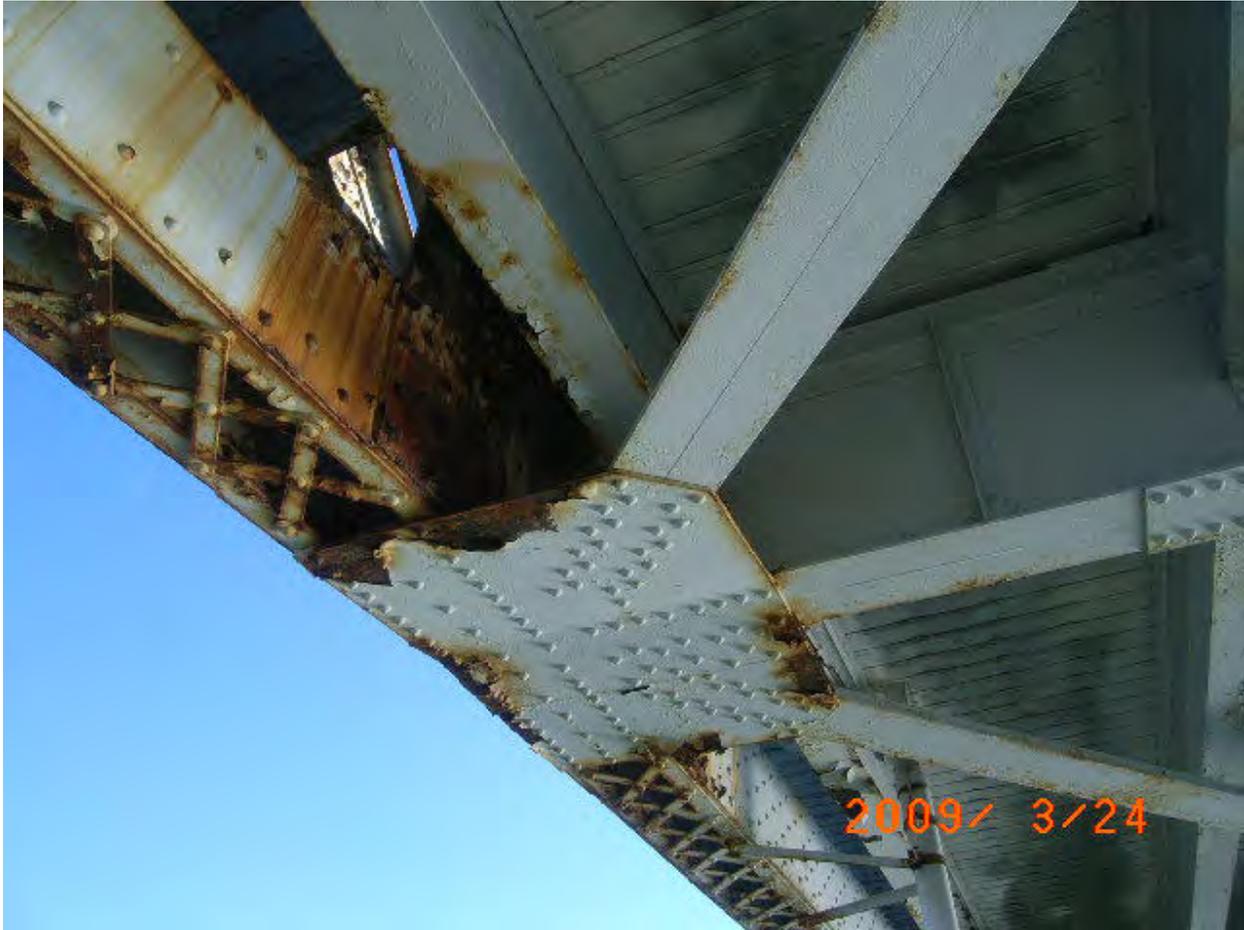
Figure 115. Span 7 lower chord connection at L12, interior side.

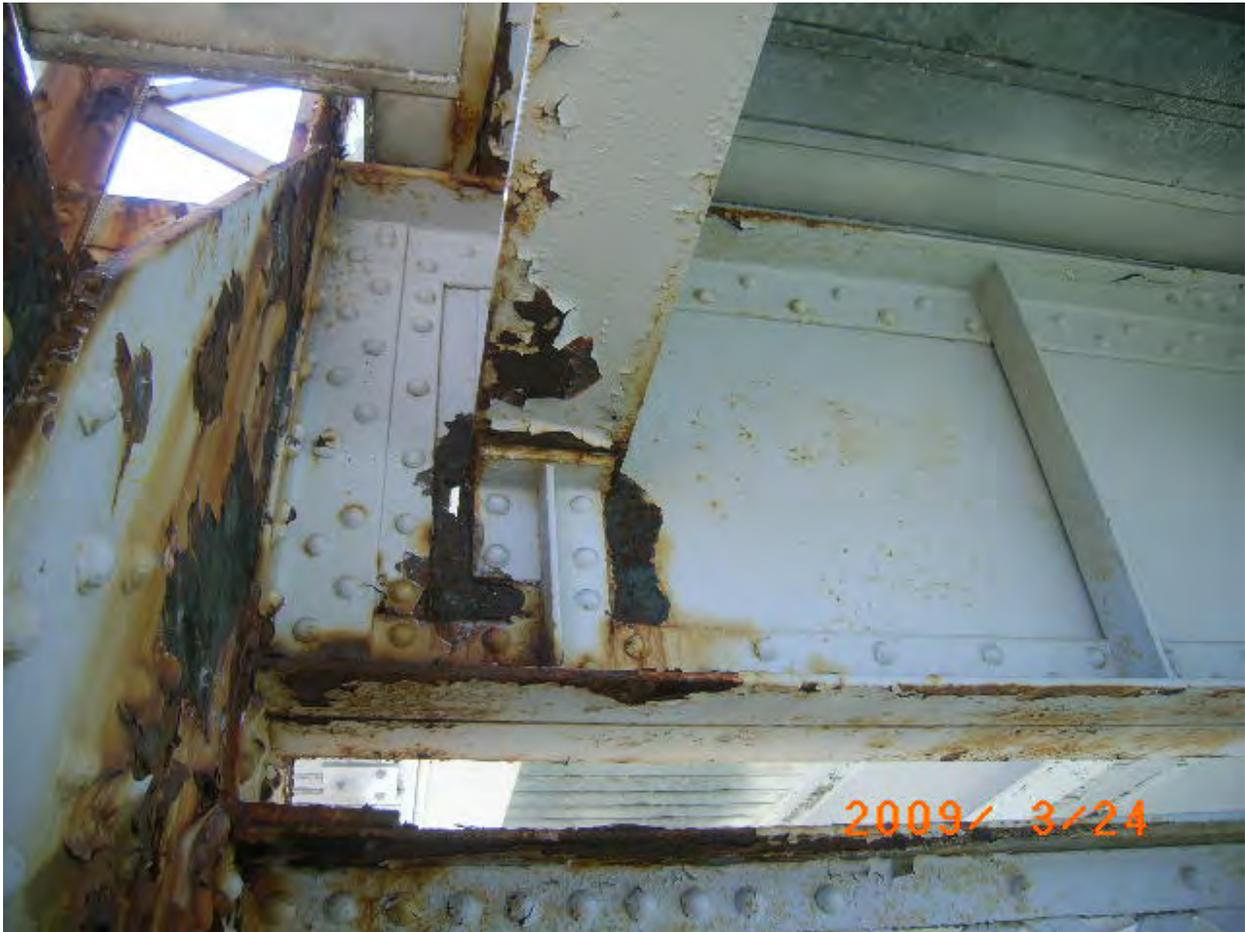
Figure 116. Span 7 lower chord lateral connection at L14.

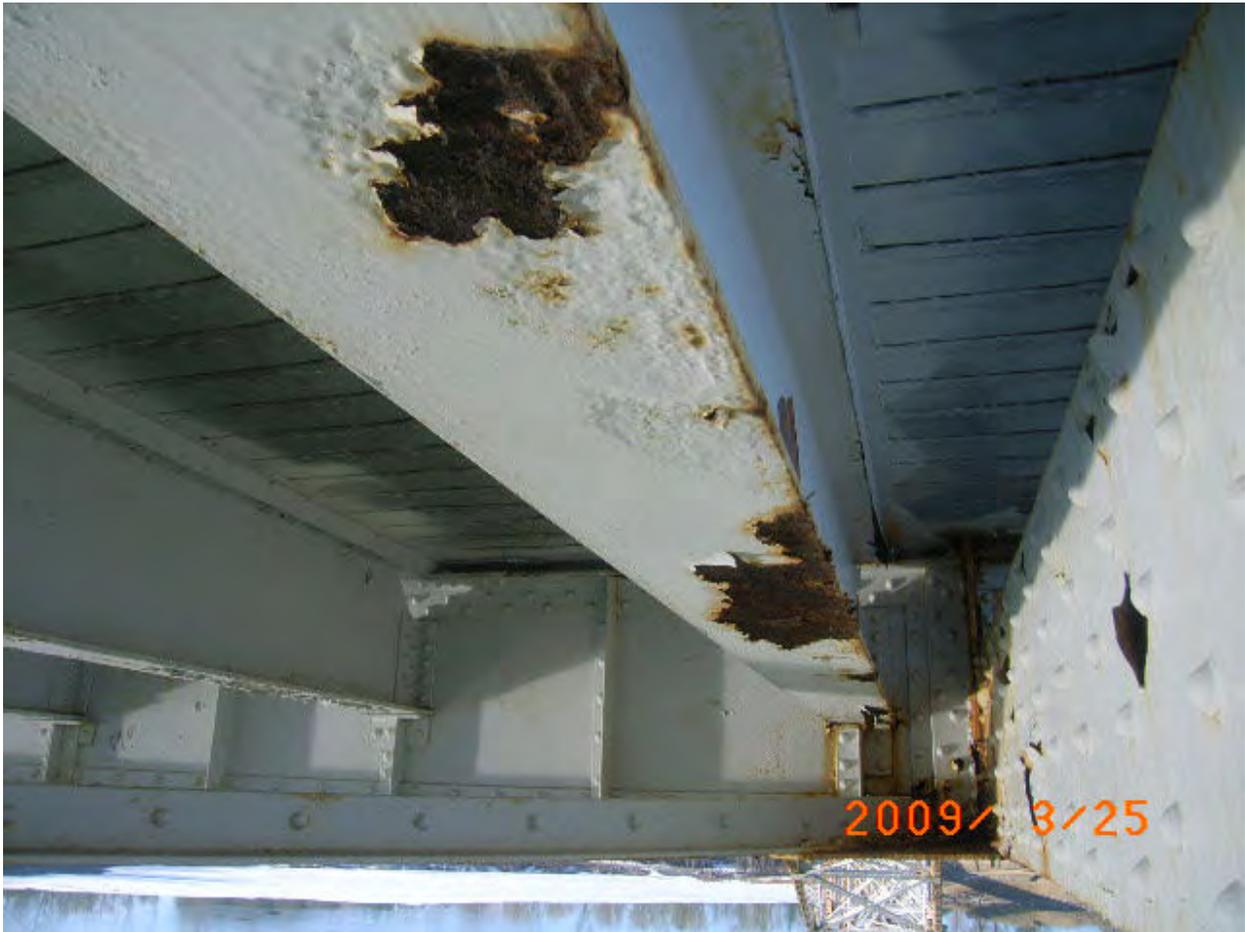
Figure 117. Span 7 Floor Beam 13.

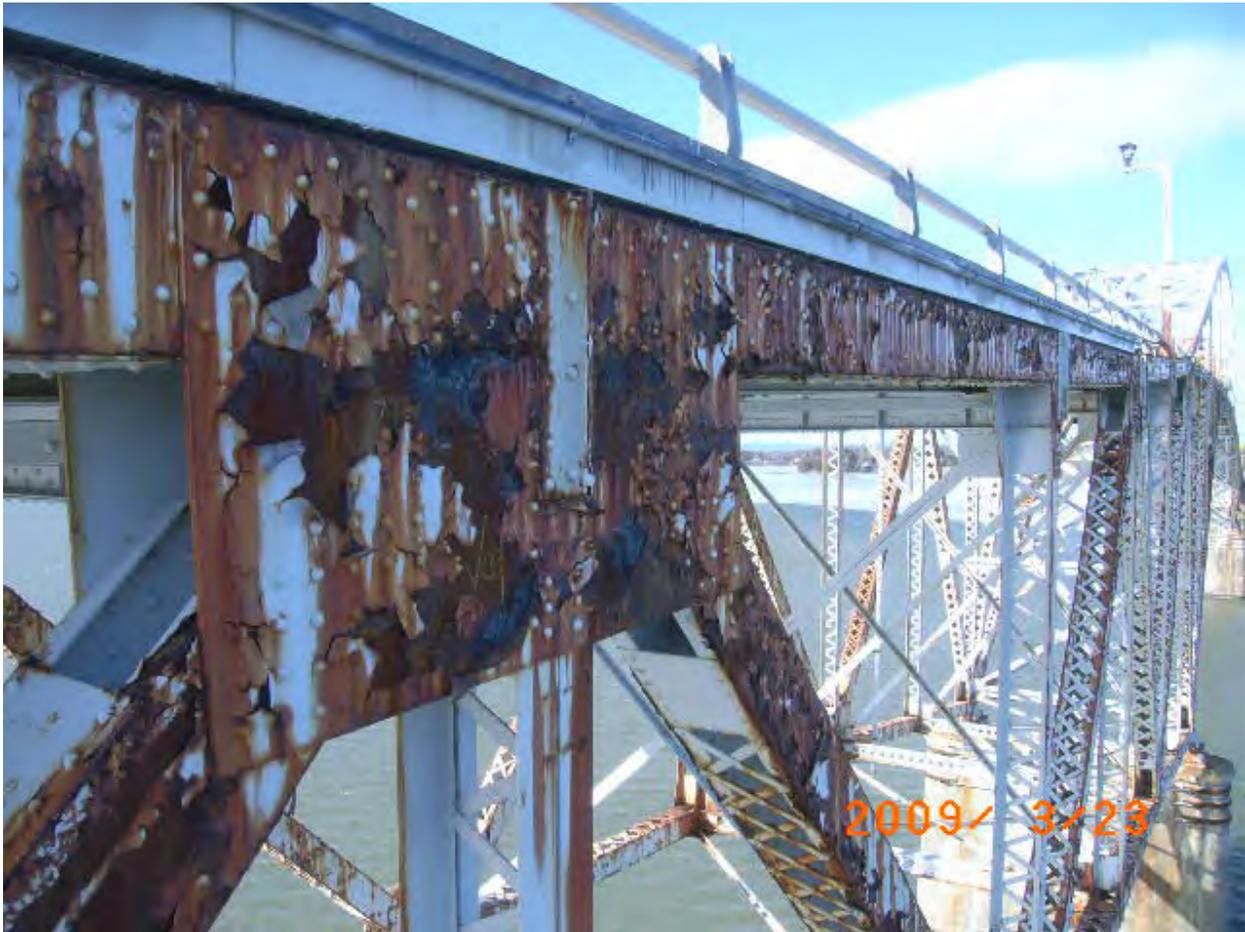
Figure 118. Span 7 Panel 20 stringer.

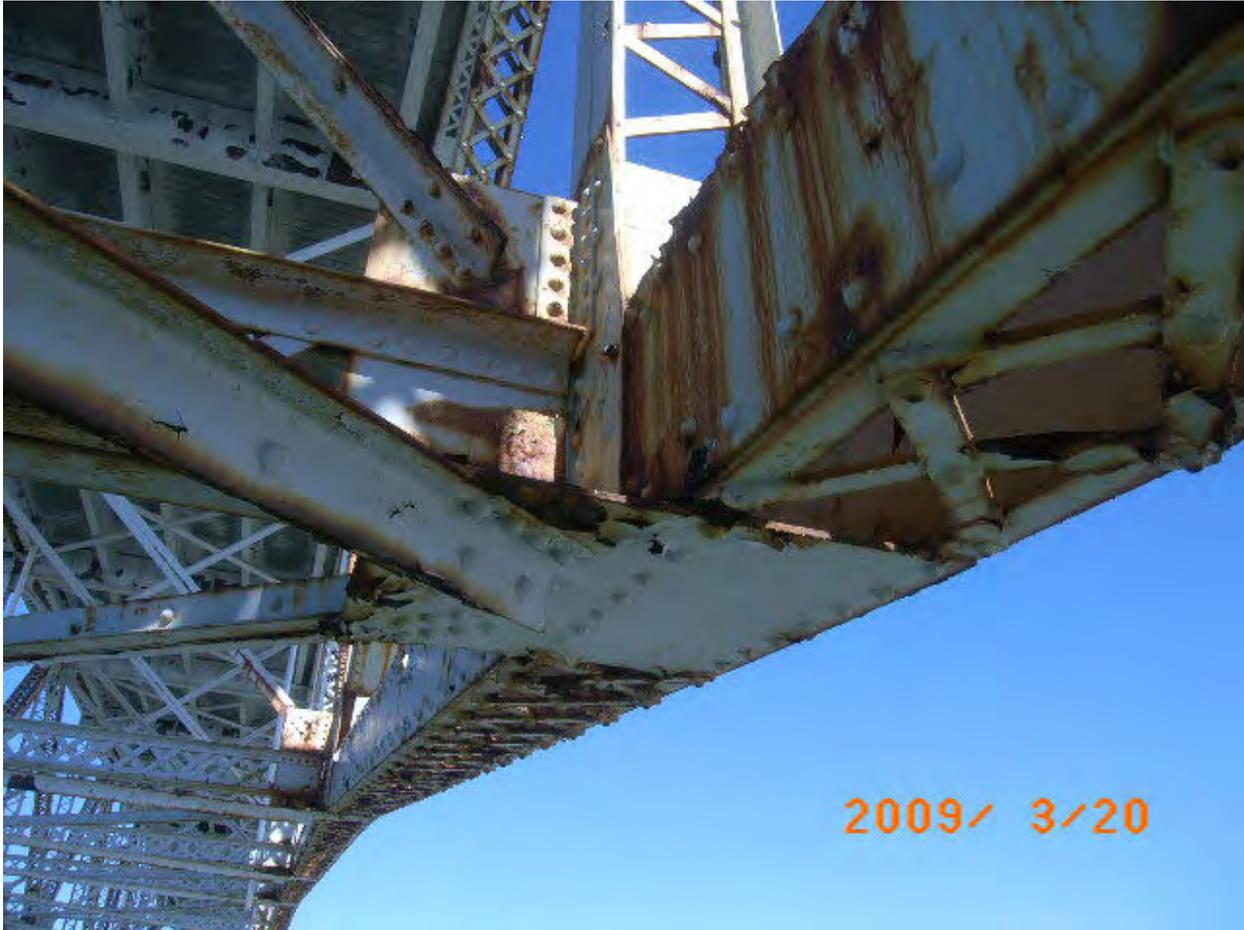
Figure 119. Span 6 upper chord connection at U05.

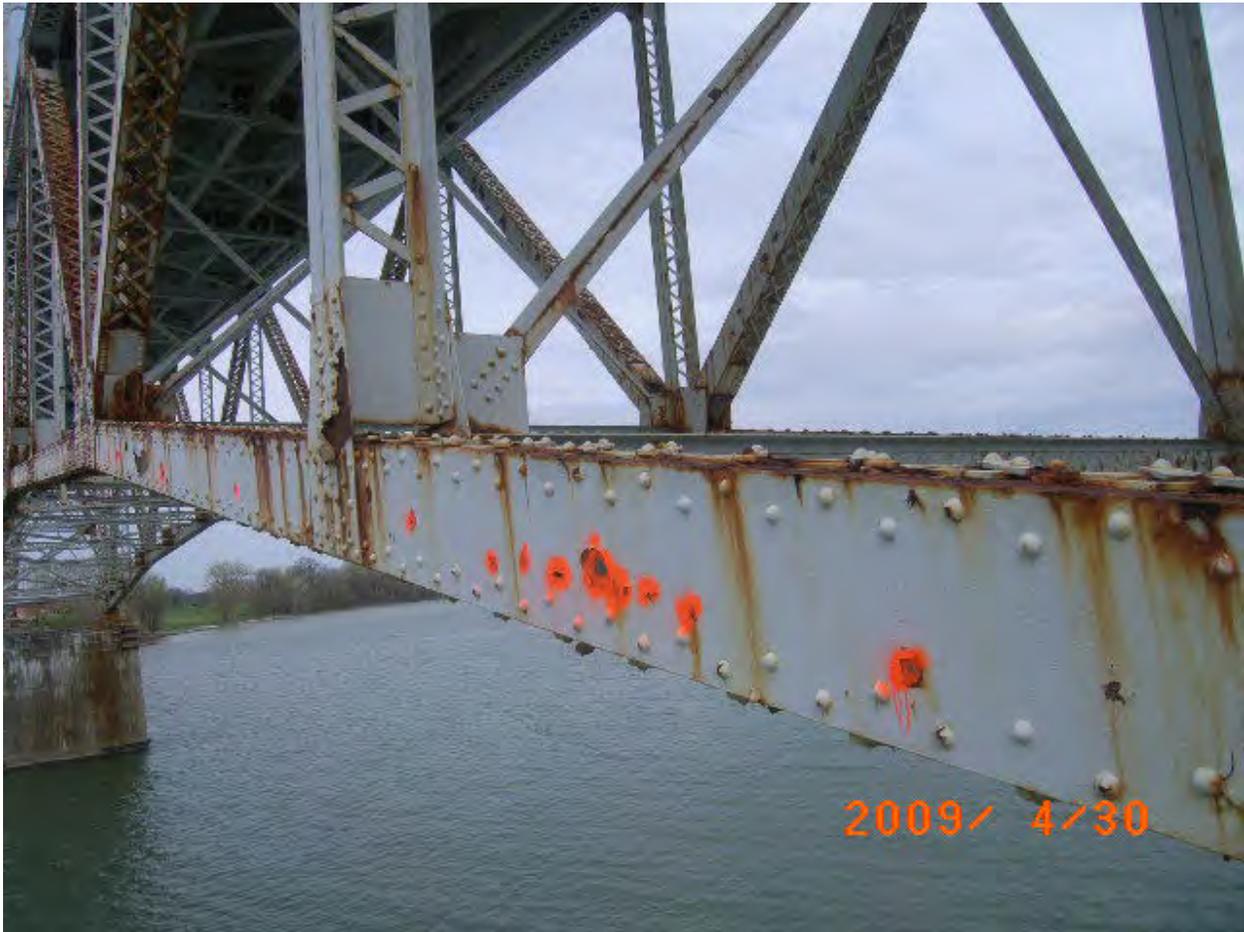
Figure 120. Span 6 lower chord connection at L01 (Spans 4, 5, 6, 8 and 9 are similar).

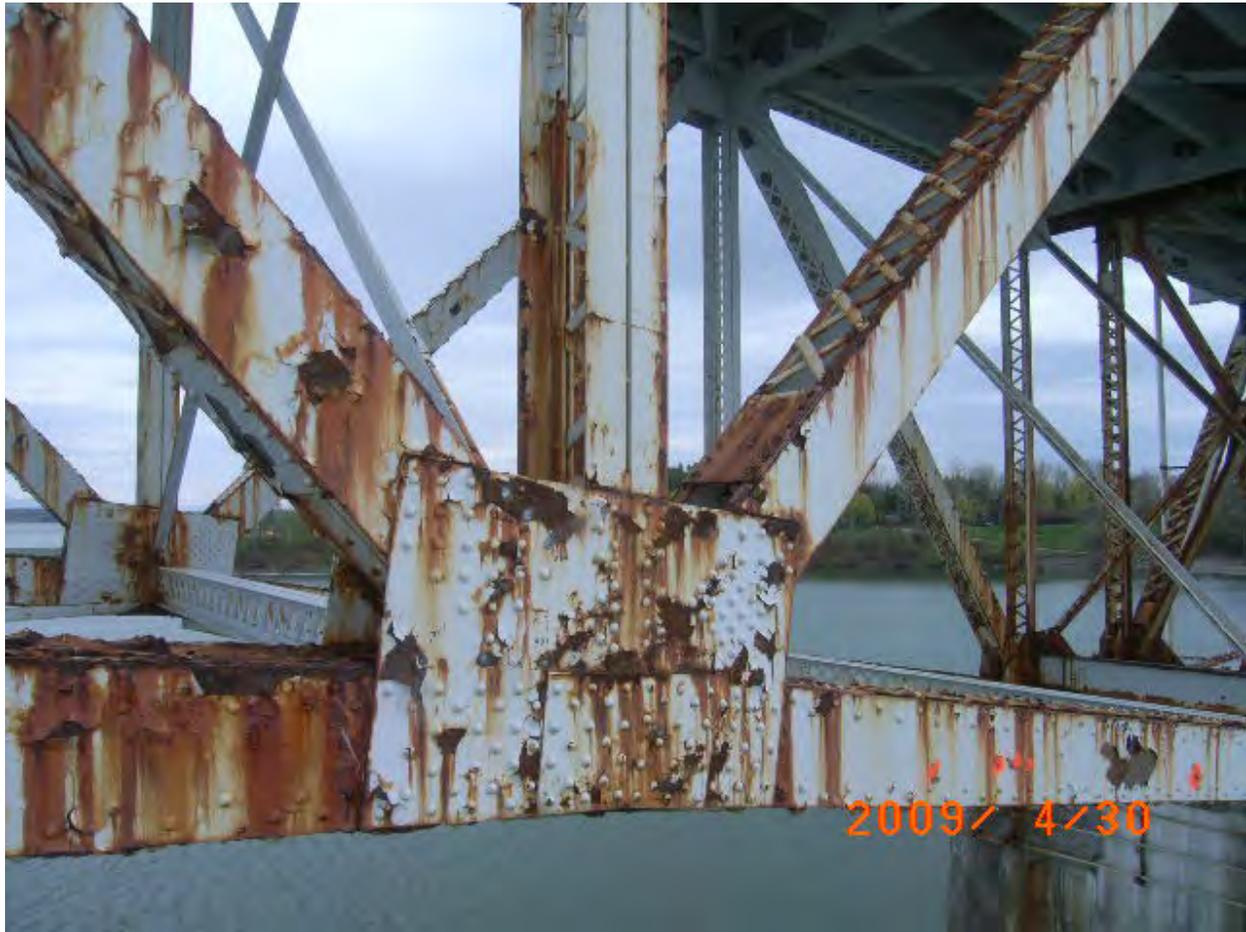
Figure 121. Span 6 lower chord at L00-L02.

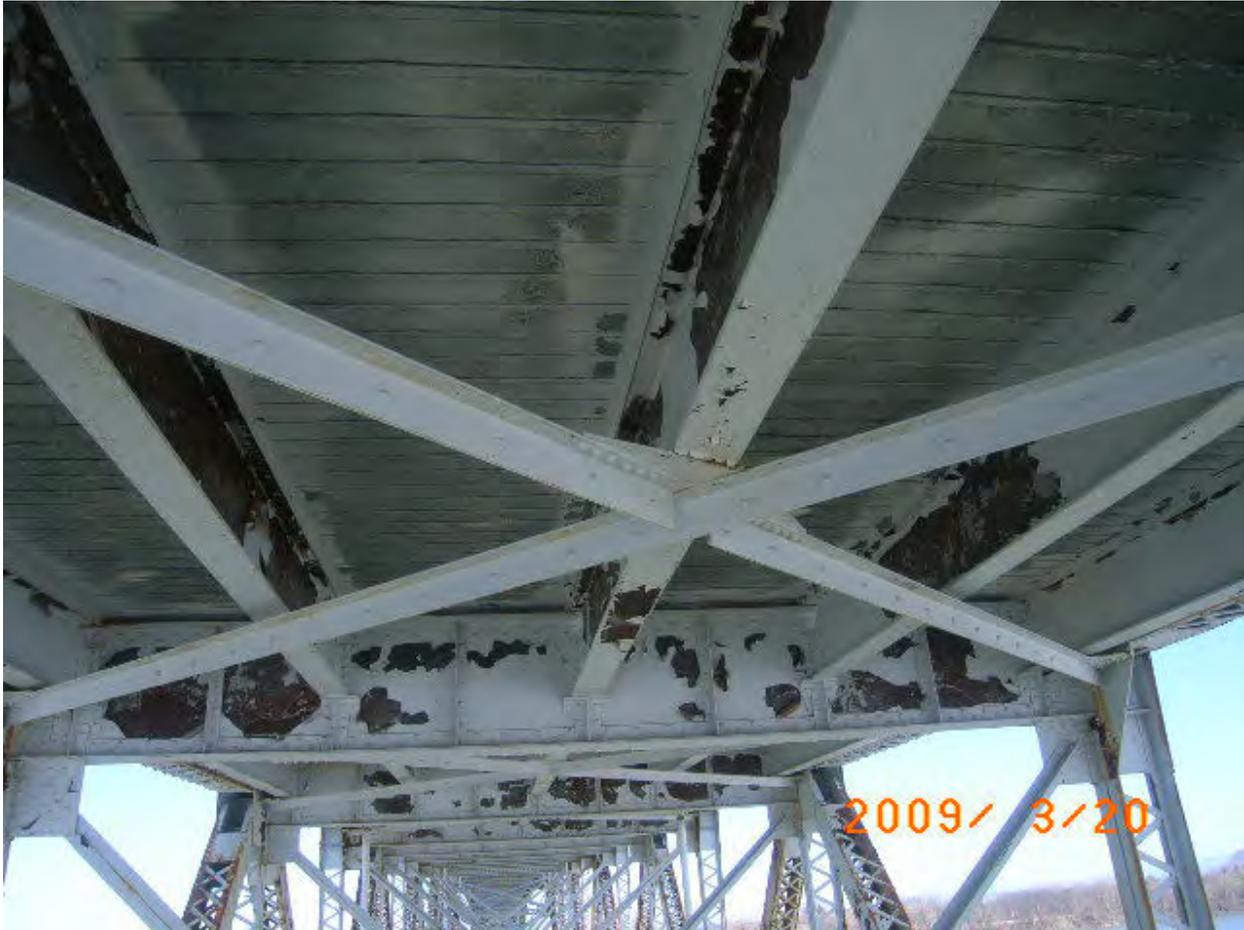
Figure 122. Span 6 lower chord connection at L02.
