HISTORIC AMERICAN ENGINEERING RECORD

LAKE CHAMPLAIN BRIDGE

HAER No. NY-541

Structural Type: Steel continuous through and deck truss span

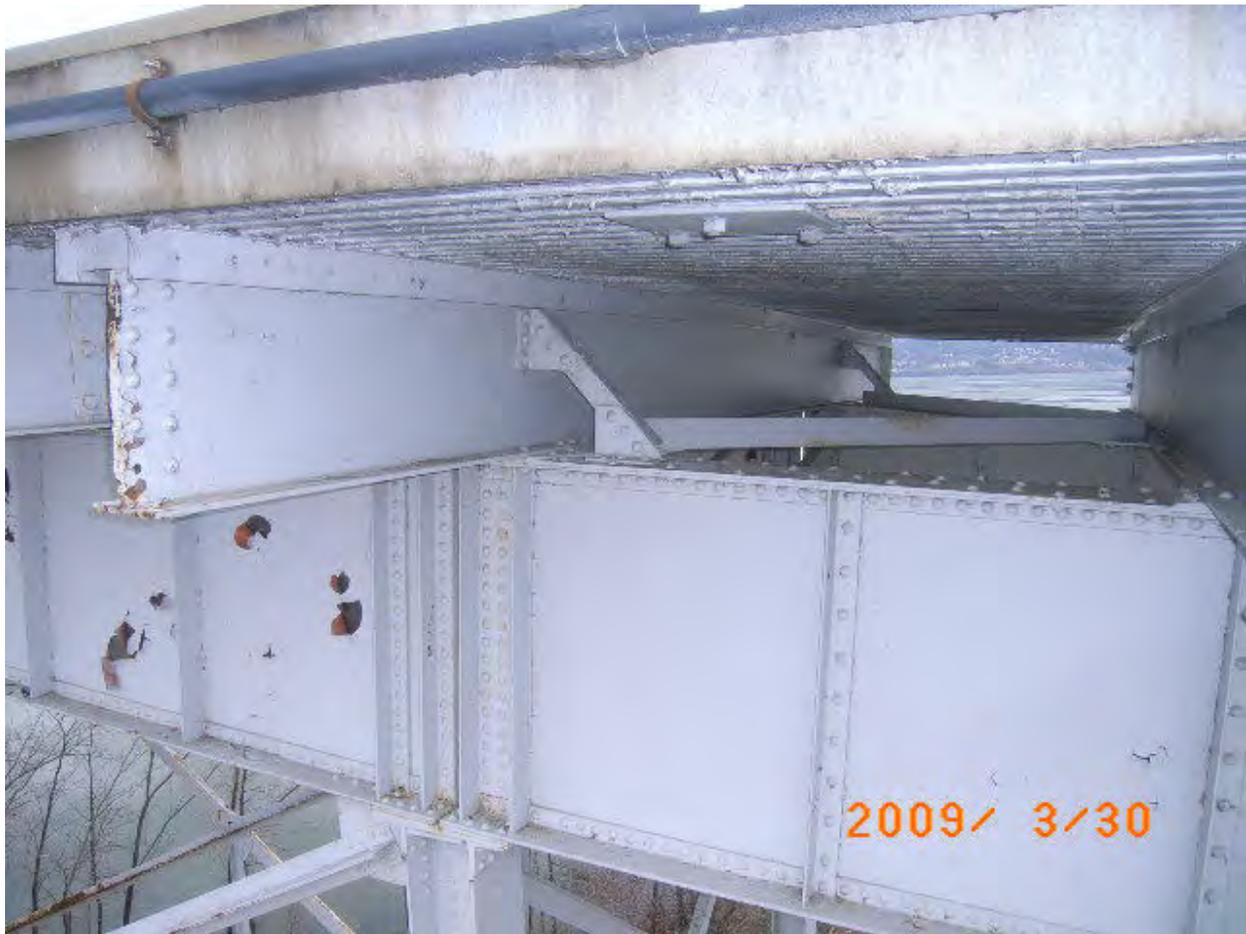
Figure 124. Span 11 Floor Beam at G2 (All girder spans are similar).

As originally designed, the deck systems for the viaduct and truss spans differed. For the viaducts, plate girders supported transverse 24" I-beams employed as floor beams but without intermediate stringers. For the truss spans, floor beams carried longitudinal I-beam stringers set slightly more than 6' apart. The deck beams carried a reinforced-concrete slab strengthened with unit trusses to counteract shear stresses in the slab. Initially, a patented, two-course, plain-concrete, wearing surface - 1-¹/₂" in depth - was poured above the reinforced concrete slab.

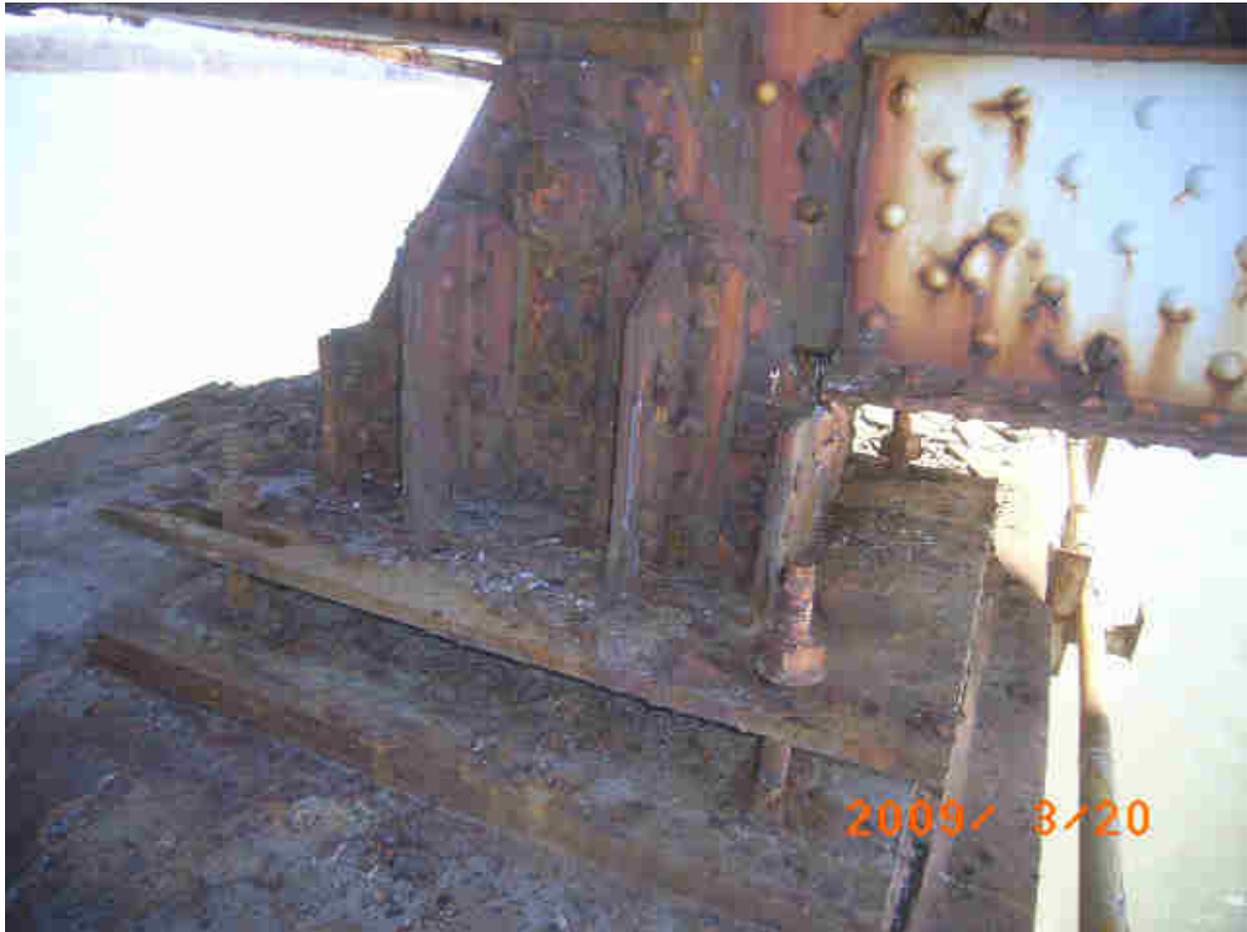
Figure 125. Pier 3 fixed bearings (Spans 3-4).

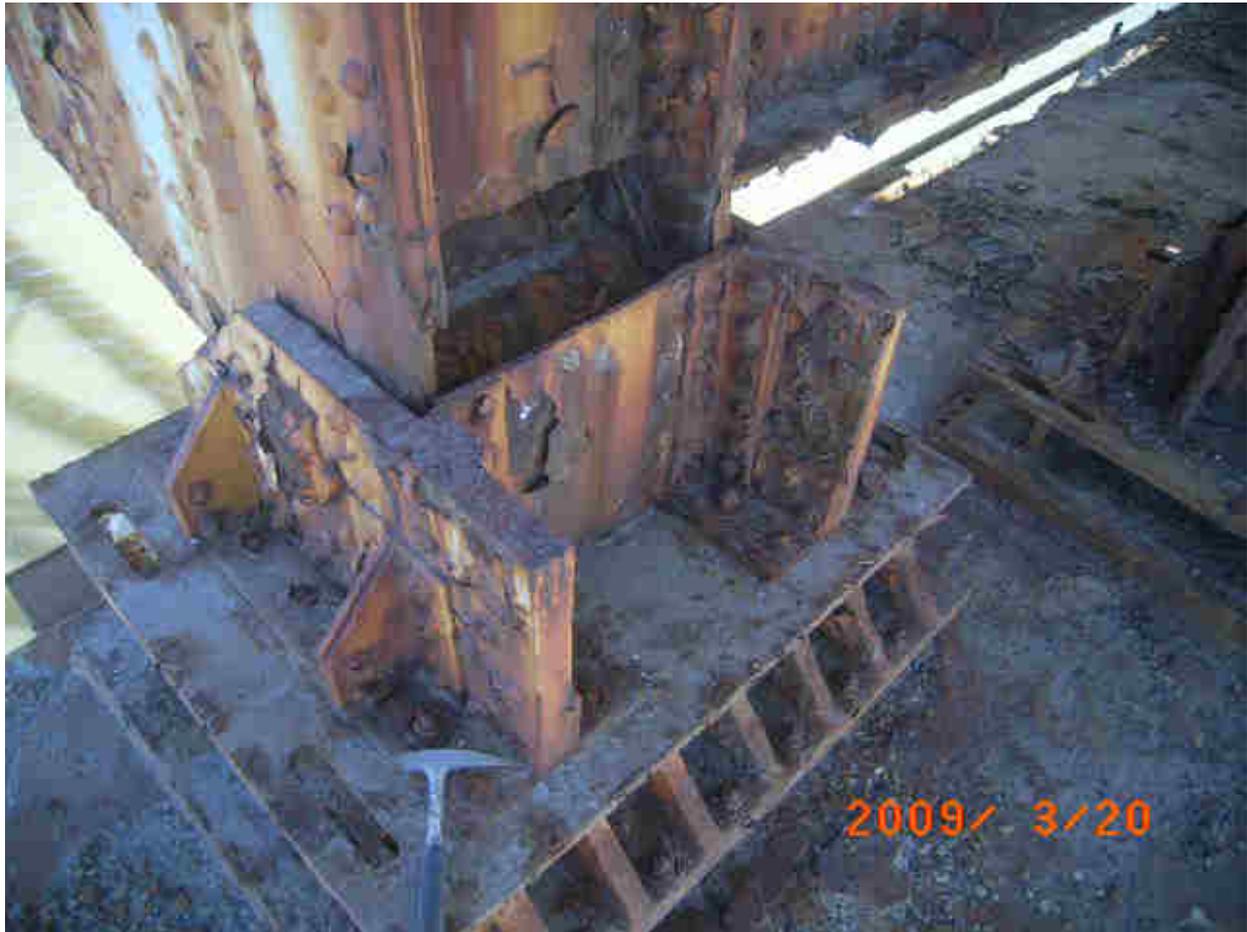
Figure 126. Span 5 at Pier 5, right truss roller bearing.

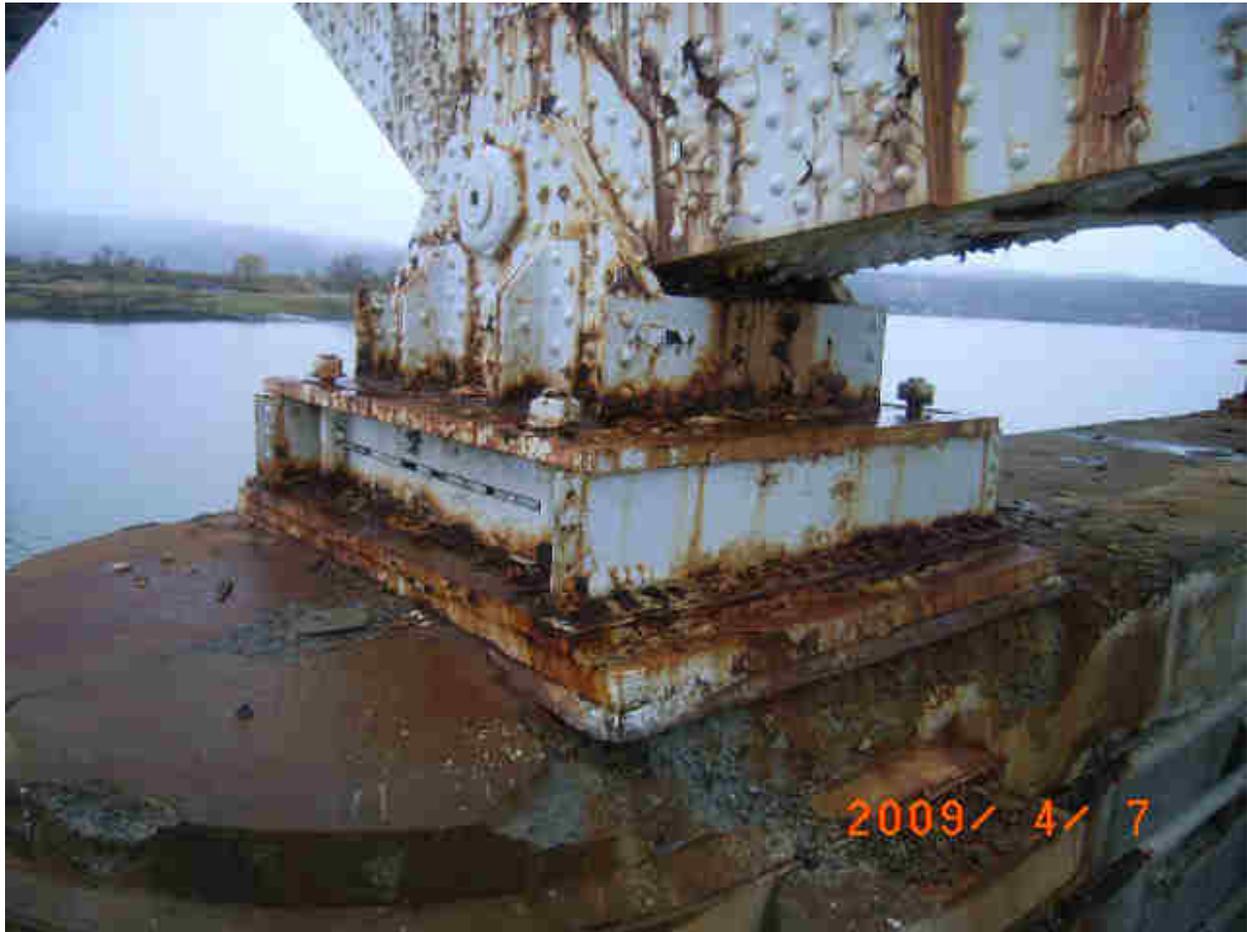
Figure 127. Span 6 at Pier 5, left truss roller bearing.

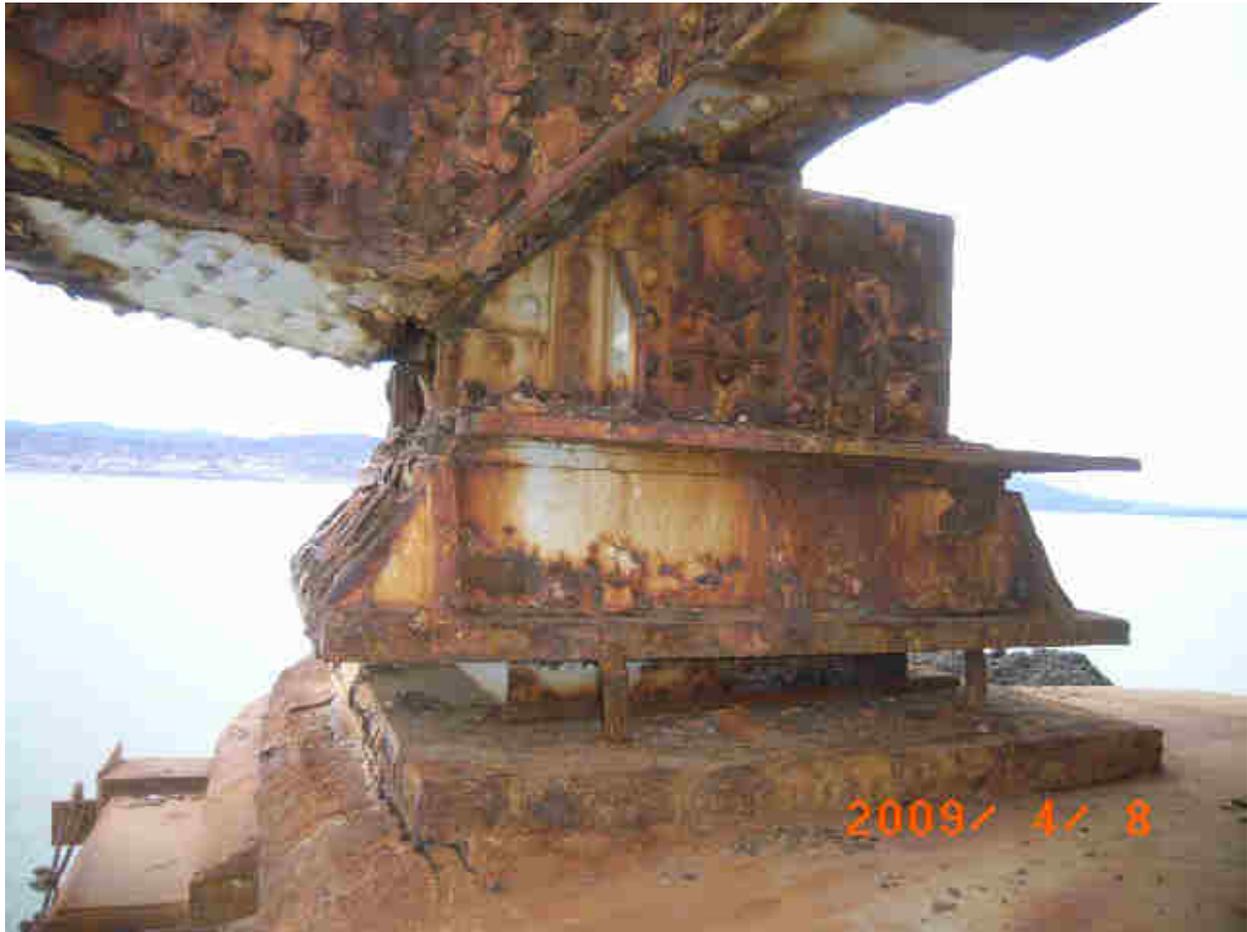
Figure 128. Spans 7/8 at Pier 7, right truss rocker bearing.

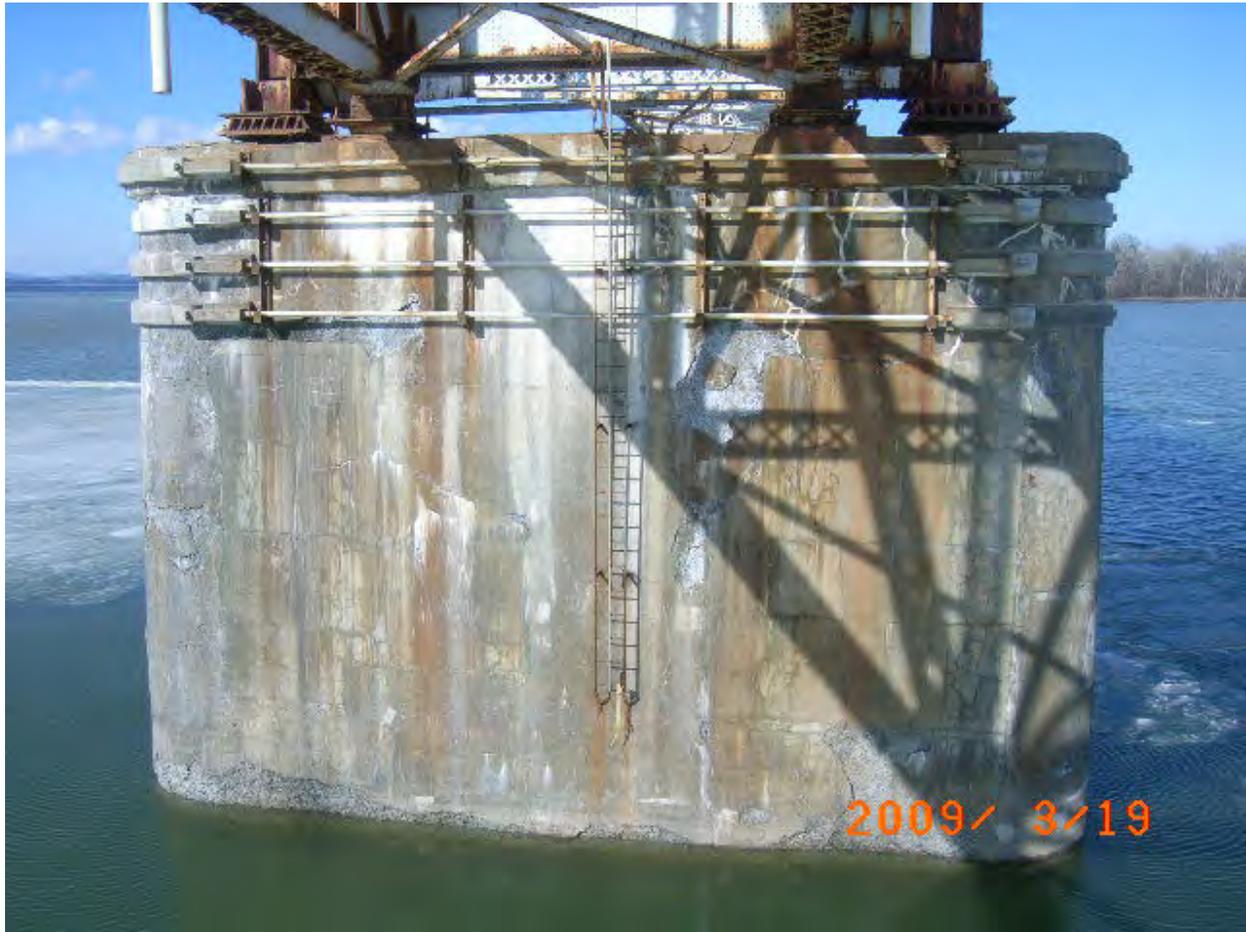
Figure 130. Pier 5, south side of stem. The potential failure of this pier resulted in the permanent closure of the Lake Champlain Bridge.

The future of the bridge was decided suddenly in 2009. Following an emergency repair of the floor system and a partial closure in July, the bridge was closed to all traffic on October 16 due to the potential failure of one of the piers. A final structural inspection by NYSDOT determined that due to extensive deterioration of the substructure and the possibility of a catastrophic failure, the bridge was unsafe for rehabilitation and would not reopen. On November 9, 2009, Governor Paterson of New York officially announced that the bridge would be replaced.

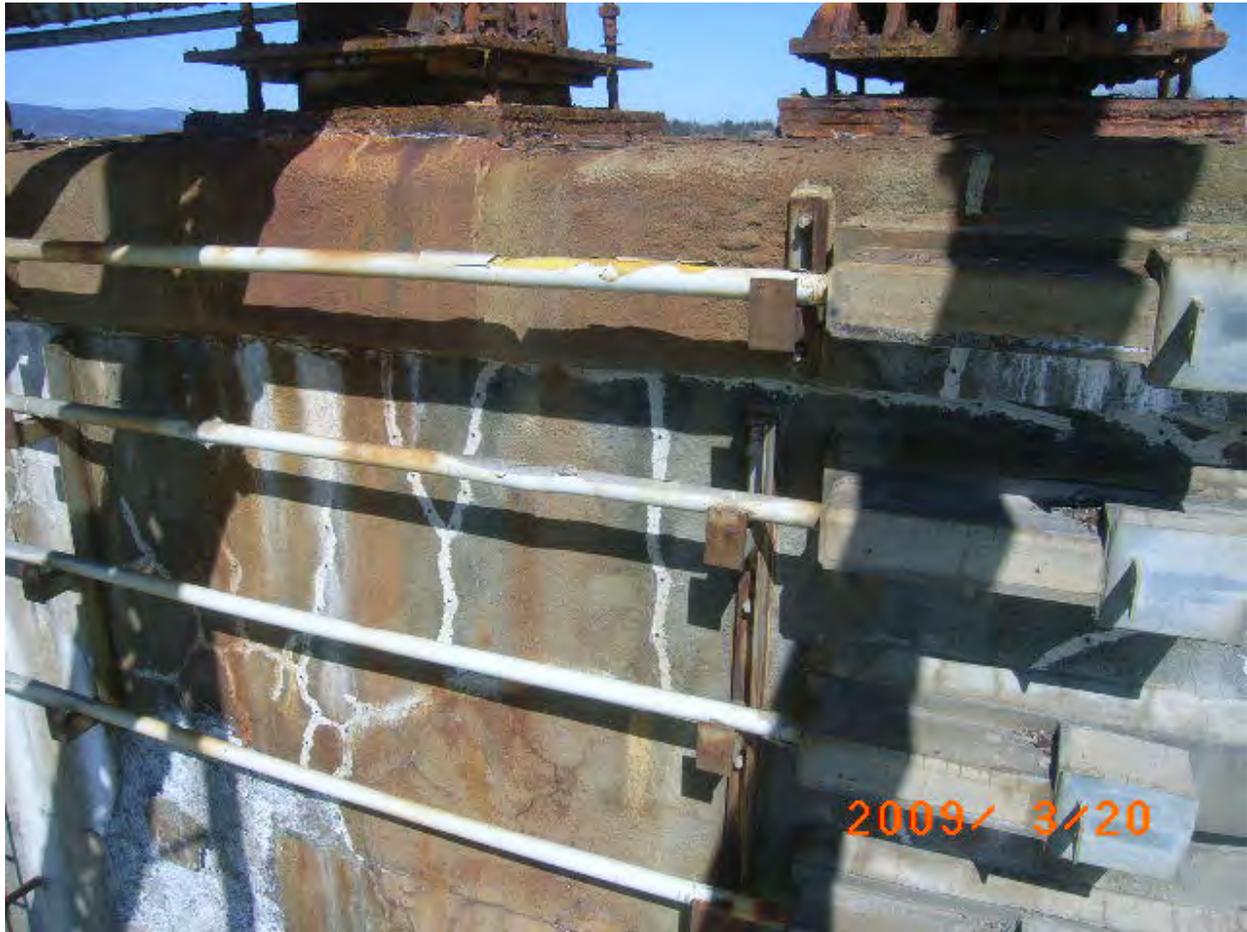
Figure 131. Pier 5 upper south side of stem, cap and tensioners.
